## Changes in Codes, Standards and Practices Following Structural Failures

### Part 2: Buildings

*By Robert T. Ratay, Ph.D., P.E.*

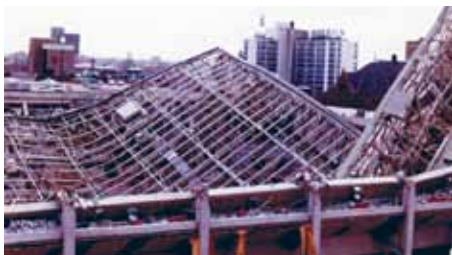
*Figure 1: Collapsed space frame roof at Hartford Civic Center.*

Related activities of the previous and subsequent years popularized the idea and, on many projects, introduced the practice of peer review. This effort followed the catastrophic collapse of the space-frame roof of the Hartford Civic Center in Hartford, CT on the evening of January 18, 1978 (*Figure 1*), just hours after the University of Connecticut Men’s Basketball team defeated the University of Massachusetts (the author’s Alma Mater), and was enhanced by other long-span roof collapses at the C. W. Post Center Auditorium of Long Island University in Greenvale, NY in 1978, the Kemper Memorial Arena in Kansas City, MO in 1979, and the Rosemont Horizon Arena in Rosemont, IL in 1980.

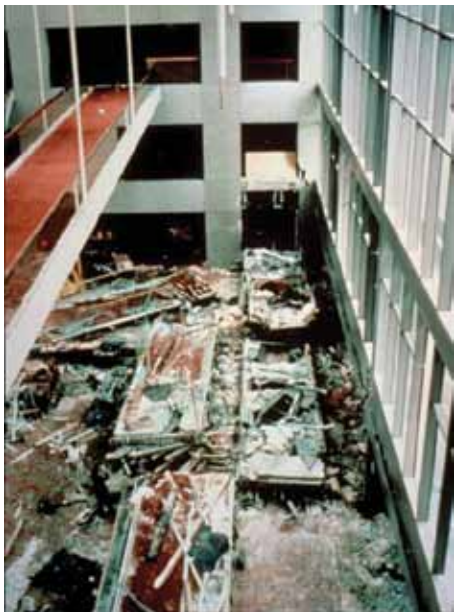
Figure 2: Collapsed skyways in Kansas City Hyatt Hotel.

professional engineers to contractors. Part of the early debate was the article, *The Hyatt Regency Decision – One View*, by Robert Rubin and Lisa Banick in the August, 1986 issue of *The Construction Lawyer*. In this article, the authors opined that “The Hyatt collapse should be used as impetus to modify structural engineering practices [related to delegation of design responsibility] in order to avert other potential tragedies – even though it is recognized their implementation might not have averted the Hyatt collapse. It is a good opportunity for re-evaluation and remediation.” The issue is still alive today, as discussed in the article, *Structural Design Delegation*, by David Hatem and Matthew Tuller in the November 2009 issue of *STRUCTURE*. The authors report that “Over the last decade, national groups representing structural engineers have provided guidelines for providing appropriate contract language to outline the design services included in ‘normal’ structural design, and those that are delegated to third-parties.” One of these organizations is the Council of American Structural Engineers (CASE), which developed a series of National Practice Guidelines. This undying attention, debate and re-evaluation was triggered by the catastrophic failure of two suspended walkways in the Hyatt Regency Hotel in Kansas City, MO, on July 17, 1981 (Figure 2), killing 114 and injuring over 216 people;

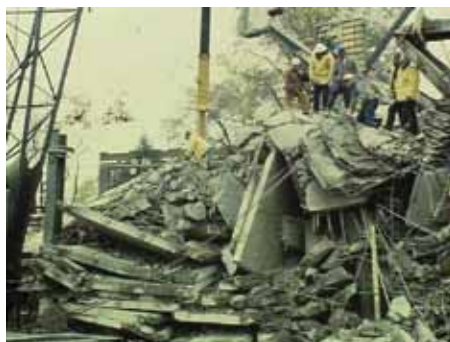
Figure 3: Collapsed lift-slab buildings at L’Ambiance Plaza.

- 3) Temporary ban and tighter design and construction requirements in some states on lift-slab construction. This was the result of the April 23, 1987 collapse during construction of the L’Ambiance Plaza 16-story residential building in Bridgeport, CT (Figure 3), in which 28 workers of the lift-slab construction project were killed. The L’Ambiance Plaza catastrophe also added fuel to the debate on the matter of delegation of design responsibility as a result of the alleged deficiencies in the design of the post-tensioned slabs that had been delegated to the contractor.

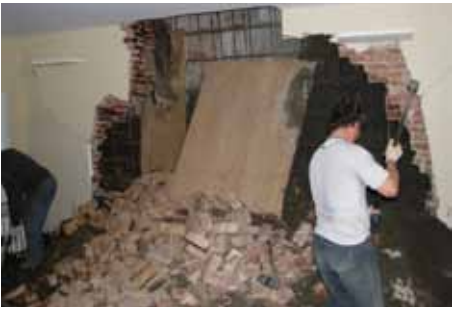
Figure 5: Collapsed wall adjacent to construction site.

for such concrete placement.” These requirements have been generated by the numerous instances of failures of existing old building walls when concrete walls of new buildings were being poured against them (Figure 5). The final trigger for the action was the March 6, 2009 collapse of the wall of a restaurant when workers poured concrete against an exterior side wall at 270 West 123rd Street in New York City, in which eleven restaurant customers and construction workers were injured.

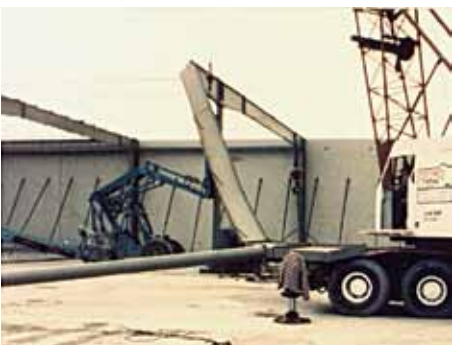
Figure 6: Toppled column during erection.

- 7) *New Steel Erection Final Rule* by the US Department of Labor, Office of Safety and Health Administration (OSHA), issued on January 18, 2001, effective January 18, 2002, mandating the use of four, rather than two, anchor bolts in structural steel column base plates, as well as a minimum design load and eccentricity in Section 1926.755(a) *General requirements for erection stability* of the Construction Industry Standards. This rule was “negotiated” as a result of numerous construction accidents caused by the toppling of unbraced steel columns during erection (Figure 6).
- 8) New and stricter requirements by the New York City Department of Buildings in Section 3306.5 *Submittal documents for demolition* of the NYC Building Code, introduced in Local

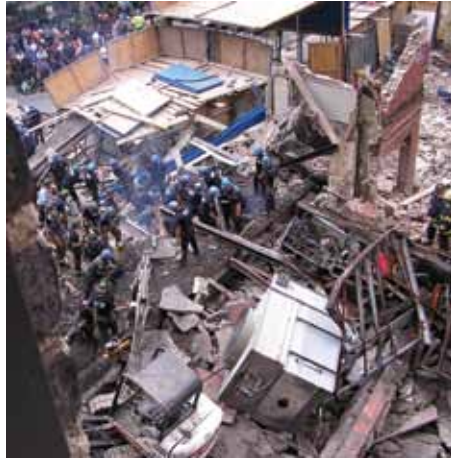
Figure 7: Collapsed building during demolition.

Law 57 of 2009, effective December 2, 2009. The new requirements include that documents signed and sealed by a registered design professional shall be submitted for the Building Department’s review and approval. The documents shall show the extent, sequence, means and methods of demolition, the bracing and shoring necessary to support all demolition operations, as well as the description of mechanical equipment proposed to be used, together with calculations showing the adequacy of the existing structure to support loads imposed by such equipment. This followed the July 14, 2005 complete collapse during demolition of a one-story building at 2633 Broadway in New York City (Figure 7), injuring one person, and the complete or partial collapses of several multi-story buildings during demolition work in New York City.

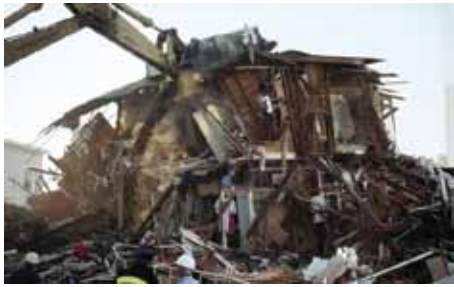
Figure 8: Collapsed wood frame buildings following the Loma Prieta earthquake.

capability of essential Federal buildings to function during or after an earthquake, and to reduce earthquake losses of public buildings, all in a cost-effective manner.” The Order followed the moderately large (7.1 on the Richter Scale) October 17, 1989, Loma Prieta, CA earthquake.

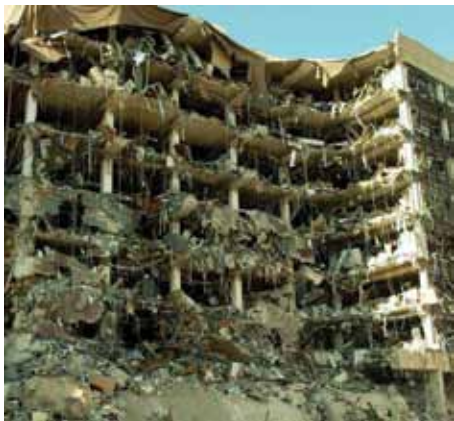
Figure 9: Heavily damaged Murrah Federal Office Building following its bombing.

continuity of reinforcement, first in the ACI 318-02 by the addition of Section 21.2.6.1(b) for mechanical or welded butt splices, and later in the ACI 318-02 and -08 by increasingly stricter and more detailed minimum requirements in Section 7.13.2 for continuity of reinforcement. The intent of the changes was, as stated in the ACI 318-08 *Commentary* Section R7.13, to “improve the ductility and redundancy of structures so that in the event of damage to a major supporting element or an abnormal loading event, the resulting damage may be confined to a relatively small area and the structure will have a better chance to maintain overall stability.” These actions were precipitated by the April 19, 1995 bombing of the Murrah Federal Office Building in Oklahoma City, OK, which resulted in heavy damage and collapse of a large part of the building (Figure 9).

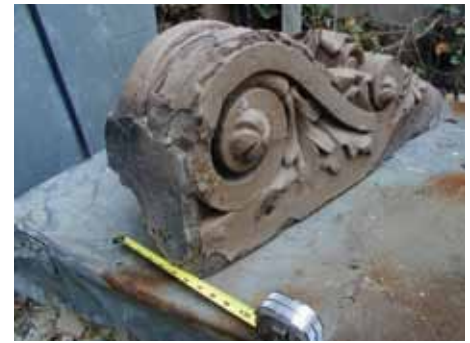
Figure 10: Decorative pediment fallen from a building façade in Brooklyn, NY.

- 12) Rules, regulations, local laws, façade ordinances in a number of cities – including Boston, Chicago, Columbus, Detroit, Milwaukee, Philadelphia, Pittsburgh, New York, and St. Louis – to assure public safety against crumbling façades, falling appendages and other hazards by requiring and strongly enforcing periodic inspection, maintenance and repair of building façades. Their developments were influenced by local politics, economics and engineering practice. (It is noted that façade failures are often the results of inadequate maintenance or repair rather than of design and/or construction defects.) The façade ordinances are mostly in response to incidents of falling materials from buildings onto sidewalks that had caused damage, disruption of traffic and serious injury (Figure 10). In particular, some of the much-publicized incidents that triggered the responses included those of the 1974 falling of a façade tile and the 1999 falling of a piece of wind-propelled glass in Chicago that struck and killed two people; the 1979 falling of a stone appendage that struck and killed a college student in New York; and the 1997 bulging and subsequent partial collapse of the brick veneer on a wall high above Madison Avenue in New York, raining bricks down onto the adjacent building and onto Madison Avenue.
