# CONSTRUCTION ISSUES

## Accommodating Movement in High-Rise Wood Frame Building Construction

By Richard W. Howe, P.E.

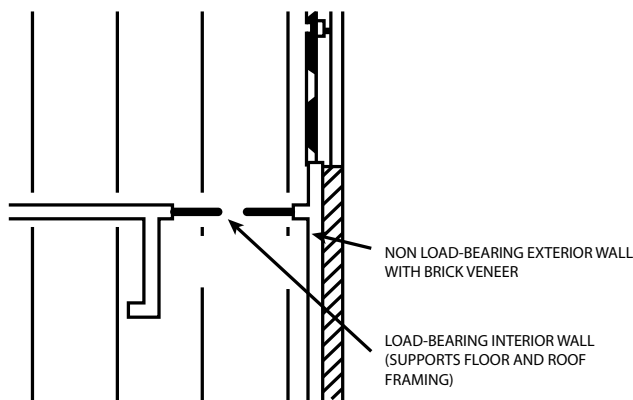
Figure 1: Interior load-bearing wood stud walls with doorways located immediately adjacent to intersecting exterior non-load bearing walls with brick veneer invites problems at header corners.

- Interior load-bearing wood stud walls with doorways located immediately adjacent to intersecting exterior non-load bearing walls with brick veneer – This unique condition invites never ending distress to finishes at door header corners. An example of such a condition is shown in *Figure 1*.

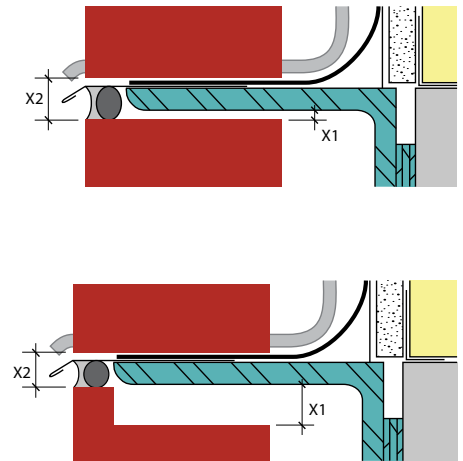
Figure 2: Lipped brick is an effective way to address soft joints.

In *Design and Detailing of Expansion Joints in Clay Brick Veneer*, G.A. Dalrymple points to the use of lipped brick as an effective way to address soft joints (*Figure 2*). This is perhaps the most effective, if not only way, to address the classic problem of typical  $\frac{5}{16}$ - and  $\frac{3}{8}$ -inch shelf angle outstanding legs while maintaining the standard  $\frac{3}{8}$ -inch mortar joints and achieving a soft joint. Even this detail calls for special attention to compressibility of sealants vs. anticipated movement.
