That Hollow Feeling

By Milan Vatovec, P.E., Ph.D., Paul Kelley, P.E. and Gustavo Tumialan, P.E., Ph.D.

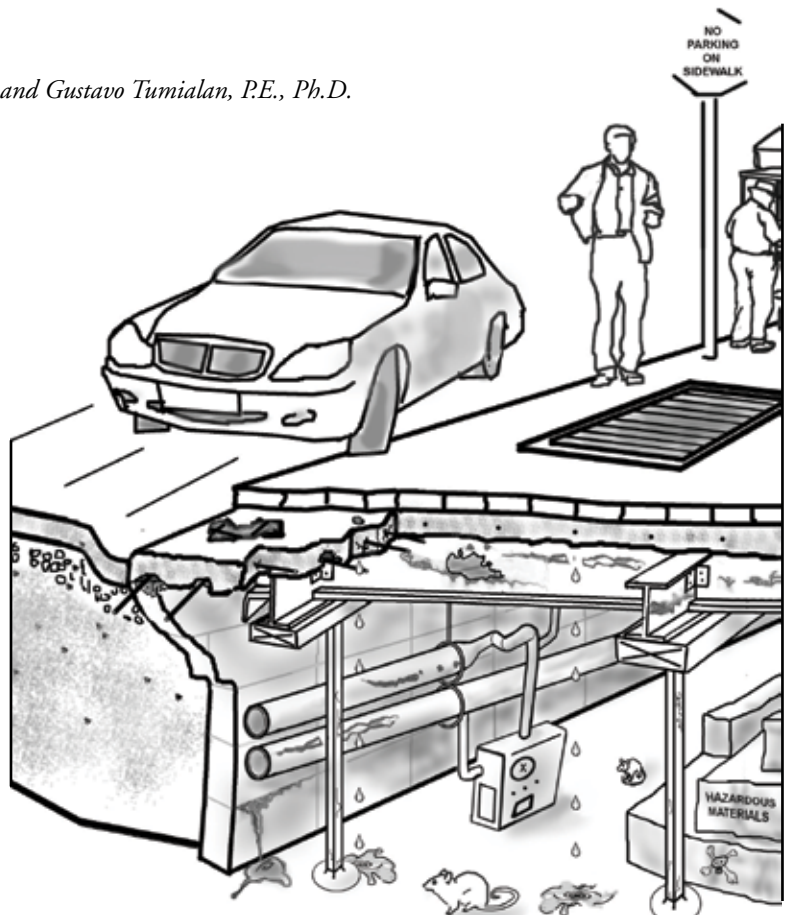
Figure 1: Frequently, the sidewalk over the vault, the only barrier preventing people and vehicles from falling into the basement, is badly deteriorated and unsafe.

A city sidewalk might not be as simple as it appears – it depends on your perspective. Many pedestrians do not expect that the common sidewalk they walk on might be hollow. But hollow sidewalks are common in many older cities; the sidewalk was the early loading dock through which the building was stocked with supplies via a sidewalk hatch. In these older buildings, the basement extends beyond the footprint of the building and under the city sidewalks. The “vault” space under the sidewalk ends with a concrete or masonry wall that retains the soil beneath the street. And frequently, the sidewalk over the vault, the only barrier preventing people and vehicles from falling into the basement, is badly deteriorated and unsafe (Figure 1).

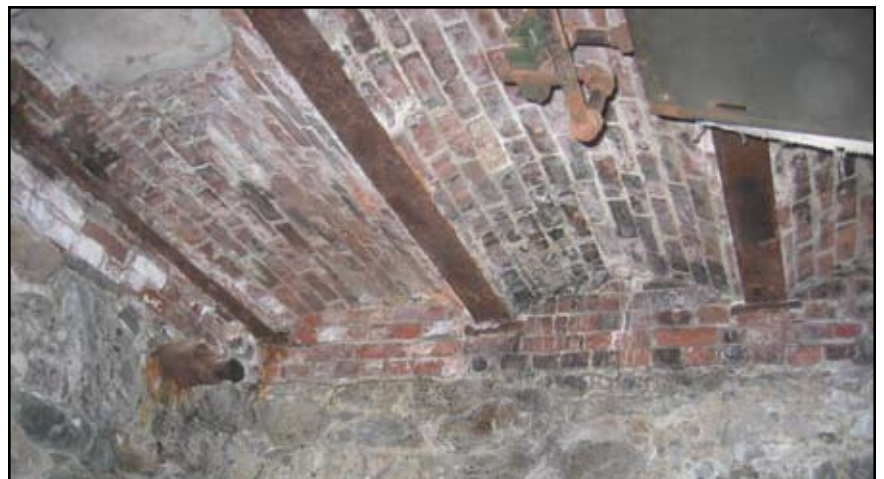
Figure 2: Segmental masonry brick arches supported by steel beams and stone masonry walls.

Some sidewalk-vault structures consist of brick or terra-cotta arches, supported by steel beams concealed in the arches (Figure 2). This construction includes concrete toppings (typically 4 inches thick), or thin brick pavers (typically in the range of 2 inches thick), which tend to crack or dislodge due to heavy traffic above. Due to the arch configuration, these vault covers are generally capable of supporting high loads. However, their susceptibility to water penetration often results in heavily corroded steel beams and masonry arch deterioration due to freezing and thawing cycles, therefore rendering the entire system very weak and unreliable.

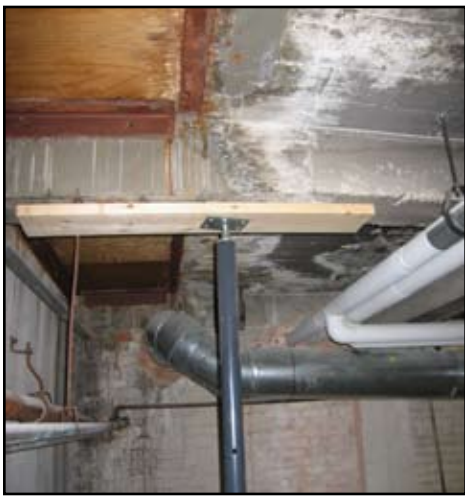
Figure 3: Concrete beams and slabs forming the vault cover. Note the shored beam and leaching on the slab underside caused by moisture migrating from the top.

Newer systems are very similar to modern bridge decks, and include concrete slabs on metal deck supported by steel beams. Other typical systems include concrete beams and infill slabs. These vault types typically also have a topping for pedestrian traffic. Just like any other systems, if not constructed properly and with forethought, these structures can also deteriorate very quickly if water is allowed to enter the system (Figure 3). Just like modern bridge decks, there is frequently no waterproofing membrane to protect structural components from water ingress, which when laden with deicing salts, can cause very early

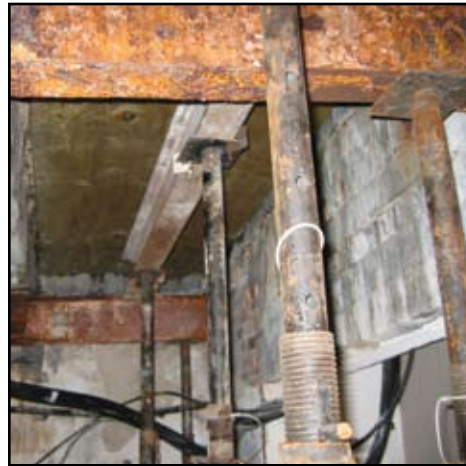
Figure 4: Shoring of a deteriorated vault structure.

In many of the vault spaces there are remnants of past attempts to “shore up” the deteriorating decks, rather than evidence of leakage maintenance and/or structural repair. The shoring often involves timber or metal posts and other types of structural elements (Figure 4). These conditions are difficult to evaluate, because very frequently there is no documentation showing who installed the shoring, for what reason, and when. In addition, the shoring elements (plywood, timber) often cover the underside of the actual structure, rendering observation of structural conditions impossible. Shoring of the structure also frequently gives a false impression of safety to building inhabitants and to the untrained inspector.

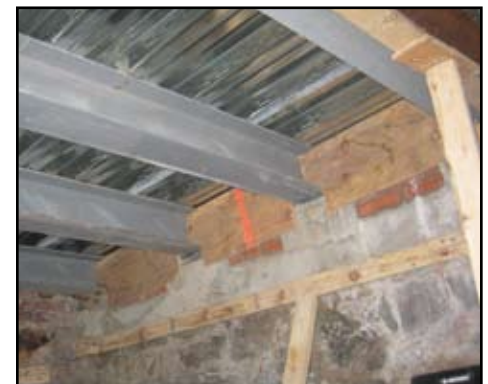
Figure 5: Support for new cover vault consisting of metal deck and steel framing.

Total or partial replacement of the vault structure is usually the best solution, but it can be shockingly expensive. The sidewalk covers can be replaced with a more-durable system, supported by a new permanent support structure below (Figure 5). Partial replacement of

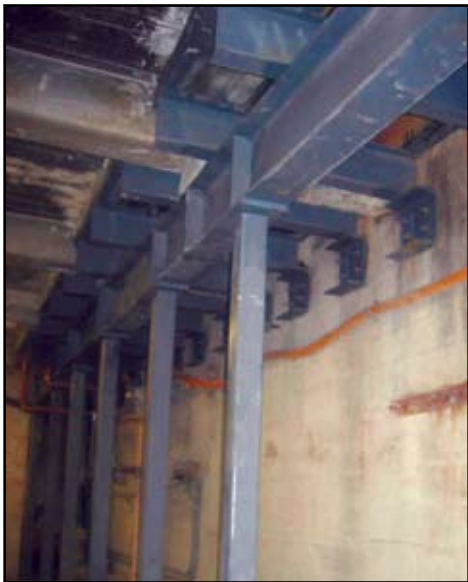
Figure 6: New steel structural support for partial replacement of a vault cover. Note that the original structure consists of concrete beams and slabs.

the cover is also an alternative, but it requires integration between the existing and new covers (Figure 6). A common and comprehensive waterproofing system should be installed, and/or the entire deck and support systems must be made robustly resistant to water ingress. The problems with comprehensive cover and structure replacements include access solutions (around the existing equipment, tenants, etc), rerouting of pedestrian traffic, temporary support of the retaining wall during construction, temporary or permanent relocation of utilities, etc. Relocation of utilities typically deserves special attention, since the vault spaces often house very congested utility lines (Figure 7). Utility relocation and even identification of active versus abandoned components, can result in additional expenses, potentially requiring special permits and coordination with the building departments.

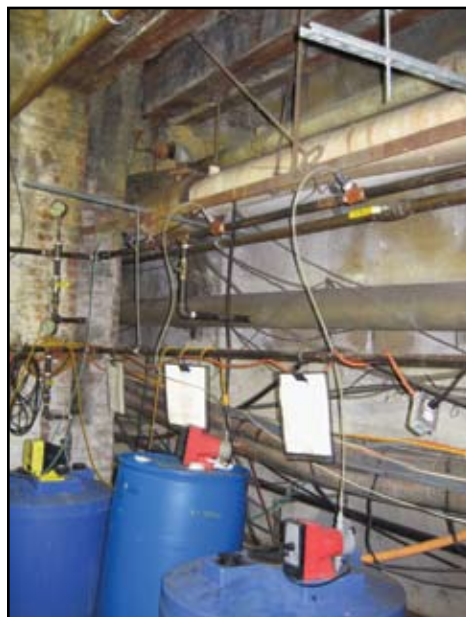
Figure 7: Vault space congested with utility lines.
