Fox Oakland Theater Renovation & Seismic Retrofit

By Hratch Kouyoumdjian, S.E., LEED AP

The KPA Group was an Award Winner for the Fox Oakland Theater Seismic Retrofit project in the 2010 NCSEA Annual Excellence in Structural Engineering awards program (Category – Forensic Renovation/Retrofit/Rehabilitation Structures)

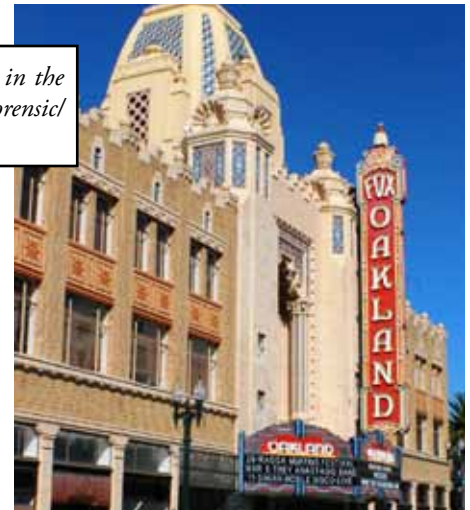
- New buttresses hidden in the adjacent wrap-around building on each side of the roof to stabilize the roof, and also connected to the balcony to resist seismic forces and reduce demands on diaphragms.
- A new steel frame behind the proscenium wall braced back diagonally to the main building corner columns.
- New shotcrete walls behind proscenium side walls, theater back wall, balcony side walls and other locations to enhance wall capacities.
- Two new U-shaped concrete walls constructed immediately to the north and south of the entrance structure and

doweled into the existing walls to brace the trusses supporting the Dome to resist earthquake forces.
