THE TRANSFORMATION OF THE HISTORIC FIRST NATIONAL STATE BANK BUILDING

Newark New Jersey – Part 1

By D. Matthew Stuart, P.E., S.E., FASCE, FSEI, SECB, MgtEng
and Ed D. Cahan, P.E., S.E.

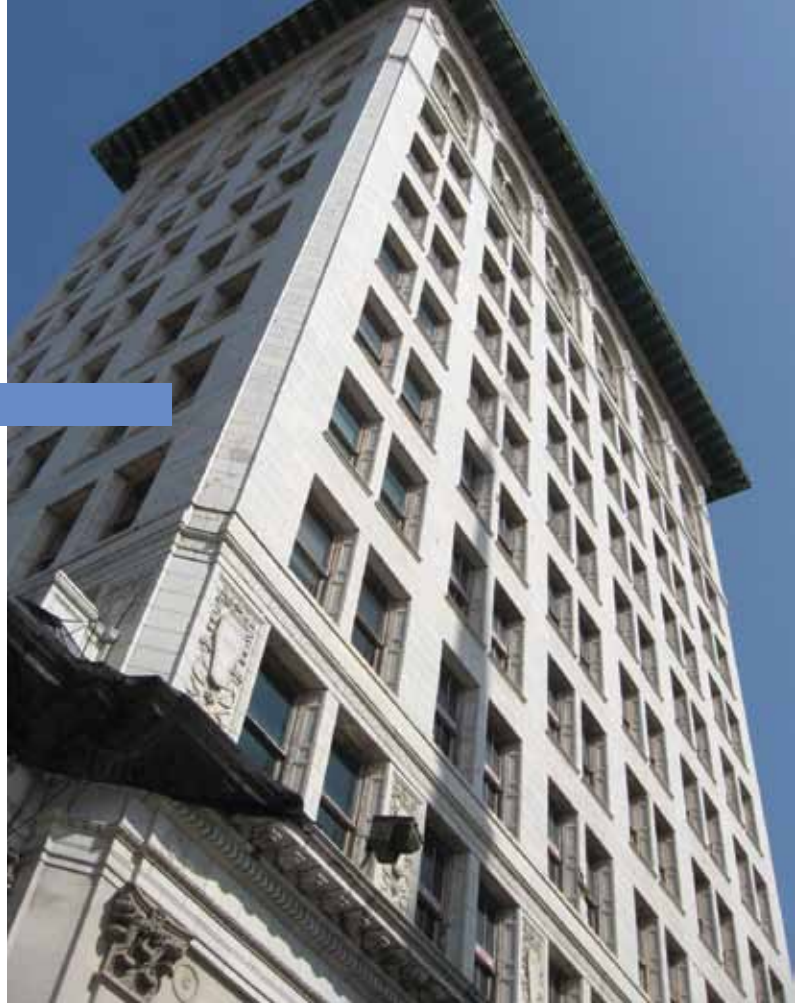
Figure 1: Existing façade prior to renovations.

More than 100 years after its original construction in 1912, the First National State Bank Building in Newark, New Jersey (*Figure 1*) is ready to return to prominence. Located near the intersection of Broad and Market Streets, one of America's busiest intersections just after the turn of this century, the rehabilitation of this structure is paramount to the ongoing revitalization of Newark's historic commercial and business district known as the "Four Corners". The structure consists of a 12-story mid-rise building with concrete slabs, steel I-beams and built-up steel columns; an adjacent three-story addition with concrete slabs and steel W-shape beams and columns constructed at an unknown date; and a more recent four-story structural steel, masonry block and brick stair and elevator tower at the very rear of the property.

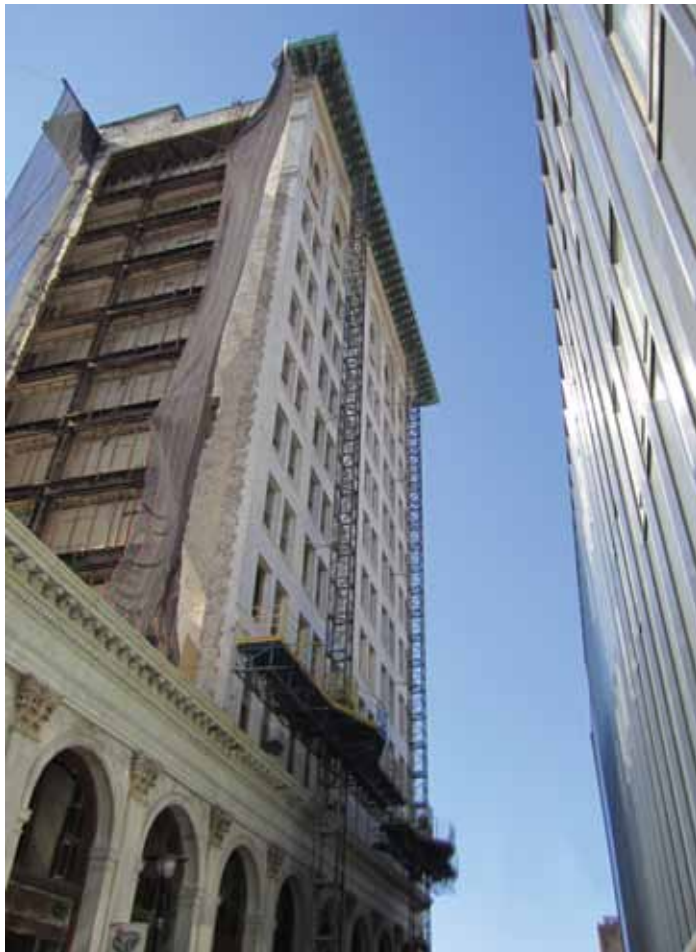
Figure 2: Exposed existing spandrels after east masonry wall demo.

adjacent floor framing and a small portion of the exterior brick cladding, while the exterior member supported only the exterior brick cladding (Figure 2). Both spandrel beams framed to, and were supported by, the same steel column, but the exterior member required an extended single plate shear connection because it did not align with the column centerline.

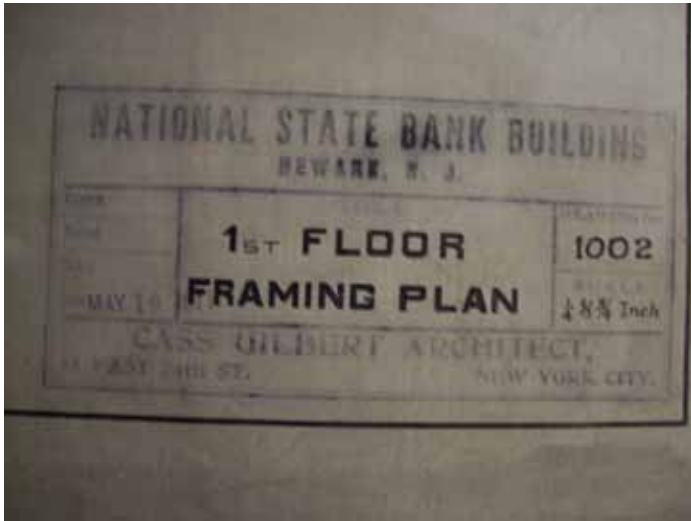
Figure 3: Cass Gilbert drawing titleblock.

addition were added to the National Register of Historic Places in 1977. The structural drawings were prepared on linen sheets, and due to their age and fragility, the New York Historical Society would not allow the drawings to be removed from their office for reproduction purposes. Therefore, each drawing sheet was laid out on a table at the Historical Society's office and photographed for future use in analyzing the existing structure for the required modifications. The first step was taking a photograph of an overall drawing, followed by taking close-up photographs of portions of the same drawing that could be laced together in sequential order so that the entire drawing could be viewed in greater detail at Pennoni's Philadelphia office (Figures 3 and 4). This

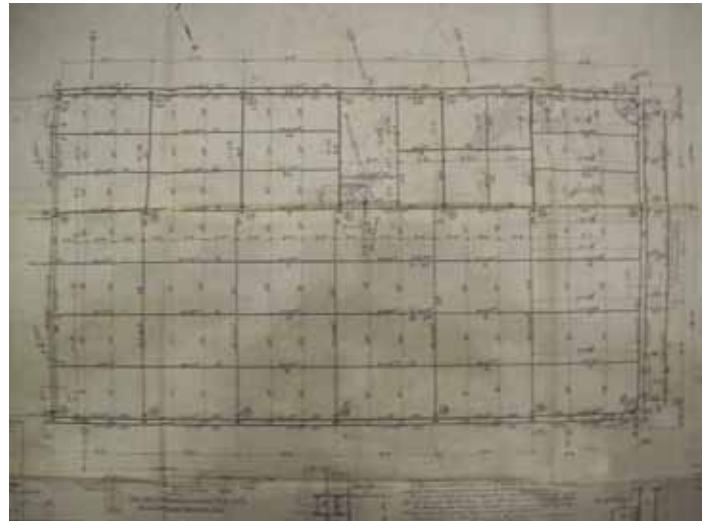
Figure 4: Cass Gilbert drawing 1st floor framing.

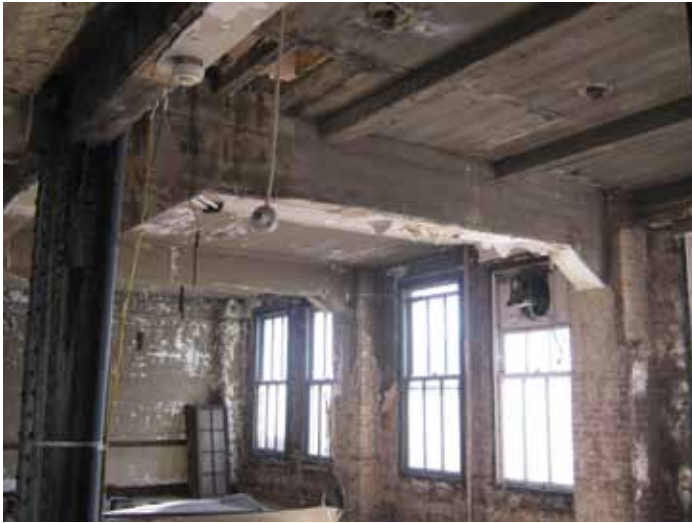
Figure 5: Existing encased bent prior to renovations.

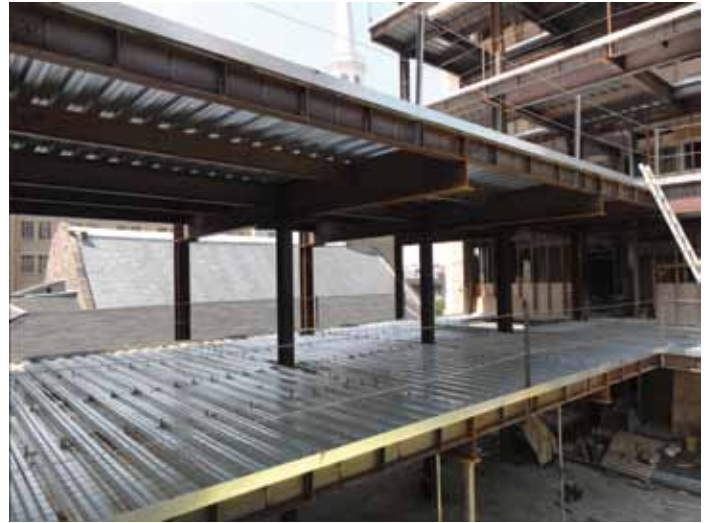
Figure 6: 4th & 5th floor addition north elevation cantilevers.

extension from the existing north elevation of the original facility because of a National Register of Historic Places and State Historic Preservation Office (SHPO) requirement not to alter the sightlines of the building as viewed from Broad Street. As a result, the north exterior wall of the new addition was set back from the north exterior wall of the existing low-rise below. The existing interior and exterior columns along the south exterior wall were used to support the new addition, but a large cantilever at the new fourth and fifth floors was required to support the portion of the addition on the north side of the interior column line (Figure 6). Excessive deflections at the cantilever were mitigated by using an upward camber equal to the total dead load deflection, and by providing slightly deeper members than those required for strength design only.
