Who is Responsible for the Support of Nonstructural Elements?

By Richard Hess, S.E., SECB

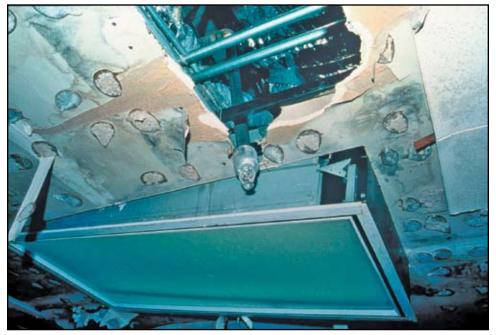
Figure 6: Broken Fire Sprinkler Pipe and Water Damage. Photo by Bob Reitherman, courtesy of EERI.

A major cause of damage during Katrina (2005) was from detached nonstructural elements turning into missiles that penetrated and destroyed the building's skin or its structural supports. Interior partitions are not designed to resist high wind, but when the exterior glazing of the New Orleans Hyatt Hotel was destroyed, the wind and rain quickly proceeded to turn these partitions into rubble. Similarly, in an earthquake, the building structure may withstand the imposed forces and the hung ceiling may be properly braced, and yet the building interior can be completely destroyed by water released from broken sprinkler piping or a storage reservoir located on the roof (Figure 6).
