# Philadelphia City Hall

Exterior  
Envelope  
Renovation

By Nan R. Gutterman, AIA and Carl A. Baumert, Jr., P.E.

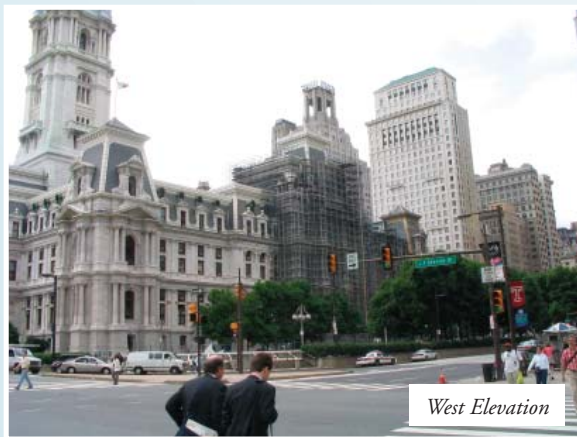
- Old window air conditioners had been installed over the years in the upper or lower parts of the windows, moving the sash to suit and stuffing insulation between the upper and lower sash. Various methods of support were employed, ranging from blocking or posts on the sill to hangers from inserts in the stone soffit above. Condensate damaged wood sills and the marble below. All of these units were removed and turned over to the Owner.
- New support frames were designed and installed, with proper closures at the sides and above or below. Frames were anchored to the window frames, not to the masonry. The new window units with upgraded electrical service were then installed.
