# structural forum

## Results for March Drawing Quality article

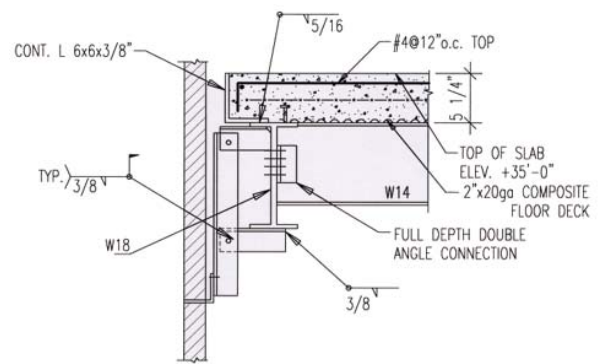
3 TYPICAL SPANDREL SECTION

*"Fictitious" modern-day CAD-drawn detail showing many common drafting and detailing errors. How many can you find?*

1. Welded wire reinforcing shown too far down below top of slab

2. WWR shown out of scale. Cross wires should be drawn at 6" o.c.

3. No length indicated for reinforcing bars

4. Reinforcing bar bends have a radius on them. It's not good detailing practice to draw sharp bar bends (especially for the larger bar sizes.)

5. When pointing to the top of a slab the leader arrow should not be pointing to the underside of the top surface – it should point down onto the top of the slab.

6. 2" deep floor deck is drawn out of scale.

7. 2" deep floor deck is not drawn with the correct deck profile for composite floor deck commonly used in the U.S.

8. "All around" weld symbol is not appropriate when a continuous angle is welded to the top flange of a beam.

9. "All around" weld symbol (the circle) is drawn too small. (note: See page 8-31 of the 3rd Edition AISC Manual for additional info on how weld symbols should look.)

10. Fillet weld size is shown on wrong side of fillet weld triangle.

11. Fillet weld symbol (triangle) is drawn backwards.

27. The 6x6 angle is also much bigger than is needed (i.e., a waste of steel). A gage metal pour stop would probably be more appropriate for this condition.

30. Information on welds between the angles and W shape are missing.
