structural REHABILITATION

The case to replace terra cotta in-kind with the integration of a corrosion mitigation system, rather than full-scale replacement or replacement with an imitation material, provides clients with a durable, long-term repair and restoration program that retains the original building fabric. This article discusses the history of architectural terra cotta and various repair options in lieu of stripping and replacing.

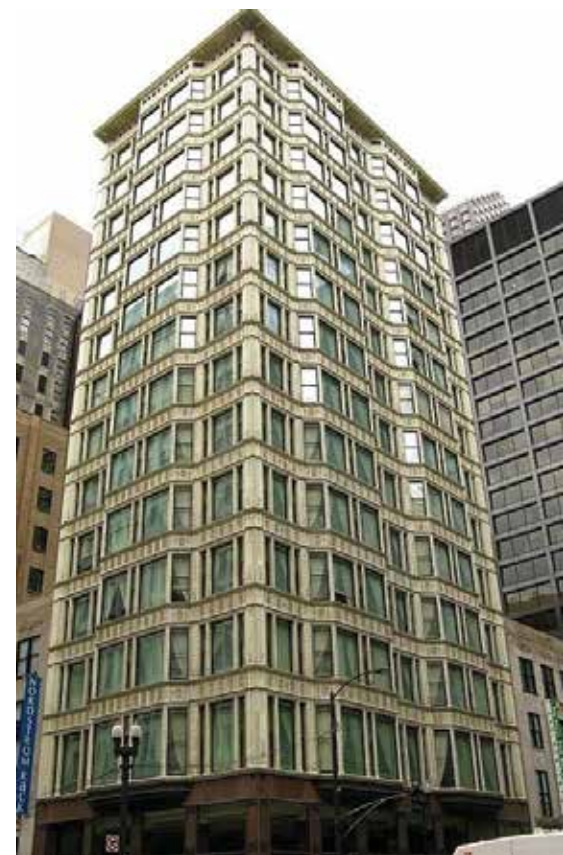
Figure 1. The Reliance Building, Burnham and Root/Atwood. Example of an early steel frame terra cotta clad building. Courtesy of TheArchitecturePost.com.

It was not always practical or economical for the tall steel frames to support solid, hand-carved stone. Terra cotta was an excellent substitute. Made of clay, its plasticity allowed it to be formed into any shape; the use of molds made it easier to mass produce high-quality beaux art design. Terra cotta units were hollow and significantly lighter than stone, and its compressive strength could support its own weight. Hence, a new non-load bearing enclosure for the metal skeletal structure, i.e., the curtain wall, was developed (*Figure 1*).

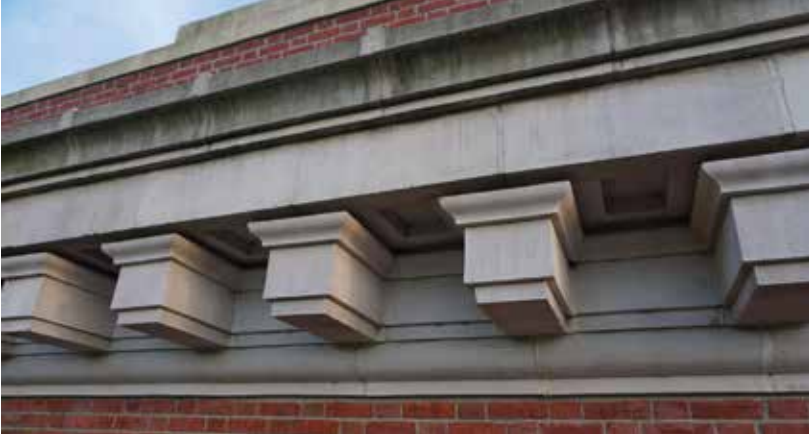
Figure 2. Terra cotta cornice spot replacement with ICCP in 2004. Two pieces of terra cotta were replaced on the full cornice, and the entire steel outrigger system is protected by Impressed Current Cathodic Protection.

When conditions allow, a spot replacement program with terra cotta and an integrated impressed current cathodic protection system (ICCP) can provide a 25+ year repair. These systems control corrosion of the embedded steel, not surface erosion of terra cotta. ICCP systems are low-voltage DC systems that provide electrons to the steel from an external anode. This process controls the corrosion reactions. All the embedded steel becomes "cathodic" or protected. The systems are installed in the mortar joints and backup masonry material, and are then painted over. This allows for the original material to remain in place, while mitigating corrosion, and only requires "unsafe" cracked or damaged terra cotta units to be removed and replaced. These systems have been successfully used since 1991 in historic restorations. Aside from being sympathetic to the historical integrity of the structure, they ensure that future damages to the building envelope by corrosion are addressed (Figure 2).

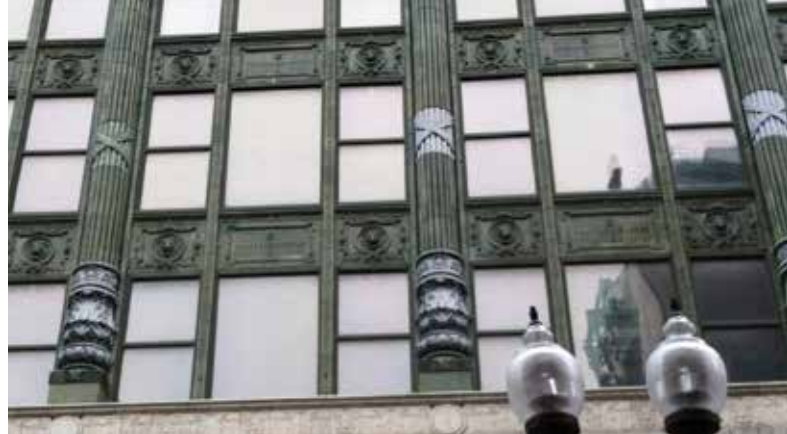
Figure 3. Discoloration of GFRC units used in conjunction with original terra cotta.

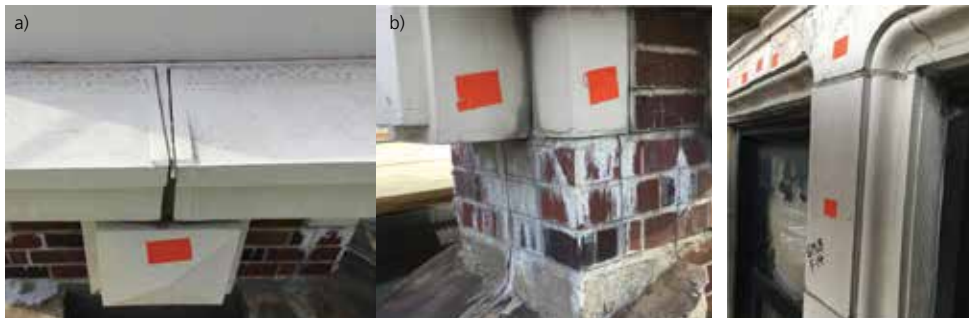
Figure 4. a) Full cornice replacement with GFRC. Note shrinking of sealant, opening of joints, water infiltration, and subsequent calcium leaching; b) Detail.

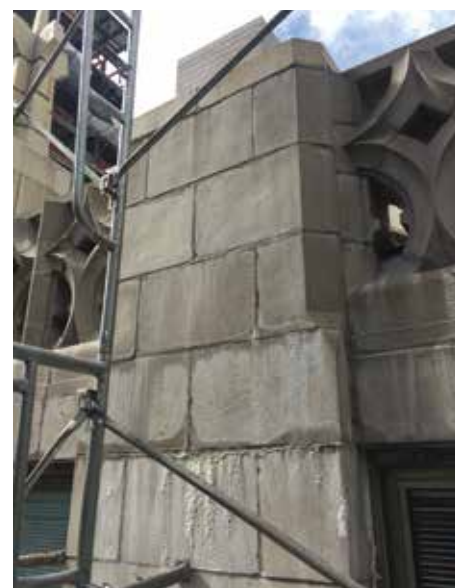
Figure 6. Full wall replacement cast stone units. Note the shrinkage, water infiltration, and leaching.

Cast Stone is comprised of a mixture of cements, aggregates, and mineral pigments using either a dry tamp or a wet cast process. Cast stone is not kiln fired; it is cured for approximately five days in various degrees of dampness. Like terra cotta, cast stone has been used as a decorative element in construction. Cast stone units often replace surface stone and ornamental features. All cementitious materials will shrink in service, thereby pulling the mortar joints into tension. To mitigate mortar cracking, control joints are incorporated, and soft joints must be placed between the dissimilar materials.
