urricane Michael, one of the strongest Atlantic hurricanes to ever make landfall in the contiguous United States, made a direct hit on Mexico Beach, Florida, on October 10, 2018. The Category 4 storm strengthened unexpectedly as it raced through the Gulf of Mexico with maximum wind speeds of 155 mph. At landfall in Mexico Beach, the measured storm surge was nearly 16 feet and, if wave height is added, the height of the wall of water was over 20 feet. The storm caused 45 deaths and resulted in damage of approximately \$15 billion.

In Mexico Beach, almost all of the homes along the beach were destroyed by the wind and waves and swept away. However, one building along the shoreline (*Figure 1*) remained standing, alone in a field of devastation. Several news reports, including coverage in the

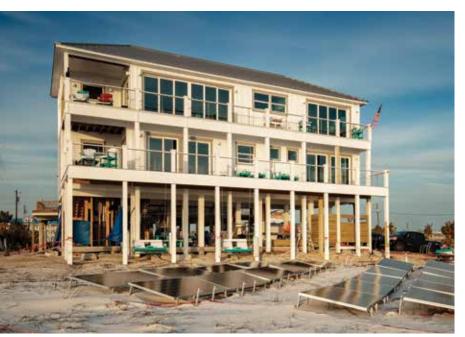
Figure 1. Sand Palace after the hurricane.

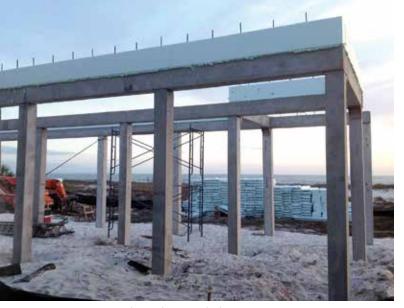
Figure 2. Concrete base - beams and piles.

SCE: The base of the building consists of 12-inch square precast, pre-stressed concrete piles that cantilever upward from the bearing stratum below the surface beach sands. Atop the piles, there are precast concrete beams that support the exterior and interior walls. (See *Figure 2* for the base of the pile base of the structure and the concrete beams at the first elevated floor.) The beams are attached to the piles with epoxied #10 reinforcing steel bars for uplift and shear transfer. The perimeter walls are constructed using Insulated Concrete Forms (ICF) with a seven-inch thick concrete wall inside with a single layer of #5 bars at 18 inches on center, each way (Figure 3). There are 2½ inches of insulation on each side for a total thickness of 12 inches. The interior walls are non-bearing wood stud. The floors and roof are constructed with pre-manufactured wood trusses (Figure 4).

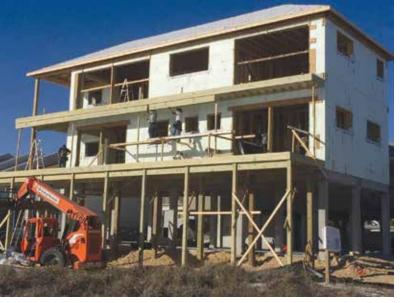
Figure 5. Nearing completion.

Lackey/King: The cost premium turned out to be 15% to 20% on a per square foot basis over the cost of an equivalent, existing building in the same area. We evaluated many options and, if the extra cost was reasonable and we thought it represented an upgrade, we went with it, while always keeping an eye on the overall cost. We actually found that some elements, such as the ICF walls, did not cost that much more at all because the extra material costs are offset by lower labor costs. The ICF also had the side benefit of better insulation and resulted in lower insurance costs. We calculated that the on-going cost savings would offset the original extra costs in six to eight years. There was no noticeable impact on the project schedule. The cost of the lot is also the same regardless of what is built. (The building at the time of near completion is shown in *Figure 5*.)
