Tilt-Up Concrete Wall Anchorage Design

A Trial and Error Process

By John W. Lawson, S.E., and David L. McCormick, S.E., P.E., SECB

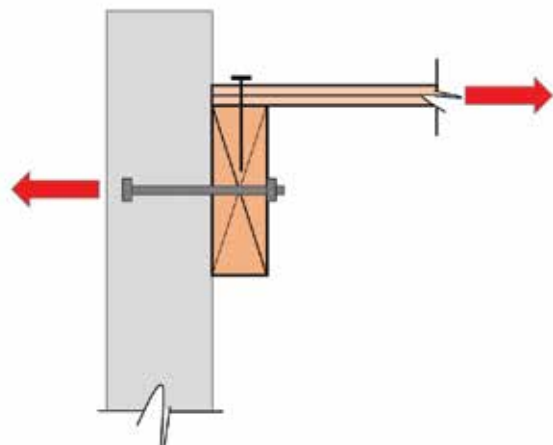
Figure 1. Typical Pre-1973 UBC wall-to-roof anchorage detail (West Coast U.S.).

In the seismically active western United States, design was governed primarily by the *Uniform Building Code* (UBC) until the advent of the *International Building Code* (IBC). Before the 1973 UBC, it was common practice by design engineers to use the nailing of the plywood roof diaphragm to the wood ledgers (which are bolted on the inside face of the walls) as the de facto anchorage for out-of-plane wall forces (*Figure 1*). This indirect tie arrangement relied on the wood ledger in cross-grain bending and the plywood panel in tension near its edge. Cross-grain bending and tension are both very weak material properties of wood. Wall anchorage design forces before the 1973 UBC were specified as $0.2W_p$ under allowable stress design (ASD), where W_p is the tributary wall weight being anchored. In the 1971 San Fernando earthquake, the wall anchorage in many tilt-up buildings performed poorly. The use of this indirect wall tie led to wood ledgers failing in cross-grain bending and to plywood edge nailing tearing through panel edges from the wall anchorage tension loads. Partial roof collapses and wall collapses were common in the areas of strong ground motion.

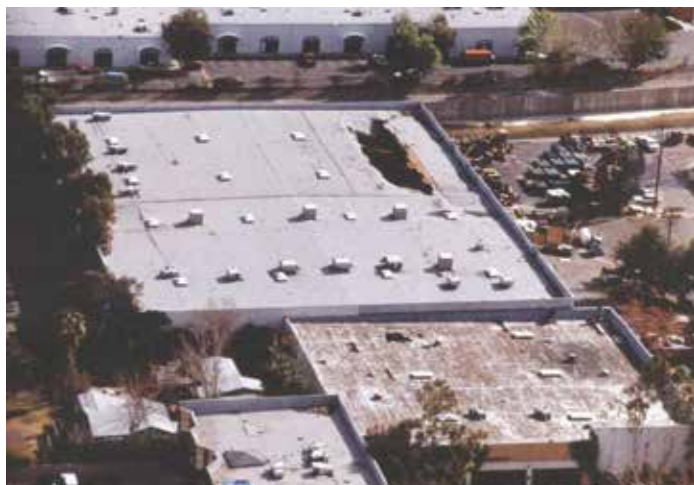
Figure 2. Diaphragm failure due to inadequate continuous crossties for wall anchorage. Courtesy of Doc Nghiem.

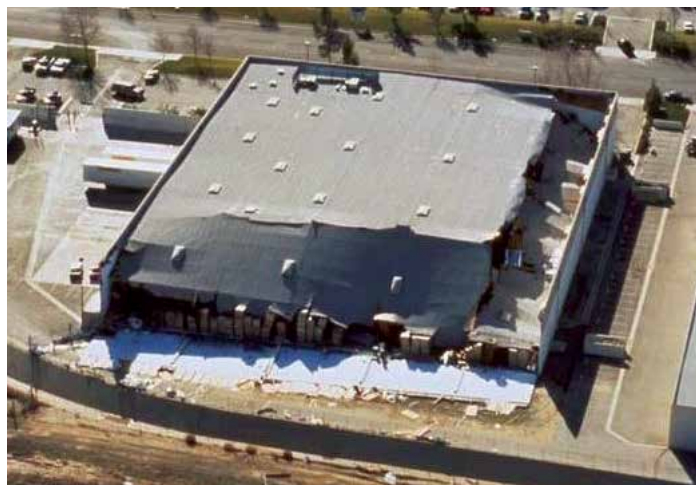
Figure 3. Damage to tiltup concrete building due to loss of wall anchorage during the 1994 Northridge earthquake. Courtesy of EERI.

The 1994 Northridge earthquake was the first test of modern, post-1976 UBC provisions for wall anchorage to flexible wood roof diaphragms under very strong shaking. Hundreds of buildings were severely damaged due to inadequate wall anchorage, often resulting in partial roof collapses as seen in *Figure 3*. The poor performance of the pre-1973 UBC tilt-up and masonry industrial buildings was not a surprise. However, the amount of damage in buildings designed to more modern codes was unexpected. Most notably, steel anchorage straps fractured through the net section in tension causing a sudden loss of anchorage strength, damage concentrated at the tops of pilasters due to inadequate reinforcing, and subpurlins with eccentric anchors failed.

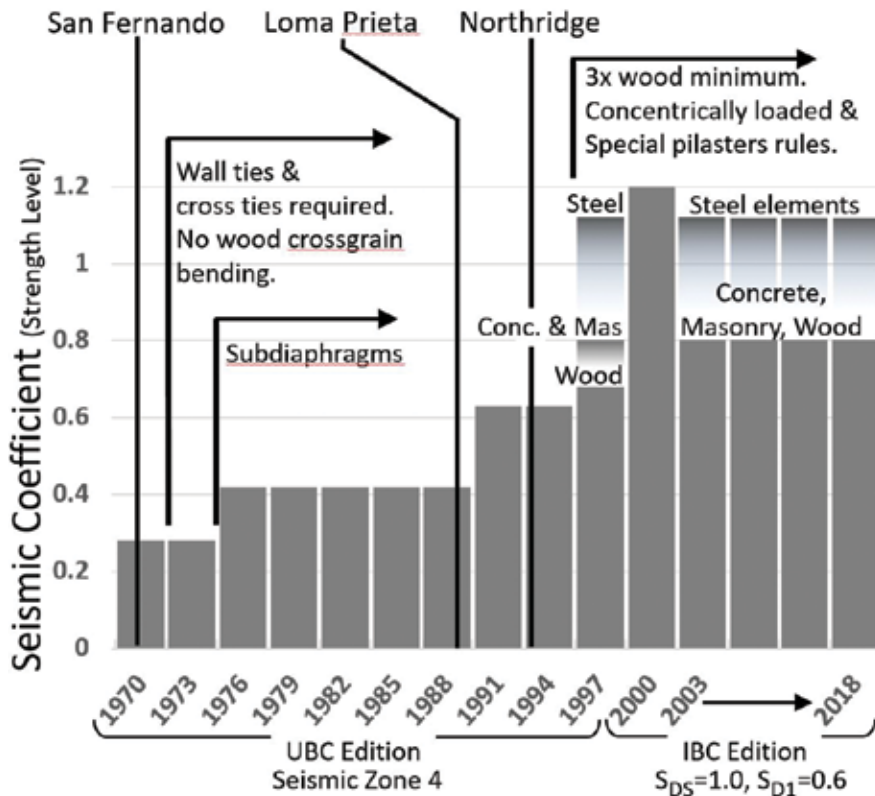
Figure 4. Evolution of UBC/IBC provisions for wall anchorage to flexible diaphragms (Lawson et. al 2018).

The increased wall anchorage forces, as well as the improved detailing and design requirements, were introduced into the 1997 UBC and have changed little under the IBC since then (Figure 4). More importantly, these provisions have yet to be tested in the field by a strong earthquake. Recent numerical modeling studies using non-linear time history analyses indicate that the wall anchorage force levels are likely appropriate under a design level earthquake (Lawson et al., 2018). However, it is possible that, if the wall anchorage weaknesses are now resolved, unacceptable inelastic behavior may appear in a new part of the structure previously not considered problematic. Currently, one such location under closer scrutiny is the flexible diaphragm.
