The IEBC's Roof Diaphragm Evaluation Requirements

When Reroofing Requires a Lateral Analysis

By Dale Statler, P.E., and Jerry Maly, P.E.

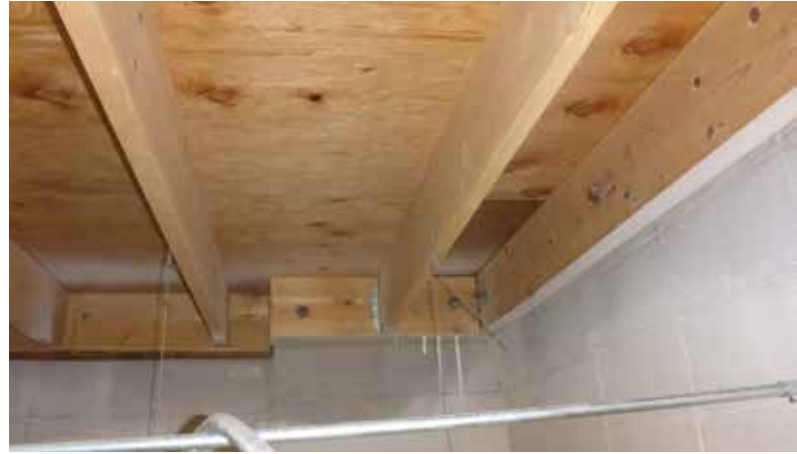
Figure 1. Wood diaphragm connections and shear walls not visible from the top surface of the diaphragm.
