Engineering Judgment for Historic Masonry Façades

By Edward Gerns, RA, and Rachel Will, P.E.

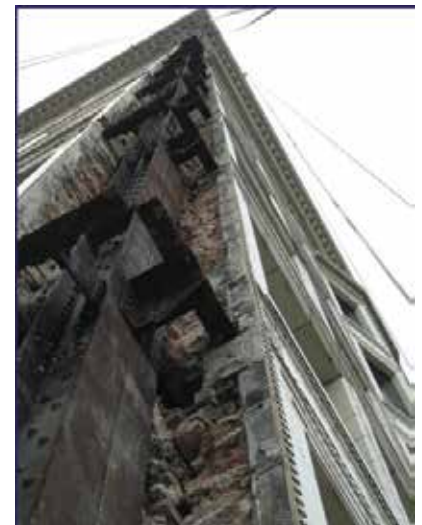
Figure 1. Lack of continuous intermediate support at a corner.

These assemblies or units are supported at floor lines, window/door heads, or corners of the building. Distress at intermediate supports is often related to the configuration of shelf angles and the lack of accommodation of general building movements. Distress is often the result of discontinuous gravity support of the masonry. Examples include corners of the building where the shelf angles from the two different façades do not align or are held short of the corner (*Figure 1*), or discrete lintel elements that are limited to openings rather than continuous shelf angles extending around the perimeter of the building. These conditions can result in vertical cracking due to the change in

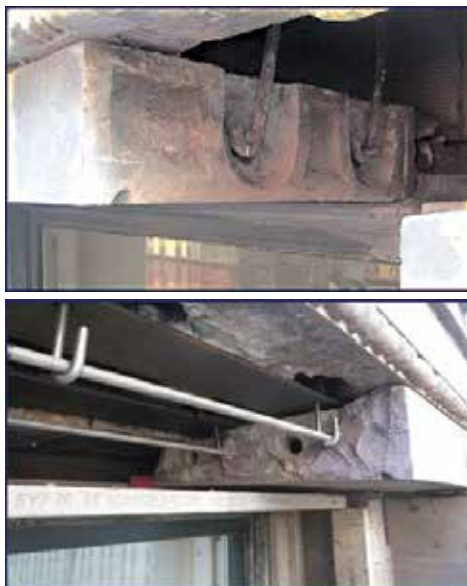
Figure 2. Hung lintel elements. Original construction circa the 1890s (top); repair detail circa 2015 (bottom).

Hung elements typically exist at openings in the façades, most commonly windows. The individual units are hung with j-hooks and rods or other anchors from the supporting structural steel above (Figure 2, page 11). Distress in hung components is often related to corrosion of the anchorages rather than other structural issues. Corrosion related distress at hung elements needs to be addressed to maintain adequate structural support due to the lack of redundancy of support with hung elements.

Non-corrosion related distress is typically associated with deflection of the units due to the flexibility of the support. When displacement of the supporting lintel is observed, particularly at larger openings, it does not necessarily warrant repairs. If the condition of the steel can be verified and it is determined to be serviceable, deflections may be a result of installation tolerances, catenary behavior, inelastic bending, or building movements. Often repairs are not necessary to “correct” the deflections. Generally, the masonry at these locations will behave as an arch in addition to the support provided by the hanger elements. Thus, while the hung assemblies may not work “on paper,” they remain functional and typically can be “repaired in kind,” as shown in Figure 2.

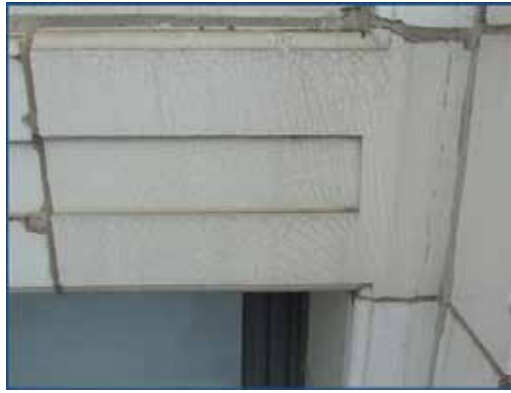
Figure 3. Units with combined support at the pier. Note diagonal stress relief cracks and crazing.

conditions. In glazed masonry products such as terra cotta, the stress occurring within these units is often manifested by crazing in the glaze, which indirectly illustrates the alternate load path (Figure 3).

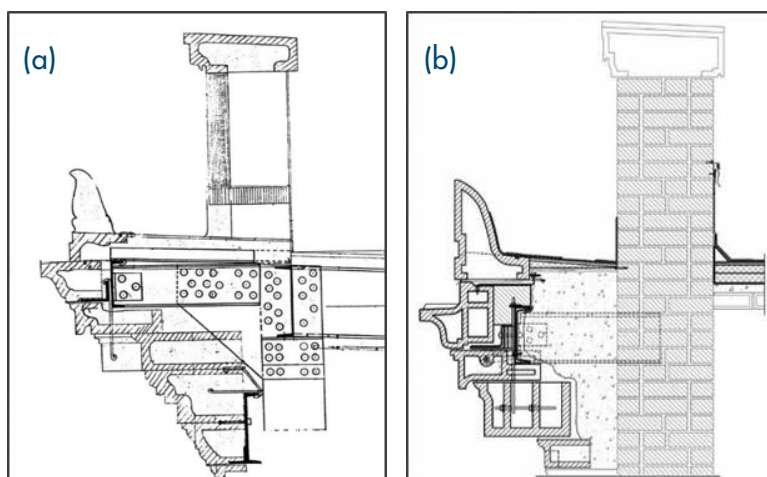
Figure 4. Terra cotta cornice and parapet section. Original condition (left); repaired section (right).

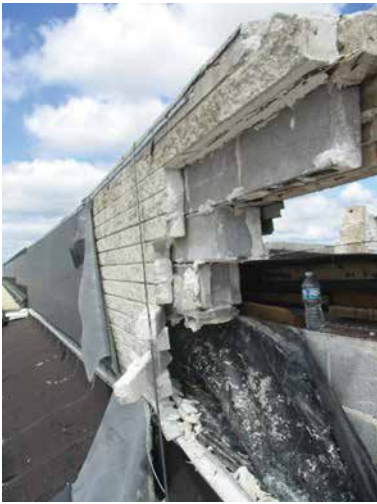
Figure 5. Parapet failure due to lack of anchors at the slip plane of flashing.

Historic masonry parapets typically are multi-wythe and are rarely reinforced. Non-corrosion related distress at parapets is generally related to bowing, bulging, and displacements, which are often a result of the stresses from unaccommodated expansion and cyclical movement. General deterioration due to being exposed on three sides, and subsequent increased freeze-thaw exposure, can also contribute to these conditions. In some instances, non-corrosion distress is exacerbated by previous repairs such as installed flashings that introduced a slip plane into the system without accommodation of anchorage of the portions of the wall above and below the slip plane, as illustrated in the example from a 1960s parapet wall (*Figure 5*). While all of the conditions above may warrant some level of repair, it is engineering judgment for each specific real-world instance and weighing factors such as serviceability, past performance, and current regulations that need to be evaluated to determine the level of repair required for each condition.

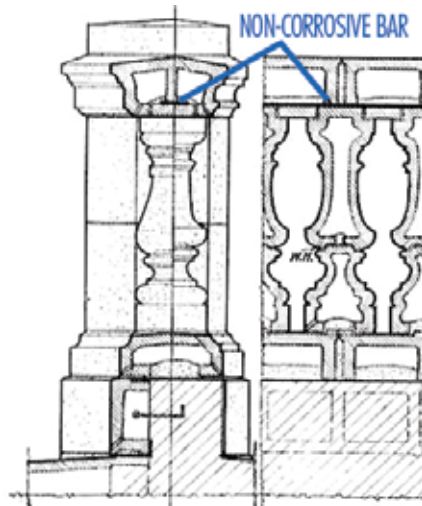
Figure 6. Terra cotta balustrade detailing, 1927.

These are ornamental rails and copings supporting a series of balusters that can be single or multiple units. Balustrades were intended to act as monolithic elements with the function of the tensile bond capacity of the mortar, with mortar keys between units as the primary load resistance mechanisms (*Figure 6*). In some systems, these mechanisms are combined with metal bars extending through the units and across the top rail. As the mortar deteriorates and the embedded metal corrodes,
