# The Renovation and Retrofit of

# 100 Stockton Street

## CONVERTING AN INTROVERT INTO AN EXTROVERT

By David Rossi, S.E.

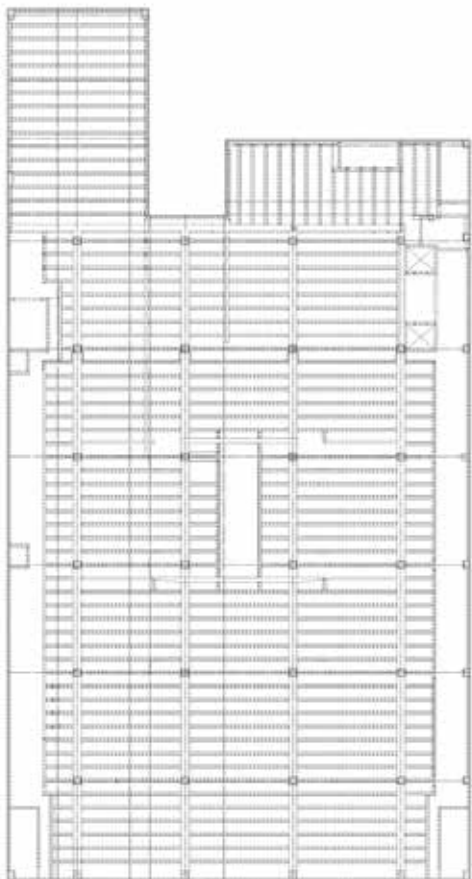
Figure 1. Typical original floor framing plan.

Originally designed in 1973 by Seattle engineers Hadley Properties, the single-tenant retail building has a floor plate of 31,000 square feet on each of eight levels, plus a one-story basement. The typical floor system shown in *Figure 1* consists of 4½-inch-thick reinforced concrete slabs spanning east-west between 18-inch-deep post-tension pan joists. The pan joists span between 24-inch-wide by 18-inch-deep post-tensioned girders spaced at 32 feet on-center, and 7-foot-wide, 4½-inch-thick closure pour slabs were placed on the north and south sides to allow the pan joists to be stressed. 24-inch-square reinforced concrete columns supported the girders. The joists were turned approximately 30 degrees from square at the roof, effectively increasing the center-to-center span to 34 feet. The street-level slab was stepped in one location due to the sloping streets on the west and south sides. Reinforcement for the framing elements was typical for that era: 60 ksi yield strength, but light on shear reinforcement and

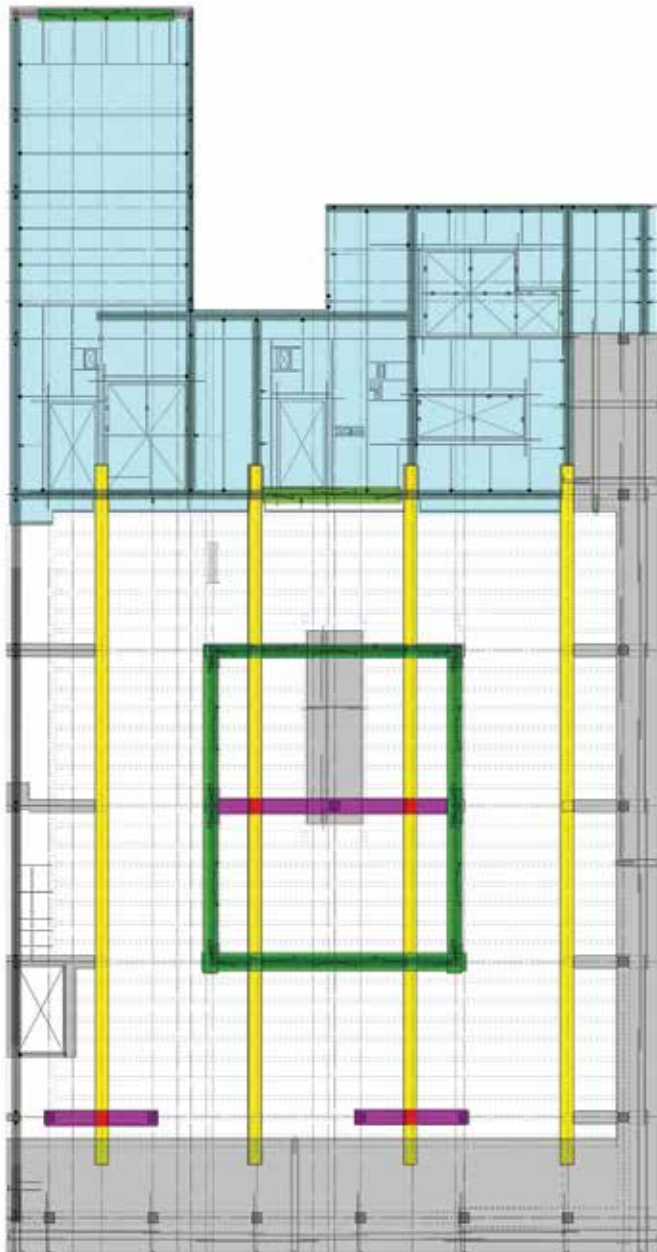
Figure 3. Typical upper-level floor plan.

Figure 3 is an upper-level floor plan illustrating the selected scheme. The existing post-tensioned girders are highlighted yellow and originally extended from the west face of the building to a grid line 32 feet into the blue highlighted area. The magenta highlights are new 3-foot-deep concrete transfer girders at every floor. The blue highlighted region is a zone where the existing concrete floor system was replaced with steel framing to accommodate new elevator banks, exit stairs, and mechanical shafts. The existing floor framing was removed and replaced with cast-in-place concrete slabs in the gray highlighted zones for architectural reasons.

In addition to the work described for the typical floors and shown in *Figure 3*, two levels were removed entirely and replaced with steel framing: the ground floor and the roof. Due to the sloping streets adjacent to the building and the desire to allow for multiple retail tenants, the original ground floor framing was removed and replaced with steel framing stepped as established by Gensler. The roof was similarly replaced with steel framing because the original framing could not accommodate the dead and live loads of a restaurant and accessible outdoor landscaped space.

The selected lateral scheme is highlighted green in *Figure 3* and is designed to substantially meet the provisions and performance objectives of the 2016 CBC. The heavily reinforced core (*Figure 5*) covers two bays in each direction and is perforated with large openings to allow open retail spaces. Two additional lines of north-south bracing were required both for loads and for reducing torsion. From the basement to the underside of the fourth floor, the lateral system is special reinforced concrete shear walls which vary in thickness from 3 feet 6 inches at the west edge of the core to 2 feet elsewhere. From the fourth floor to the roof, the lateral system changes to buckling-restrained braces (BRB's) to allow for clear views on the office floors.

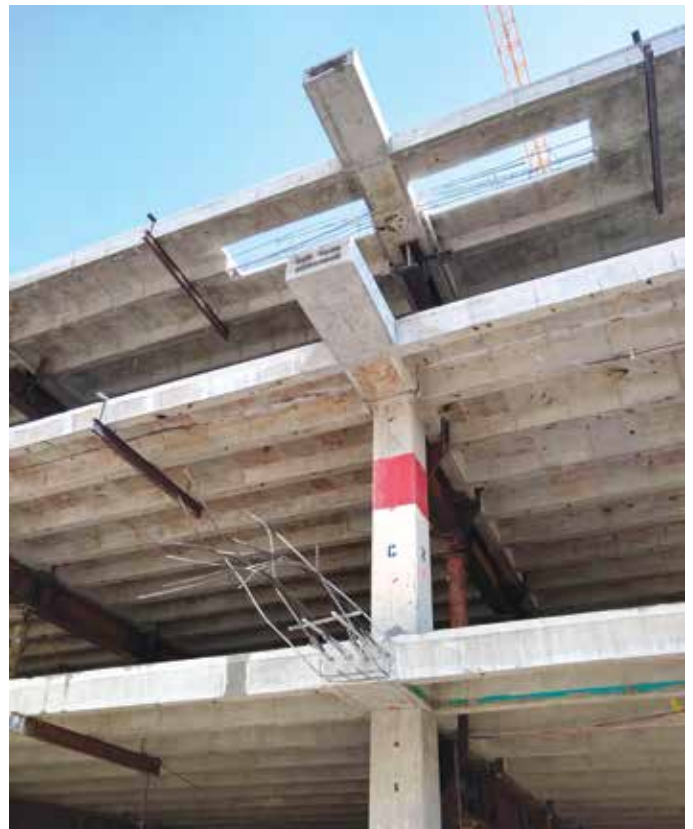
Figure 4. New cantilevered girder ends at various stages of construction, with continuous shoring installed.

Shortening the girders and removing columns involved shoring the entire building at every level, as was described in the article by Robert Graff of Degenkolb in his recent article (*STRUCTURE, January 2022*). Once shored, the ends were cut to release the cables, and the concrete was removed to the face of the nearest support, either an existing column or new transfer girder. Next, the cables were retained, reprofiled, and the girder ends were repoured as cantilevers, as shown in Figure 4. The bottom

girder end in *Figure 4* shows the retained cables and longitudinal reinforcing, the middle girder has been poured and stressed, and the top girder has been poured and stressed while the column has been removed and the slab prepared for the transfer girder.

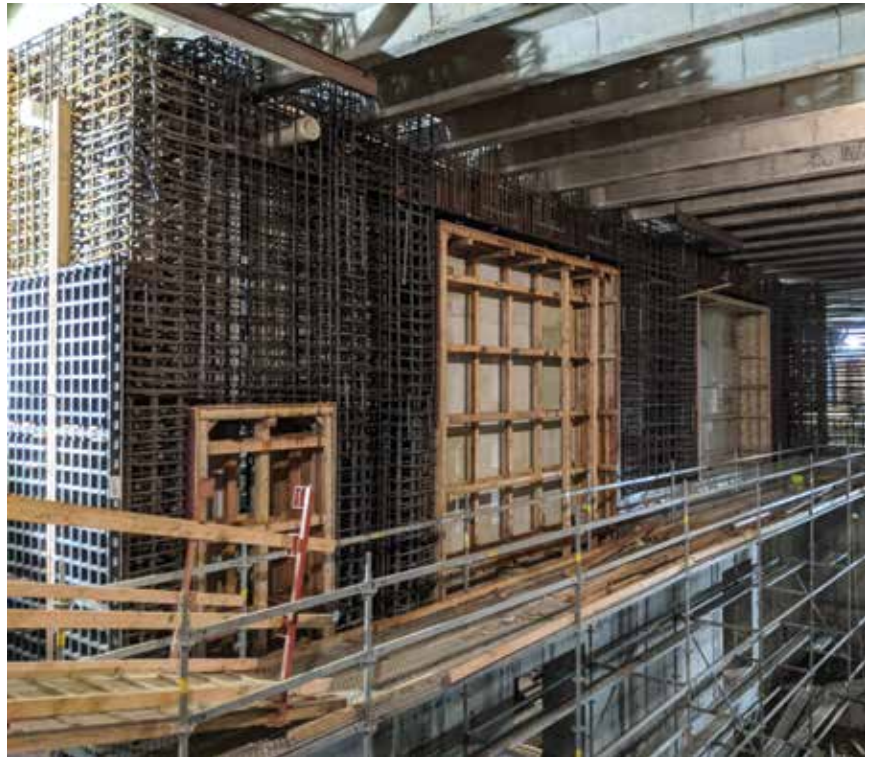
Figure 5. North-South core wall reinforcing.

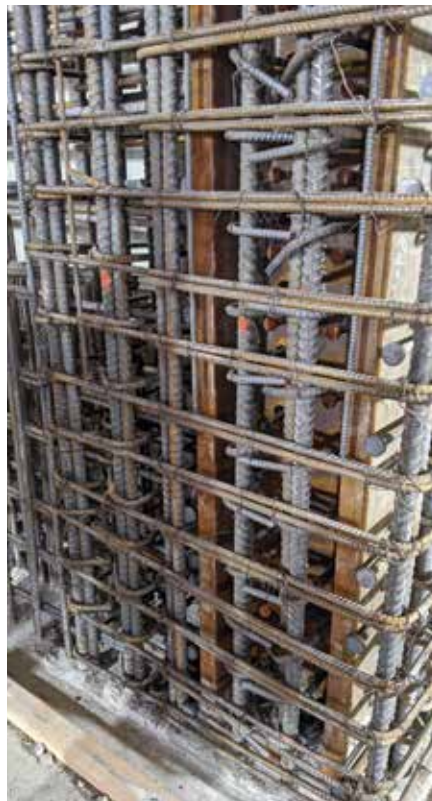
Figure 6. Braced frame column buried in the core wall for load transfer.

The transitions from steel bracing to concrete cores were particularly challenging to detail and build. Steel beams were buried in the concrete beams, allowing for load transfer between the two materials and providing locations for attaching gusset plates (*Figure 6*). Uplift on the frame columns was too high to rely on anchor bolts, so full-height steel columns were buried in the shear wall boundaries from the third to fourth floors. The confinement reinforcing maintained continuity by passing through predrilled holes in the buried columns.
