Glass Railings

To Top Rail or not to Top Rail

By Kevin Perttu, P.E.

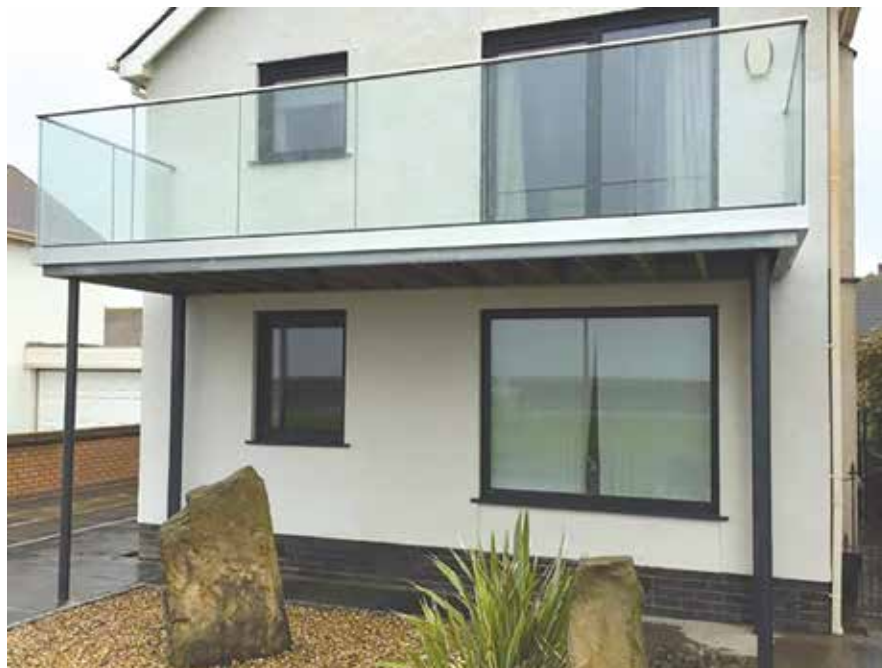
Figure 2. Base shoe glass railing (Bing Image Free Use Search).

two configurations for attaching to the host structure. *Figure 2* shows an example of a *base shoe* style railing, and *Figure 3* shows an example of a *standoff* style or *point supported* glass railing. It is important to differentiate the two attachment methods because glass behaves differently when point-supported than when secured in a base shoe. Base shoe supported glass allows structural design loads to distribute evenly as bearing stress along the bottom face of the glass that is captured within the shoe. *Figure 4* shows how glass stresses are distributed along the bottom edge of a base shoe railing. That is not the case, however, for point-supported glass railings. *Figures 5* (page 28) and *6* (page 29) show how the stress concentrates around the standoff support that is nearest the applied design load. This

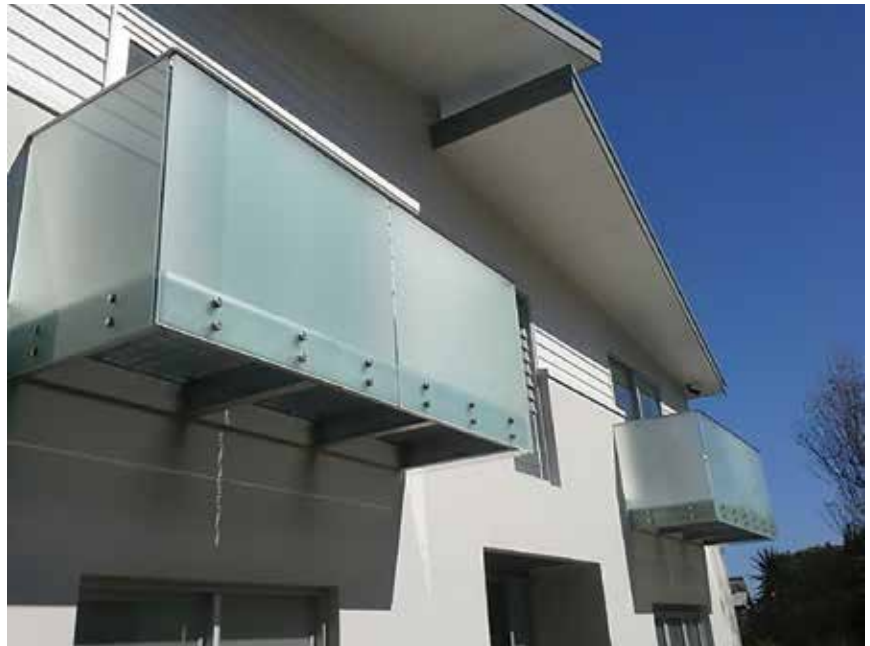
Figure 3. Point-Supported glass railing (Bing Image Free Use Search).

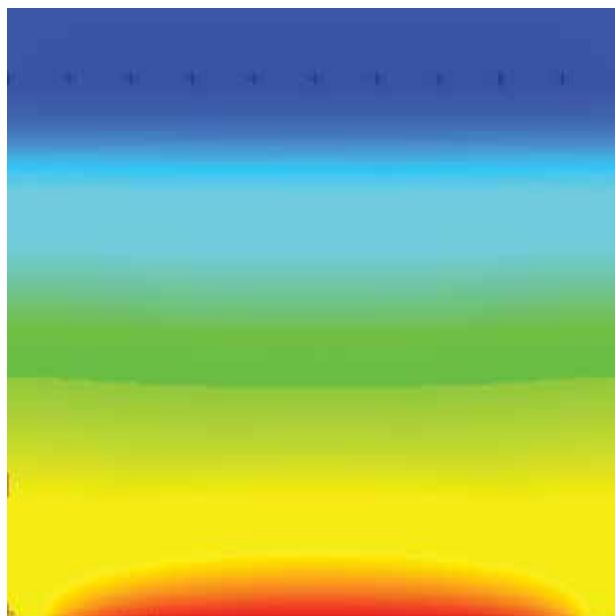
Figure 4. FEA showing stress distribution along the bottom of a base shoe glass railing.

causes increased stress in the glass surrounding the standoff, primarily at the edge of the hole in the glass where the standoff fastener passes through. In both FEA examples, a 200-pound concentrated load has been applied to the top corner of the glass panel.

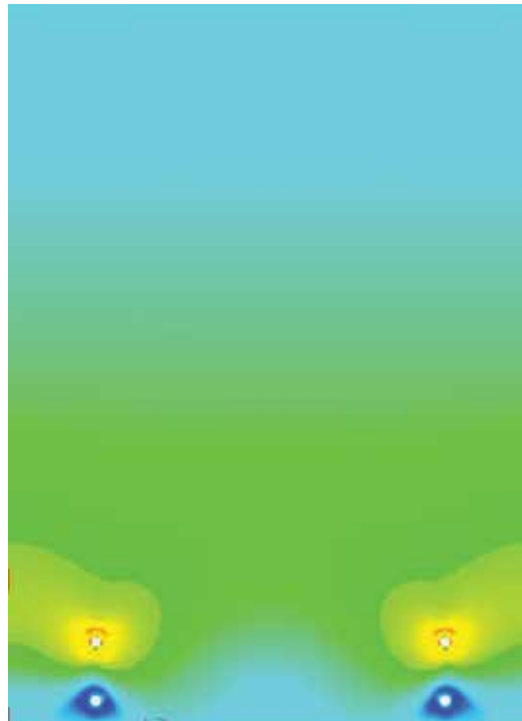
Figure 5. FEA model showing stress concentration at standoff support.

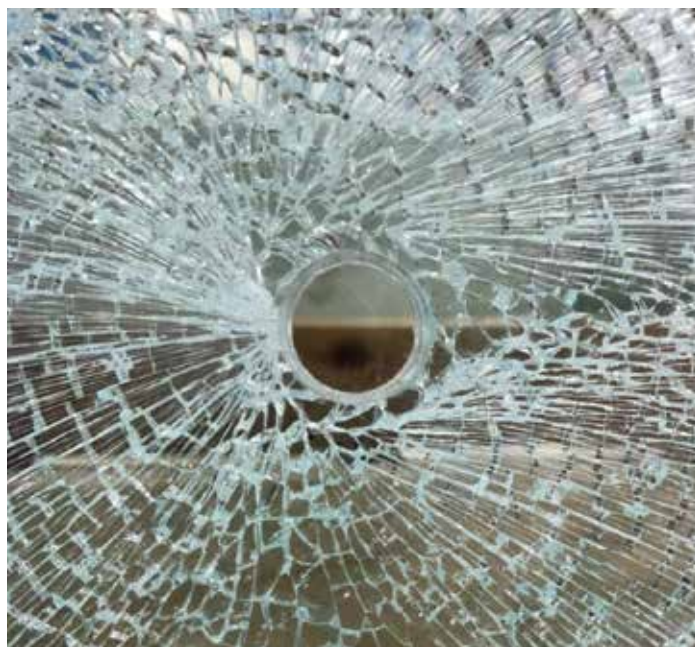
Figure 7. Testing failure at standoff hole location in a laminated glass panel.

For example, 3/16-inch-thick laminated glass is comprised of (2) 1/4-inch-thick tempered glass panels bonded together by a polymeric interlayer. Laminated glass panels have different structural behaviors than monolithic glass panels, particularly bearing stresses occurring on the edge of holes in the glass. *Figure 7* shows a typical 3/16-inch-thick laminated glass panel for a point supported glass railing tested to failure. The glass breakage occurred at the left side of the standoff attachment hole, and, in this case, the compression side 1/4-inch glass panel layer failed. It is consistent with the high stress concentrations shown near the hole edge in *Figure 6*. Not surprisingly, 1/2-inch monolithic glass panels resist the concentrated stresses much better, and the same testing process resulted in much higher test loads being applied before breakage.

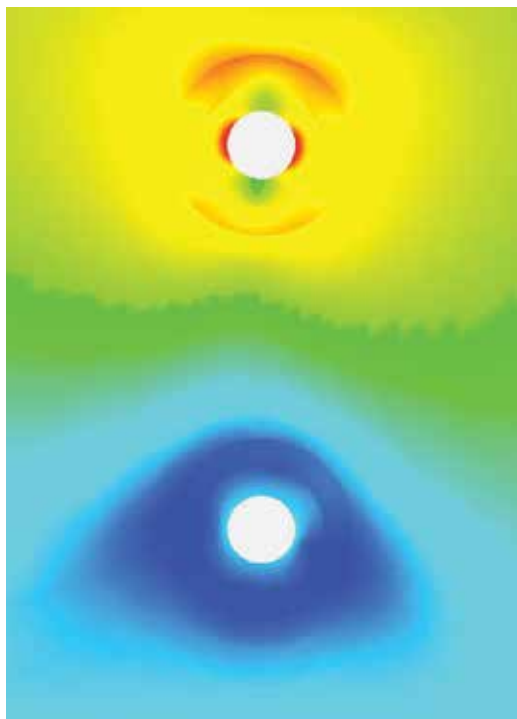
Figure 6. Close up of FEA stresses around the hole in the glass.
