Renovation Project Lifts Building 12 to New Heights

Part I: Design Process

The renovation project raises the entire building off its original foundation by 10 feet to add a basement parking level and a partial 2nd floor under the mold loft, which becomes the third floor. In addition, the building is retrofitted with new buckling restrained braces, floor diaphragms, and collectors for seismic and wind loads. The renovations maintain the historic and industrial feel of the building while creating a modern space for commercial tenants.

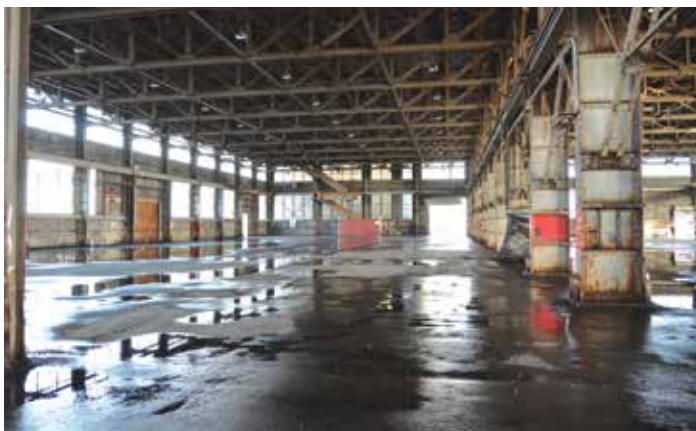
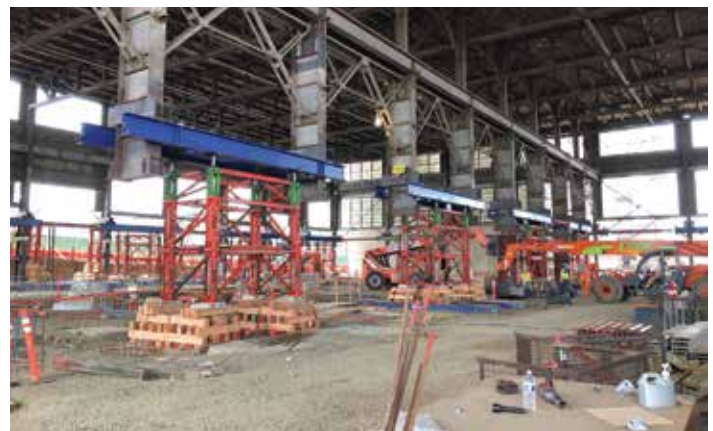
Figure 2. Section before and after the Building 12 lift.

protect the area against sea-level rise and make the new bottom story a below-grade basement. The lifting of the building required 66 columns to be jacked up simultaneously in small increments over 7 days (Figure 1). A separate article dedicated to construction engineering (shoring, temporary bracing, and lifting) will be published in a future issue. A building section before and after the lift is shown in Figure 2.

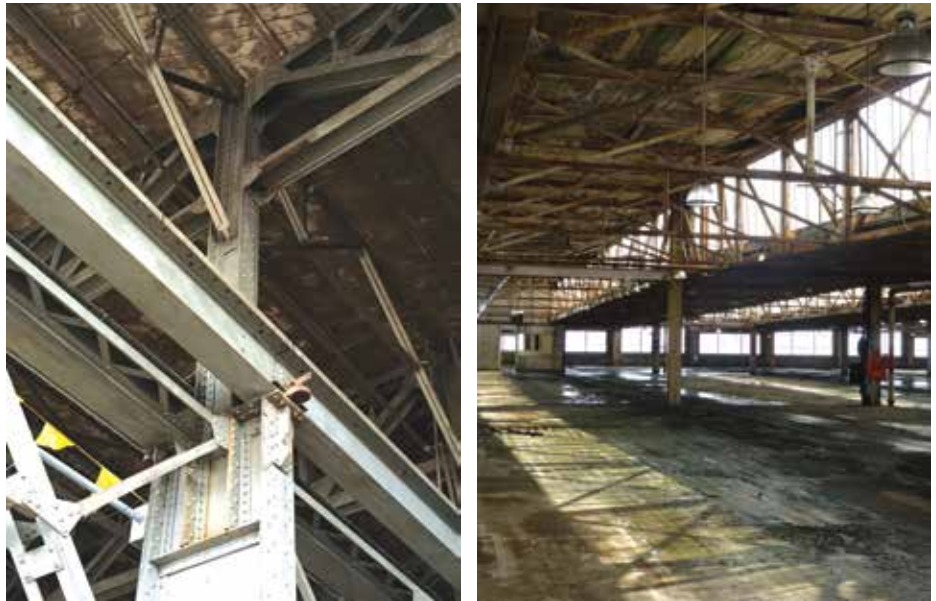
Figure 3. Complex existing conditions at the first story (left) and roof trusses (right).

One of the project's most significant challenges was a lack of existing structural drawings. Detailed site investigations were conducted to confirm the sizes and connections of the long-span trusses, built-up steel columns, and wood flooring. *Figure 3* highlights the complexity of the existing construction. Luckily, all of the structure is exposed, but it required special equipment to get close enough to determine member sizes by hand with a tape measure. Material testing consisting of yield strength testing and weldability analysis was performed on the steel elements to validate design assumptions.

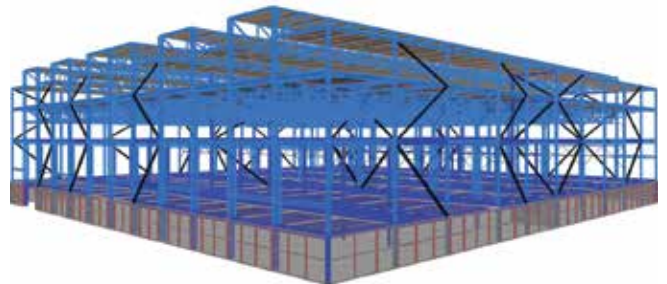
Figure 4. Structural analysis model in SAP2000.

The final design imposed the drifts on the truss frame analysis model and retrofitted the truss where excessive forces occurred. Three models were used to design the building. The first model included gravity elements that resisted lateral loads to determine the drift compatibility forces in the existing trusses and columns. The second model

A three-dimensional finite element model was built using SAP2000 (*Figure 4*) and included gravity elements that contributed to the building lateral resistance (i.e., large steel trusses). A two-stage linear dynamic response spectrum analysis was used to design the retrofit. The flexible upper portion of the structure is a buckling restrained braced frame (BRBF) system with a code-prescriptive value of $R = 8$. The rigid lower portion of the building is a special concrete shear wall system designed for overstrength loads from the BRBF system. All floor diaphragms were modeled as semi-rigid with appropriate properties for timber roof, timber floor (3rd floor), and slab over steel deck (1st and 2nd floor).

“zeroed out” the stiffness of gravity elements so 100% of the load went to the BRBF system. This model governed the BRB design. The last model applied overstrength factors (BRB upper bound axial capacity divided by the design axial demand) to design collectors and expected brace forces.

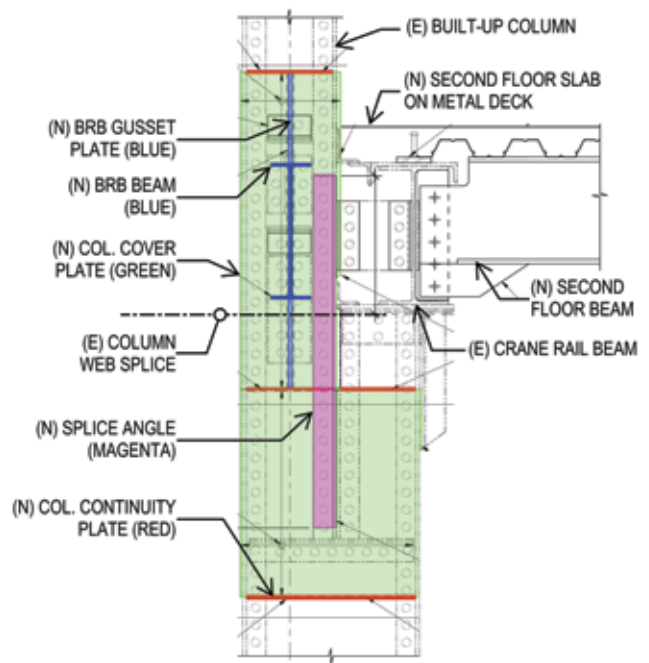
Figure 5. Reinforcing of existing column at BRB connection.

The existing built-up columns created challenges for detailing the BRB connections, particularly at the location of the existing crane beams, which occur near the added 2nd floor and complicate the geometry. *Figure 5* shows a typical condition at the second floor. The BRB gusset plate (orthogonal to the two-dimensional drawing) is centered on the upper column, which is offset from the centroid of the lower column. Horizontal continuity plates were placed above and below the BRB gusset plate. Vertical cover plates were welded across the existing column’s flange tips and also welded to the continuity plates. The column cover plates and added splice angles were designed to transfer loads between the offset column flanges and provide continuity for the maximum forces that the braces could deliver.

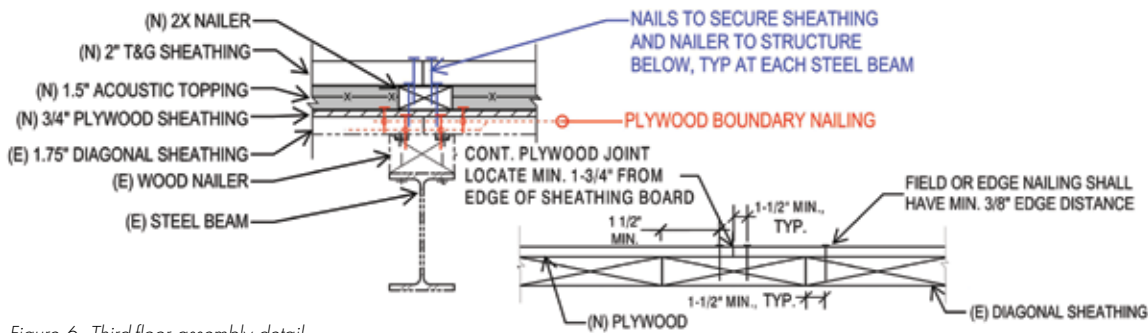
Figure 6. Third-floor assembly detail.

The third-floor assembly, shown in *Figure 6*, also presented detailing challenges:

- The 2x diagonal plank flooring of the original mold loft, viewed from the underside, had historical and architectural value that needed to be maintained,
- 1.5 inches of gypcrete was needed to satisfy acoustic requirements, and
- New 2x tongue and groove (T&G) sheathing and plywood were required for the new vertical design loads and the floor diaphragm’s seismic force path. The new 2x T&G sheathing on top of this floor system makes an architectural statement in the sky-lit space of the former loft. Although it is not placed diagonally like the original plank flooring, it reflects the original materials at the loft.

so two sets of boundary nails were required. One set was from the plywood to the diagonal sheathing and another from the diagonal sheathing to the nailer, which was attached to the steel beam with welded threaded studs. The diagonal sheathing was not parallel to the plywood edges. The contractor carefully coordinated plywood nails to avoid gaps between existing sheathing.

Special design considerations and detailing were needed. Thicker plywood was used to ensure field nailing did not penetrate through the existing sheathing and be visible below. Boundary nails were not long enough to transfer lateral loads directly to the steel beam nailer,

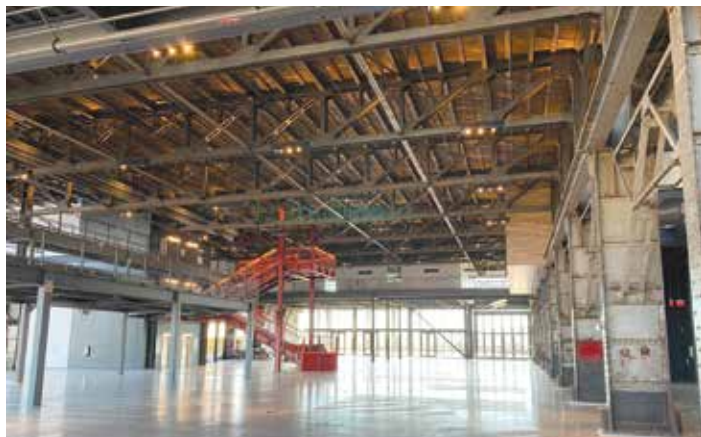
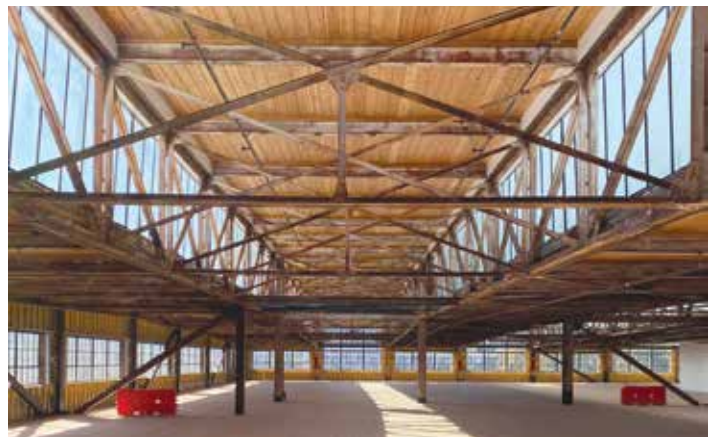
Figure 7. Completed project of the main atrium (left) and third-floor “mould loft” (right).

This project was a great success. The design, lifting, and construction teams worked through challenging as-built conditions that literally moved during the course of the project. The final product (*Figure 7*) showcases the simple beauty of structural engineering for all to see. It also allows the continued use of this building while celebrating a piece of history. ■
