Designing Life Safety  
Renovations for the

# Statue of Liberty

By Thomas J. Normile, P.E. and Denise L. Richards, P.E.

**T**he Statue of Liberty National Monument reopened to visitors July 4, 2013 after a 20-month renovation to upgrade visitor access, egress, safety, and comfort.

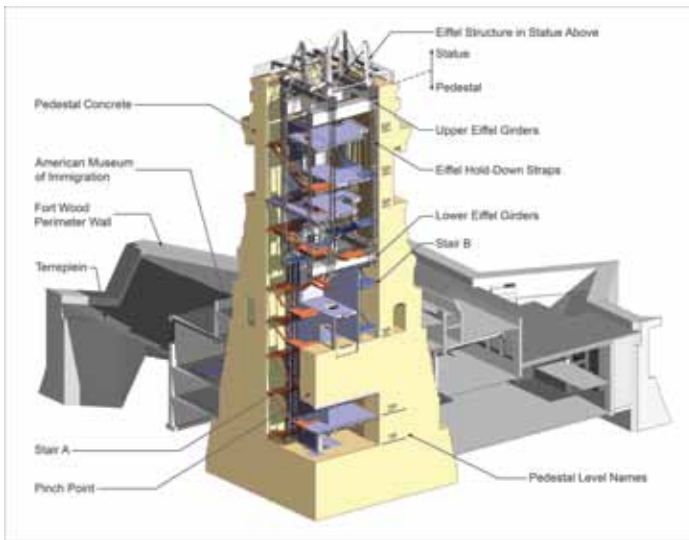
Structural revit model and monument terminology.  
Courtesy of Keast & Hood Co.

Pedestal levels are named 1P (ground level) through 7P (top level). Level 3P falls slightly above the terreplein. Above 3P, the interior shaft measures 27 feet square, and the wall thickness varies from six to 18 feet to support the granite cladding. Below 3P, the pedestal steps outward. Earlier renovations widened the center shaft below 3P from

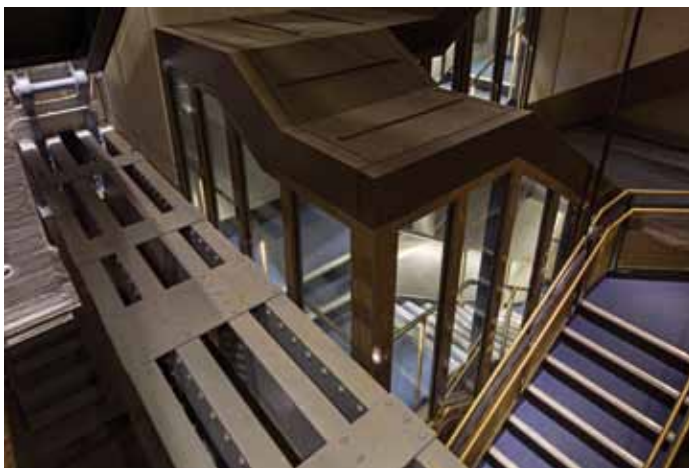
Enclosed stair structure passing through Eiffel girders between levels 3P and 4P.  
Courtesy of Brian Rose.

Between 3P and 4P, both stairs pass through the center of the Eiffel girders. To maintain fire separation, a fire-rated glass enclosure supported on the stringers envelopes one stair. There were extremely tight tolerances between the new stairs and the Eiffel girders, which the new structures were not permitted to touch.

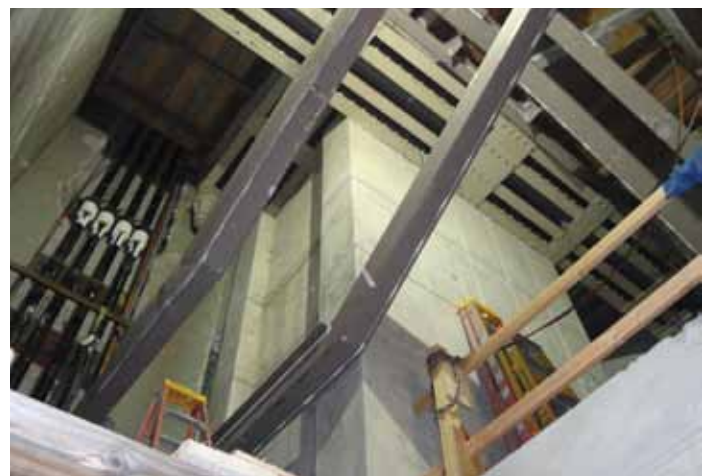
New elevator shaft and stair framing above level 3P.  
Courtesy of Keast & Hood Co.

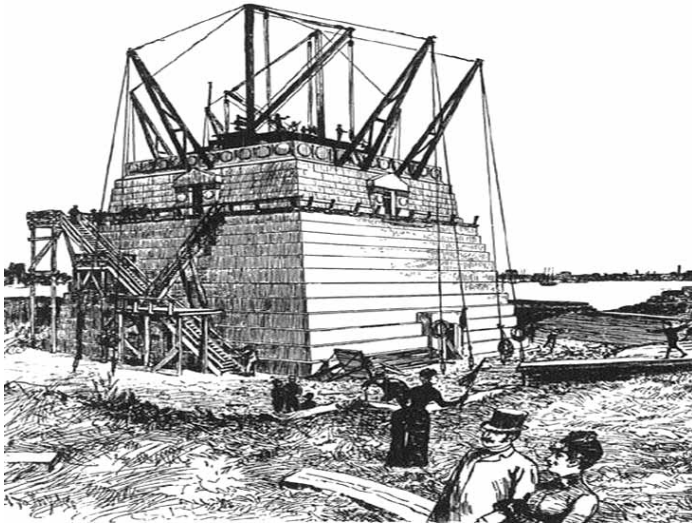
*The pedestal under construction. Courtesy of Harper's Weekly, Volume XXIX, No. 1485, June 6, 1885.*

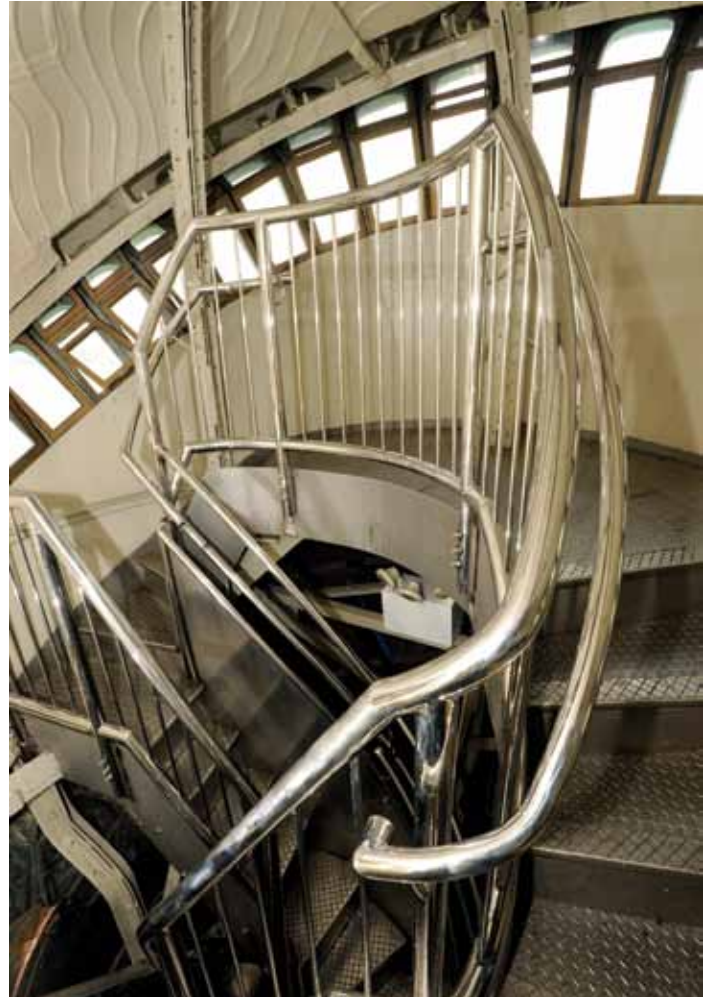
*New handrail in the crown at the top of the spiral stairs. Courtesy of National Park Service.*

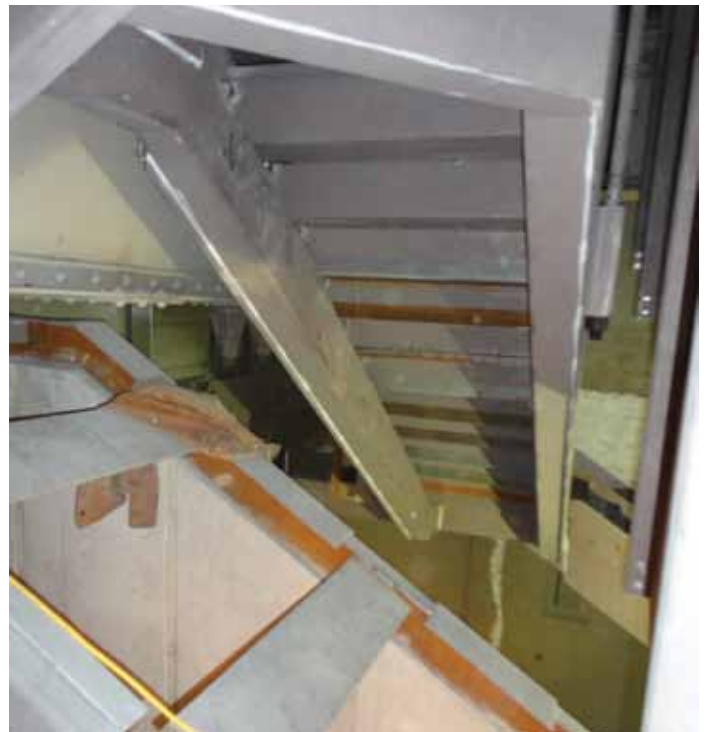
*Tight clearances for new steel at the existing Eiffel girders. Courtesy of Keast & Hood Co.*

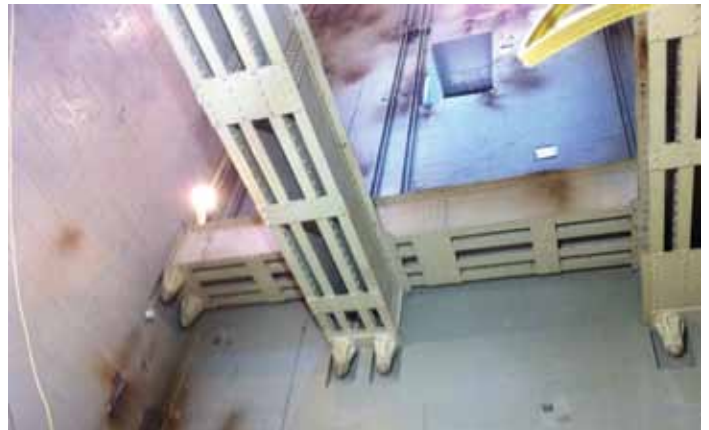
View of pedestal interior above level 3P after demolition. Courtesy of Keast & Hood Co.
