The Quigg Newton Auditorium & Ellie Caulkins Opera House

By C. Ben Nelson, P.E.

The Quigg Newton Auditorium & Ellie Caulkins Opera House project involved the complete renovation of the historic civic auditorium theatre building in the Denver Performing Arts Complex. The 1908 building's interior was demolished, preserving only the historic masonry and riveted steel frame shell. The two year renovation marked the third such major project in the building's ninety-seven year history. The reconstructed theater is home to local opera and ballet, and features 2100-seats, orchestra pit, double-warped seating bowl, three sloping and warped balcony levels, stage lifts, theatrical rig-

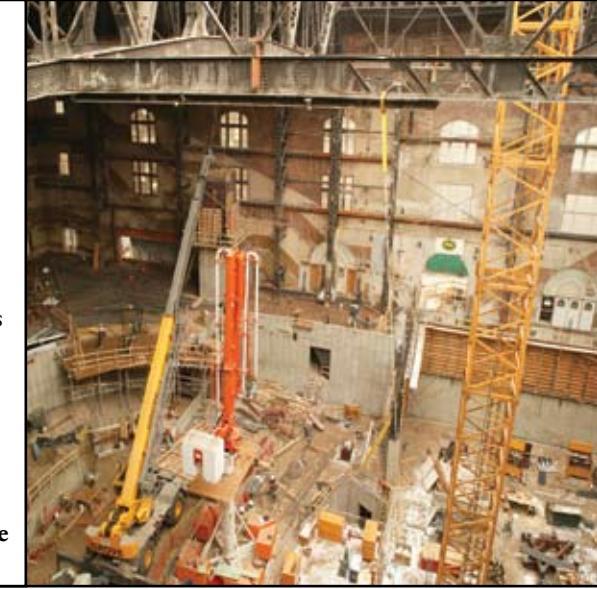
Concurrent Demolition, Foundation Underpinning, Structural Bracing And New Construction. Courtesy of Martin/Martin.

a bracing system to allow dismantling of the interior, bracing of the exterior and reconstruction of the new interior. The bracing scheme was updated on a weekly basis based upon what original structure was being removed and what new structure was being installed. Most of the bracing scheme required multiple bracing points as the braces were relocated to erect new materials. Adding to the complexity was coordination of the bracing with foundation excavation and underpinning work, materials delivery and the interior concrete "drum wall" construction.

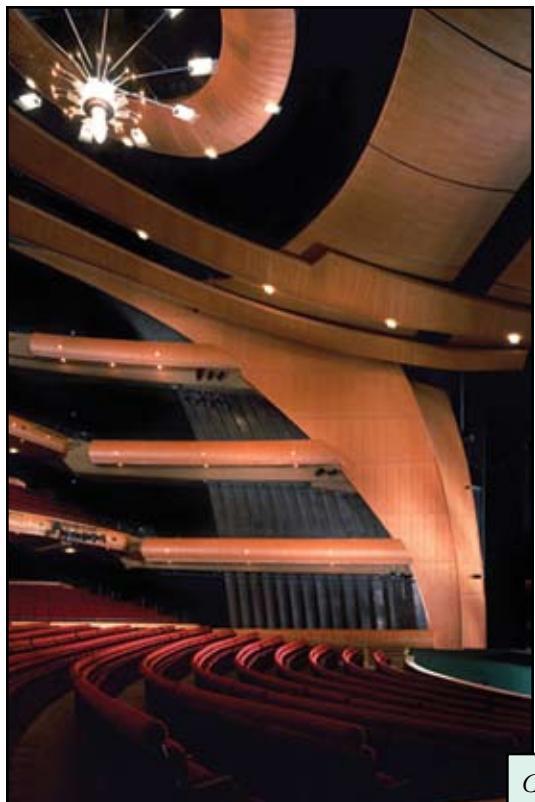
State-Of-The-Art And Acoustically Superb Opera House. Courtesy of Ron Pollard, Photographer.

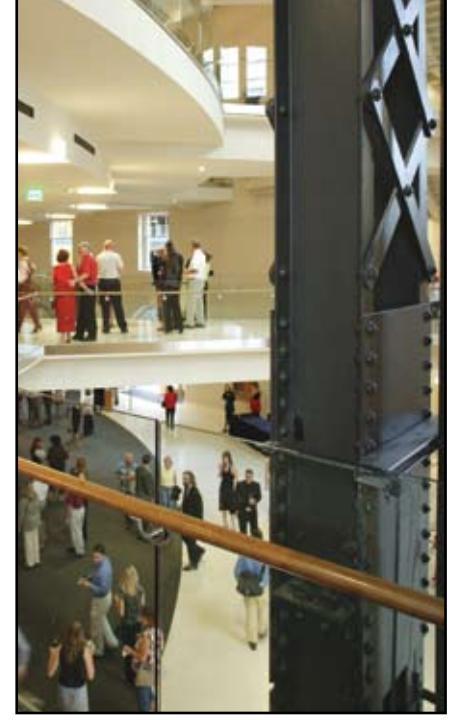
Existing Built-Up Columns To AESS Standards Restored. Courtesy of Ron Pollard, Photographer.

Each of the original seven built-up steel roof trusses are supported by a pair of builtup steel columns at each end. Several of the 1908 lattice columns and surrounding bracing were incorporated as an aesthetic feature of the lobby space. Ninety-seven years of paint and refinishing were carefully removed and the in-place steel columns were re-finished and finely painted. Missing rivets within the latticework were replaced with salvaged rivets from other locations on site. The resulting exposed structural steel columns yield a glimpse of the structural history of the building, and have been featured in virtually every critic's review of the opera house.
