# "Not Just Another Dome Idea"

Micro Tilt-Up Construction for Super Low Cost Structures By Matthew Brand and Thomas Tailer

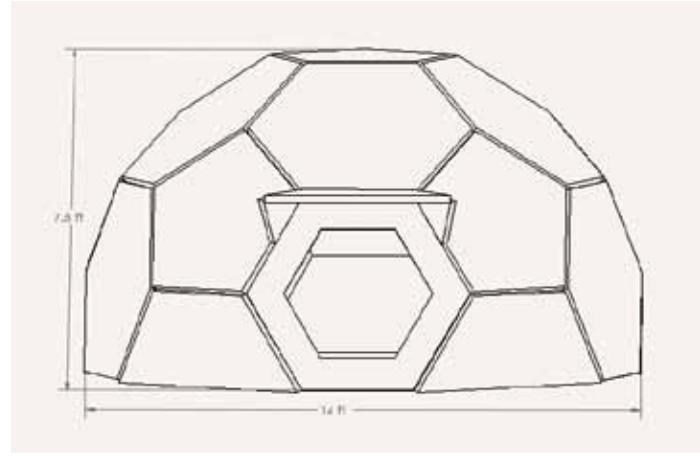
Figure 2. Diagram of dimensions. Solidworks drawing courtesy of Victoria Rude.

structural integrity. The Dome's span is fourteen feet and reaches seven and a half feet in height (*Figures 1* and 2). 2- by 4-inch wire mesh fence, laid eight inches within the panel joints, connects the individual panels together.

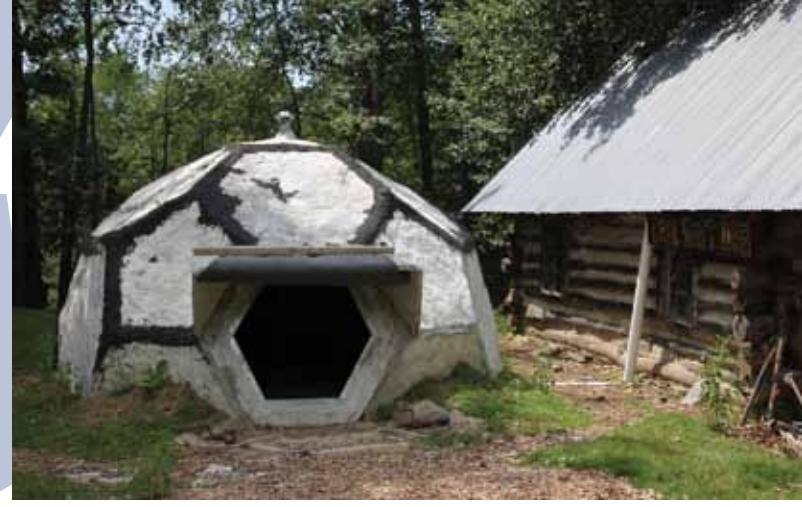
Figure 1. Completed structure. Courtesy of Meghan Holland.

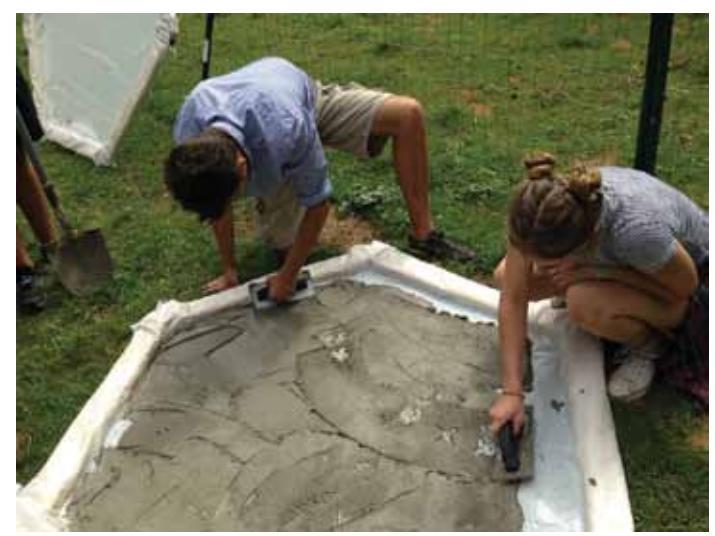
Figure 3. Panel formation of first layer. Courtesy of Hannah Marshall.

The Dome was designed by Thomas Tailer of Essex, Vermont using a compass to achieve the desired angles during planning and construction. The forms were placed on flat ground and lined with scrap plastic to hold the cement. The bottoms of the forms were lined with masonry cement by semi-skilled laborers, as seen in *Figure 3*. A carpet-cement laminate was constructed using two layers of carpet reinforcement surrounded by cement, with 14 gauge galvanized fencing wire bonded to the cement extending four inches out of individual panels to provide the panel connections (*Figure 4*). The carpet reduces the amount of cement necessary to make the panels, and also acts as tensile reinforcement. During loading events, the carpet will deform elastically; after the event occurs, it will have a tendency to return to its original shape. Each panel takes the shape of a pentagon or hexagon, weighing approximately 100 to 240 pounds, with a thickness of one and a half inches and with a side length of thirty inches.

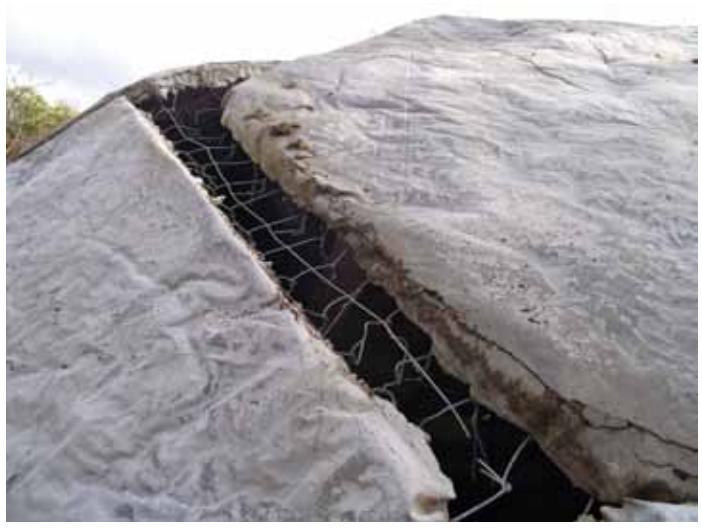
Figure 4. Attachments between the panels before addition of masonry between joints. Courtesy of Megan Strand-Jordan.

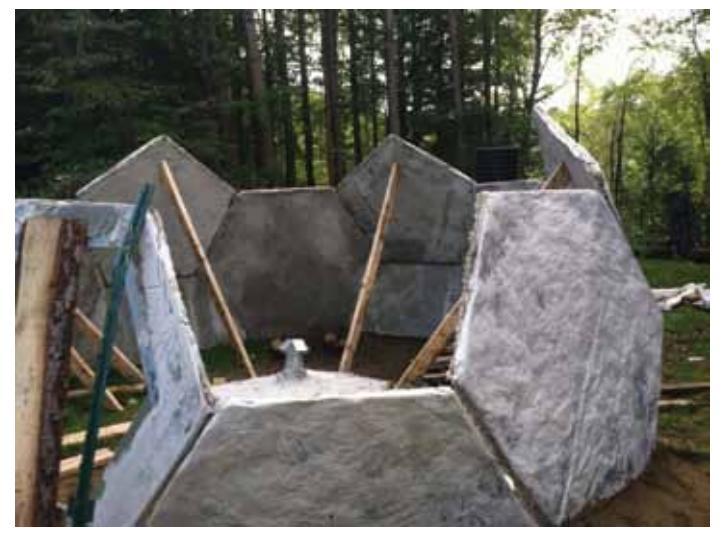
Figure 5. Temporary supported 2<sup>nd</sup> level. Courtesy of Megan Strand-Jordan.

The Dome assembly uses a layering technique with three steps of construction. The first step starts at ground or base level, and connects the panel edges to each other by twisting together the protruding wires. The second step requires cantilevering panels from the ground level panels and temporarily supporting them until three sides can be wired to the structure as displayed in Figures 5 and 8 (page 36). After the supported panel is wired into the structure, the temporary supports can be removed and used in attaching the next panel. The center piece is lifted into place by the use of temporary cribbing in the center of the dome. The temporary supports and cribbing are removed after all pieces are connected. Masonry cement is added between the joints, acting as a waterproofing feature and a reinforcing structural element. In addition, it prevents the wires from untwisting during large loading events. The Dome comfortably fits nine people (Figure 6, page 36), and would provide adequate shelter from extreme weather events. A chimney, stove, and external vent inserted into the structure allow for a cooking area, ventilation, and a heat source.

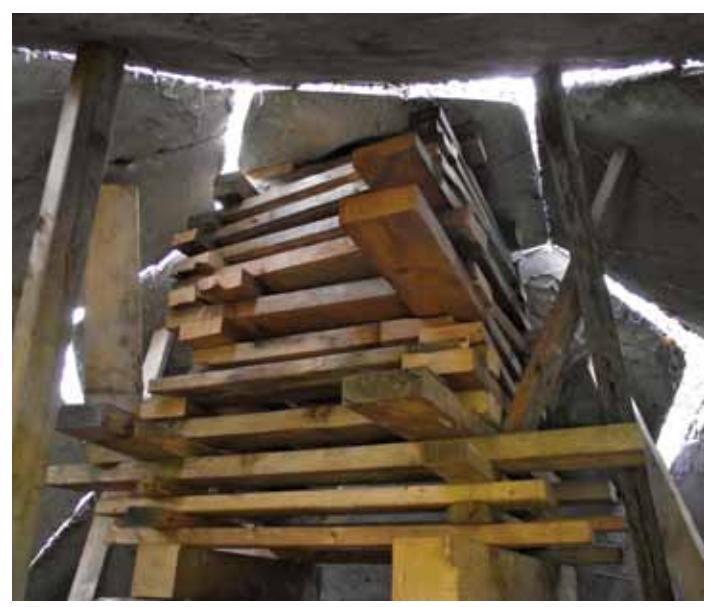
Figure 8. Second level panel supported and wired into place. Top panel with chimmney supported by cribbing in the foreground. Courtesy of Megan Strand-Jordan.
