# **Cottonwood Cornerstone Center Office Building**

Synergy of Art and Function

By Troy M. Dye, S.E. and Ryan E. Smith, S.E.

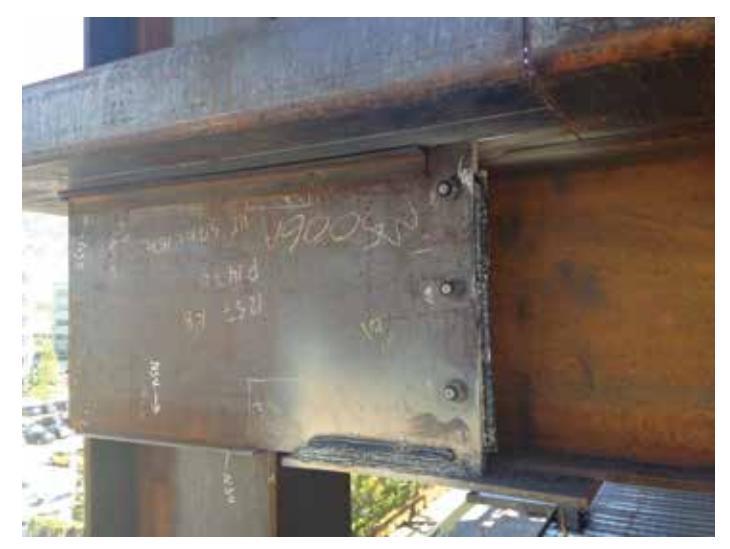
Figure 2. SidePlate connection.

0.634g, with a soil site classification of D. The design team faced the challenge of meeting the owner's desire for a "brace-free space" to obtain unobstructed views while avoiding the premium in cost associated with a conventional steel moment frame system. What made matters more challenging was the client-imposed beam depth limit of 24 inches. To solve these problems and do so in an economical way, the design team evaluated numerous structural systems and determined the most cost effective steel solution was special steel moment frames utilizing the increased stiffness of the SidePlate Connection Technology (*Figure 2*).

When comparing the various lateral systems, the design team determined that, to meet the allowable 0.02h code-mandated drift requirement, a conventional moment frame system such as a Reduced Beam Section (RBS) would have required the use of W24x131 beams and W24x370 columns. Utilizing the SidePlate system, the final beam sizes were W24x94s, and the final column sizes were W24x192s. As required per the seismic provisions, each joint was designed to resist the probable maximum moment of the beam taking into account specific hardening ratios. For these particular joints, the design moment was equal to 1455 k-ft.

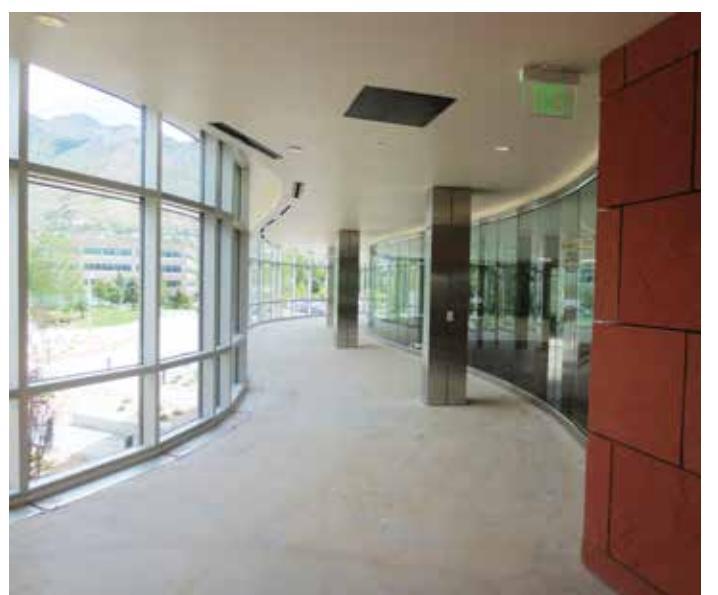
Figure 4. Curved lobby walkway.

The two-story lobby is a beautiful synergy of interior art and majestic mountains viewed through the second story curved glass walkway (*Figures 4, page 39* and 5). The curved walkway was created using  $\frac{5}{6}$ -inch thick bent plate edge angles supported by  $L3x3x\frac{1}{4}$  kicker braces aligned with the W12x19 floor beams. At other locations, the walkway floor framing was hung from the third floor to create an open lobby area below. Because the connector experiences high levels of human traffic, vibration control and floor stiffness were a primary focus of the design of the cantilevered floor systems.

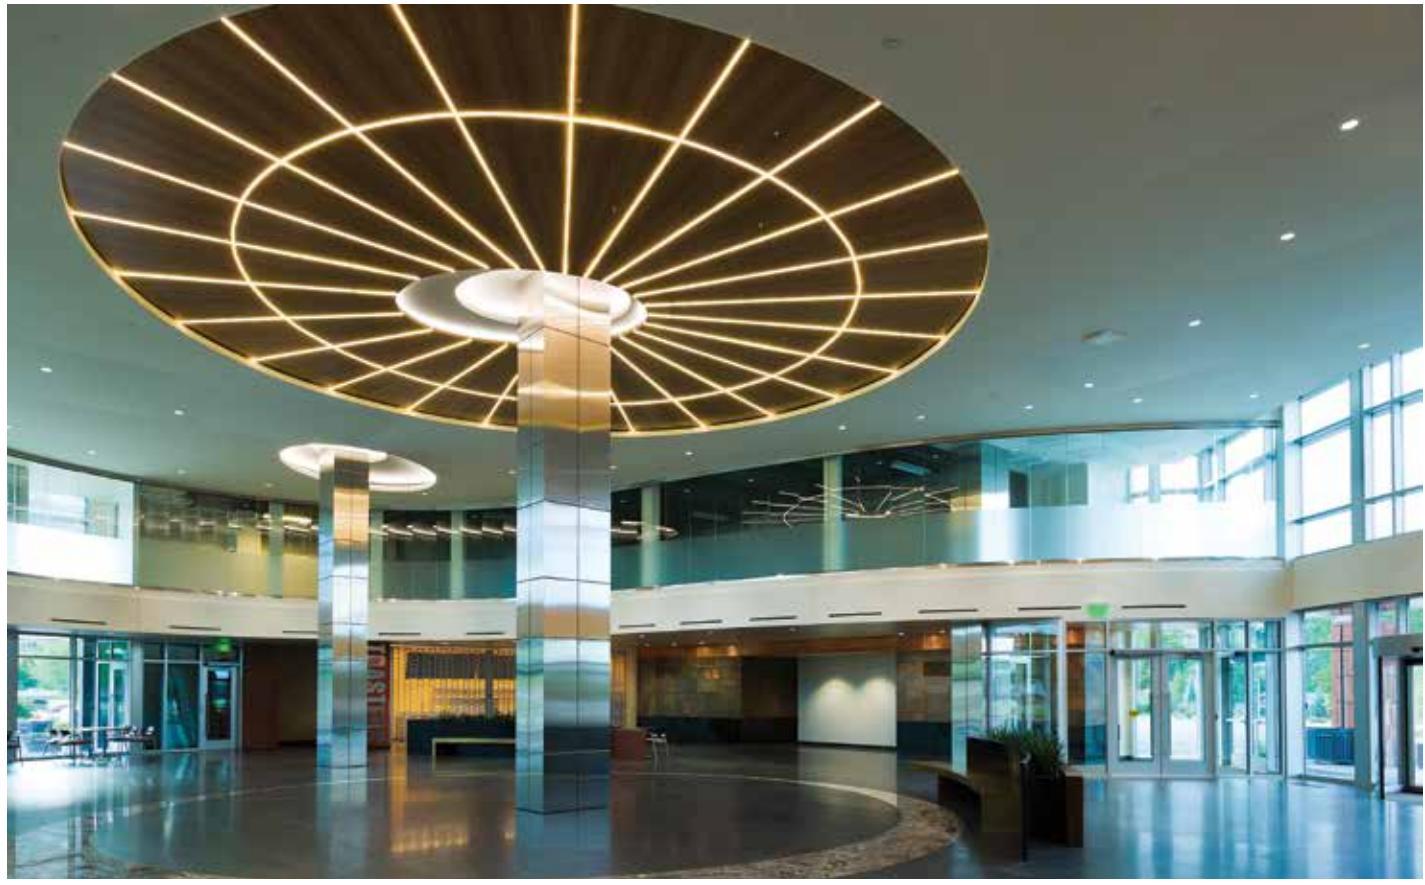
Figure 5. Two-story lobby.

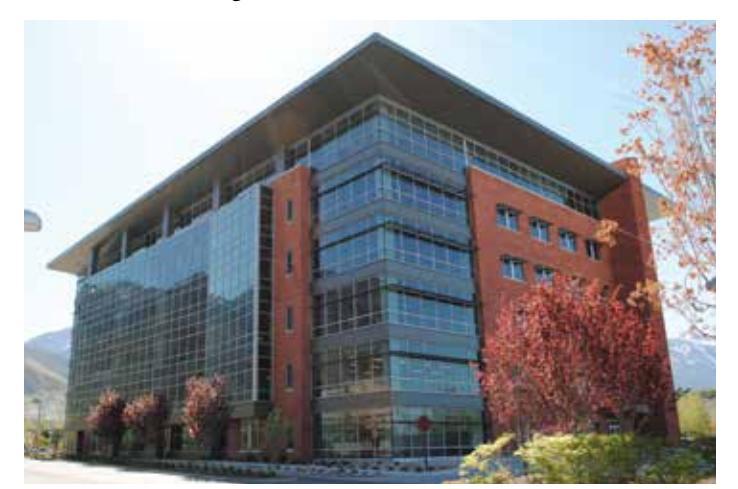
Figure 6. Cut sandstone façade and full height windows.

The façade of the building is a balance of floor to ceiling windows and punched openings surrounded by cut sandstone (*Figure 6*). There were many challenges in the design of the façade framing which included allowances for vertical deflection between floors due to gravity loads, allowances for horizontal movement between floors due to seismic and wind loads, and supporting the roof overhang framing )often referred to as "The Sombrero" by the design team).

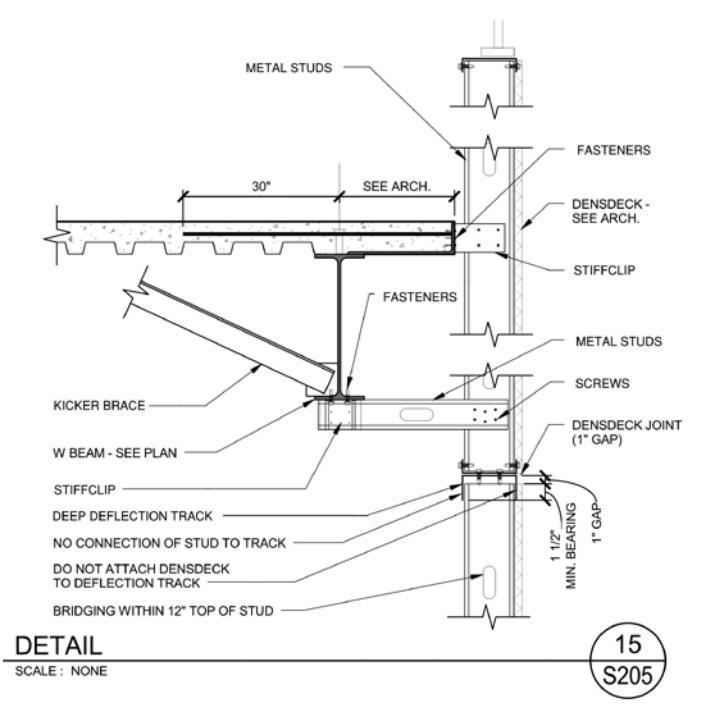
Figure 7. Vertical and horizontal slip joint detail.

deflection criterion equal to 34 of an inch was used to design the perimeter beams supporting the stone clad walls. A vertical gap was designed into the façade framing just below each floor at the tops of the floor-to-ceiling window systems. This gap in the façade framing was accomplished using a 2<sup>1</sup>/<sub>2</sub>-inch deep 16 gauge deflection track with a 1-inch gap between the track and top of the stud. The track and wall framing above the joint were attached to the floor slab edge angle and braced back to the steel structure. To allow for vertical movement, it was critical to clarify that the Densdeck must not be attached to the track, but could be attached to the stud below the joint (Figure 7).

A horizontal slip joint was designed into this same detail to allow each floor to move independently during a wind or seismic event. The typical façade framing consisted of 600S162-54 studs spaced at 16 inches on center. The 2½-inch deep track above the joint provides the out-ofplane resistance at the top of each stud. The stud wall with Densdeck below the joint is not attached to the deep track and, therefore, can slide in the plane of the wall inside the deep track.

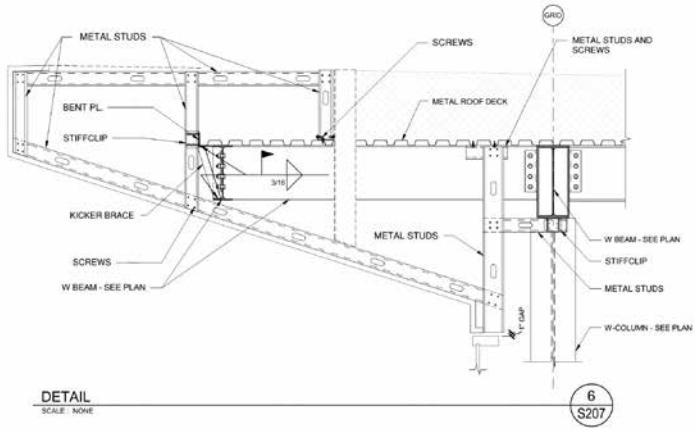
Figure 8. Sombrero light gauge framing detail.

The geometry of the "Sombrero" was designed to cantilever 5 feet past the steel

beam structure and maintain a 21-inch fascia depth. 362S162-54 studs spaced at 16 inches on center were utilized to form the roof and soffit framing. Both the roof light-gauge framing members and the soffit light-gauge framing members cantilever over the steel beam to provide a redundant cantilever support system (*Figure 8*).
