Punching of Slabs

A Discussion on the Development of the Delamination of Concrete Cover in the Soffit of the Slab

By Aurelio Muttoni, Ph.D., Miguel Fernández Ruiz, Ph.D., and João T. Simões

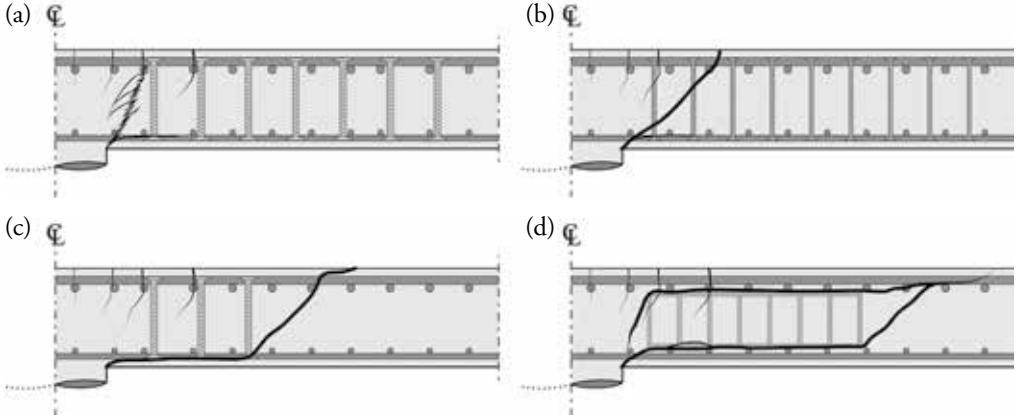
Figure 1. Different failure modes of flat slabs with shear reinforcement: a) crushing of concrete struts; b) failure within the shear-reinforced region; c) failure outside the shear-reinforced region; d) failure by delamination.

unching shear behavior is a topic that has attracted much attention from engineers in the last decades because of several collapses caused by punching shear failures. Introducing transverse reinforcement is the most common solution when the geometry of the slabcolumn connection has to be maintained and punching shear resistance has to be increased. To that aim, several transverse reinforcement systems may be used, not only to increase the punching shear resistance but also to significantly increase the deformation capacity and the residual strength after a local failure. If usual detailing rules are fulfilled, the design of slabs with shear reinforcement is governed by one of the following three potential failure modes: 1) crushing of the concrete struts in the column vicinity (maximum shear strength, see Figure 1a); 2) punching within the shear reinforcement (governing the dimensioning of the transverse reinforcement, Figure 1b); and 3) punching outside the shear-reinforced region

(governing the dimensioning of the size of the zone with shear reinforcement), *Figure 1c*.

Another common situation where delamination is observed occurs in a punching failure outside the shear-reinforced region. In this case, an inclined shear crack develops between the flexural reinforcement and the bottom of the last perimeter of transverse reinforcement (*Figure 1c*), together with horizontal cracking joining the bottom of the inclined shear crack and the column face. The *Model Code for Concrete Structures* 2010 (International Federation for Structural Concrete) already accounts for this phenomenon in the punching shear design for a failure outside the shear-reinforced area (considers a reduced effective depth).

Finally, when some important detailing rules are not respected, delamination may also occur (*Figure 1d*). This is the case of transverse reinforcement not embracing the flexural compression and tension reinforcement, which leads to a slab cover delamination and premature failure, although usually associated with large deformation capacities.

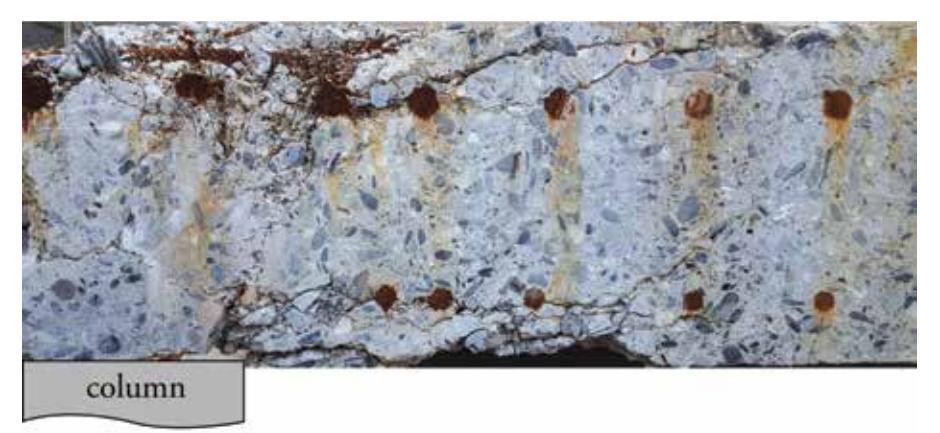
Figure 2. Specimen tested by the authors with failure due to crushing of concrete struts near the column; pronounced delamination observed in the soffit of the slab.

slabs with shear reinforcement recently tested by the authors and presenting a failure due to crushing of concrete struts (*Figure 2*). The origin of this delamination can be explained by the tangential strains developing at the column vicinity as a function of the rotation of the slab (*Equation 1*).

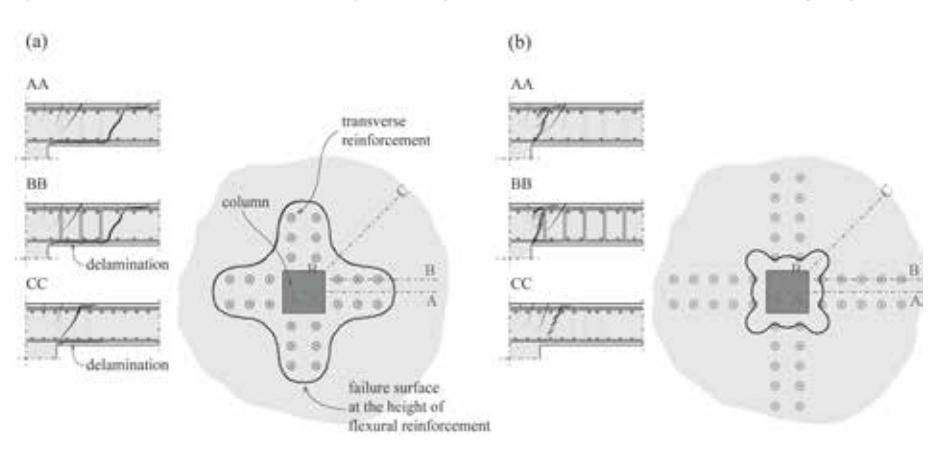
Figure 3. Scheme of punching shear failures with non-uniform location of the failure surface: a) failure outside the shear-reinforced region; b) failure by concrete crushing.

If the last perimeter of shear reinforcement is not sufficiently distant from the column to avoid a punching failure outside the shearreinforced area, the inclined cracks already formed in between the rows of transverse reinforcement will tend to propagate tangentially through the formation of a separation crack (delamination) at the level of the compression reinforcement (without crossing the transverse reinforcement elements). This will be completed by inclined shear cracks around the rows of transverse of reinforcement (*Figure 3a*).

If the last perimeter of shear reinforcement is sufficiently distant from the column, crushing of concrete struts will be the governing failure mode. In this case, the inclination of the failure surface in the areas between the transverse reinforcement rows is flatter than that developing in the regions of transverse reinforcement (*Figure 3b*).
