Night Moves on Boylston

Means and Methods for Renovation of the Boston Public Library Johnson Building

By Nathan C. Roy, P.E., and Ethan A. Rhile, P.E.

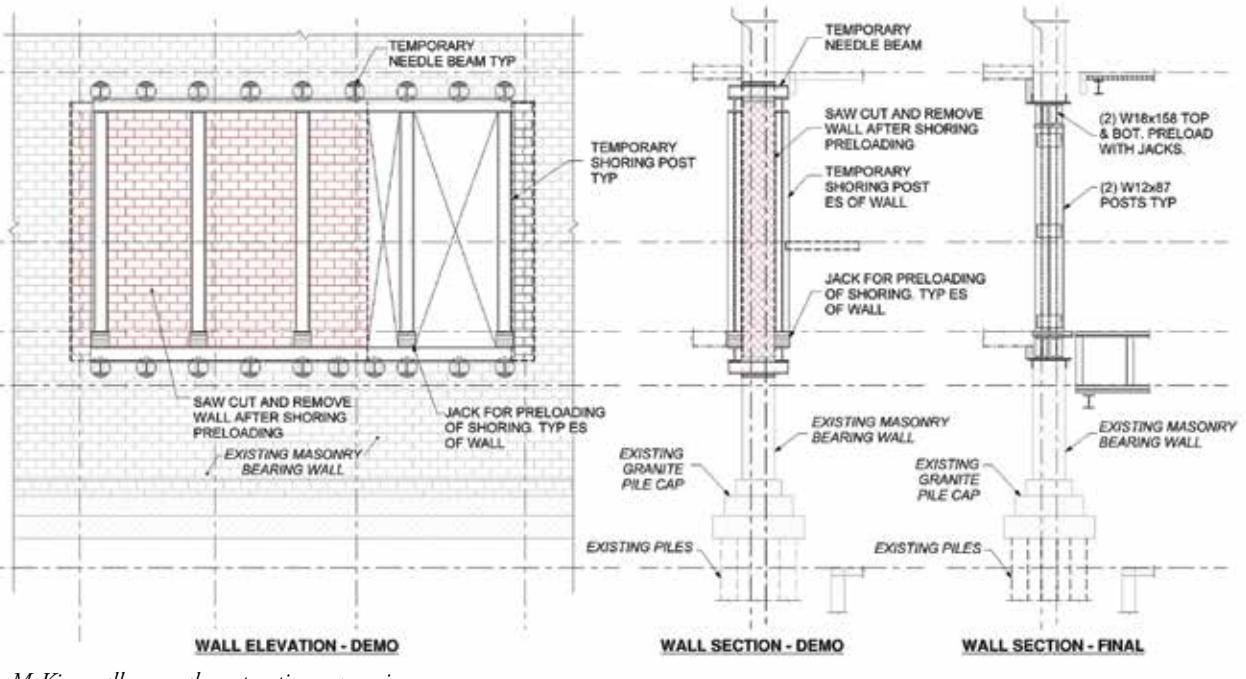
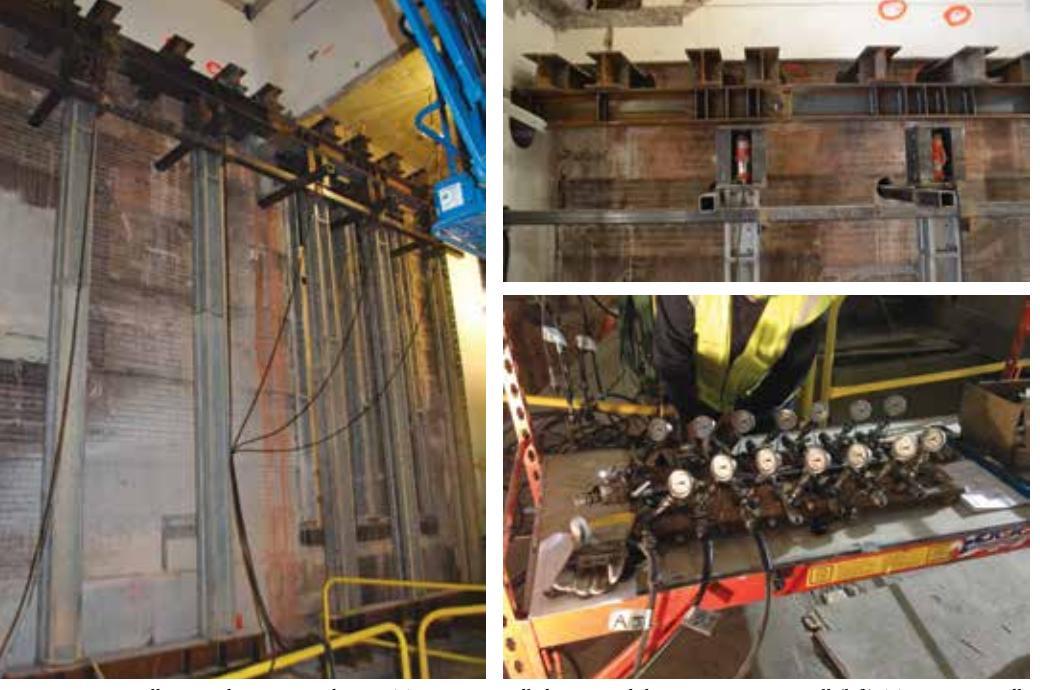
McKim wall removal temporary shoring. Temporary needle beams and shoring at McKim wall (left); Temporary needle beams, jacks, and jack boxes (upper right); 14 jacks used to simultaneously preload McKim Shoring (lower right).

The structural drawings showed recommended sequencing along with conceptual shoring for the general scheme used in the design. The existing wall was cored above and below the opening to allow for W10 needle beams to be inserted and fully grouted into the wall. The temporary shoring consisted of W10 spreader beams engaging the needle beams, each side of the wall spanning between proprietary shoring posts. To insert the new W18 beams at the base of the wall, a portion of the wall needed to be removed which compromised the support of the existing first floor McKim beams. The W10

spreader beam provided temporary support for these beams until they could be reattached to the structure.

Complete drawings for the existing McKim structure were not available. Exploratory work performed between concept and final shoring design resulted in changes, including coordination of needle beam and post locations to avoid existing framing above and below the opening. A lintel beam above an existing double door opening was discovered at an elevation higher than anticipated. The lintel conflicted with the temporary needle beams. Pre-shoring of the header within the existing opening was provided to support the wall and allow for coring of the lintel and installation of needle beams.

Both the final structural steel framing and temporary shoring were preloaded with jacks to limit deflections of the existing McKim Building unreinforced masonry walls and terracotta masonry floor arches. Fourteen independently controlled hydraulic jacks were used during preloading of the shoring. Custom jack boxes at the top of the posts were designed to accommodate hydraulic jacks to allow for preloading of the framing. The tops of shoring posts had to be temporarily braced to each other and to the wall to provide stability of columns during preloading of the wall.

Load requirements were coordinated between the design and construction teams. Loads were independently calculated, with dead loads of approximately 25.5 kip/ft and unreduced live loads of 6.5 kips/ft. It was agreed to preload the frame to 75% of calculated dead loads. Fourteen independently controlled hydraulic jacks were used during preloading of the shoring while nine inflatable air jacks were used to preload the final framing.

One of the most critical components of the construction sequence was monitoring during preloading. Representatives from LeMessurier, Becker, and Consigli were present for all jacking operations. Preloading occurred at night when floors above were closed to the public. Deflection monitoring points at the top, along the length of the opening, were set up to continuously monitor for movement. No measurable movement was observed during jacking operations, demolition, and after temporary shoring removal.

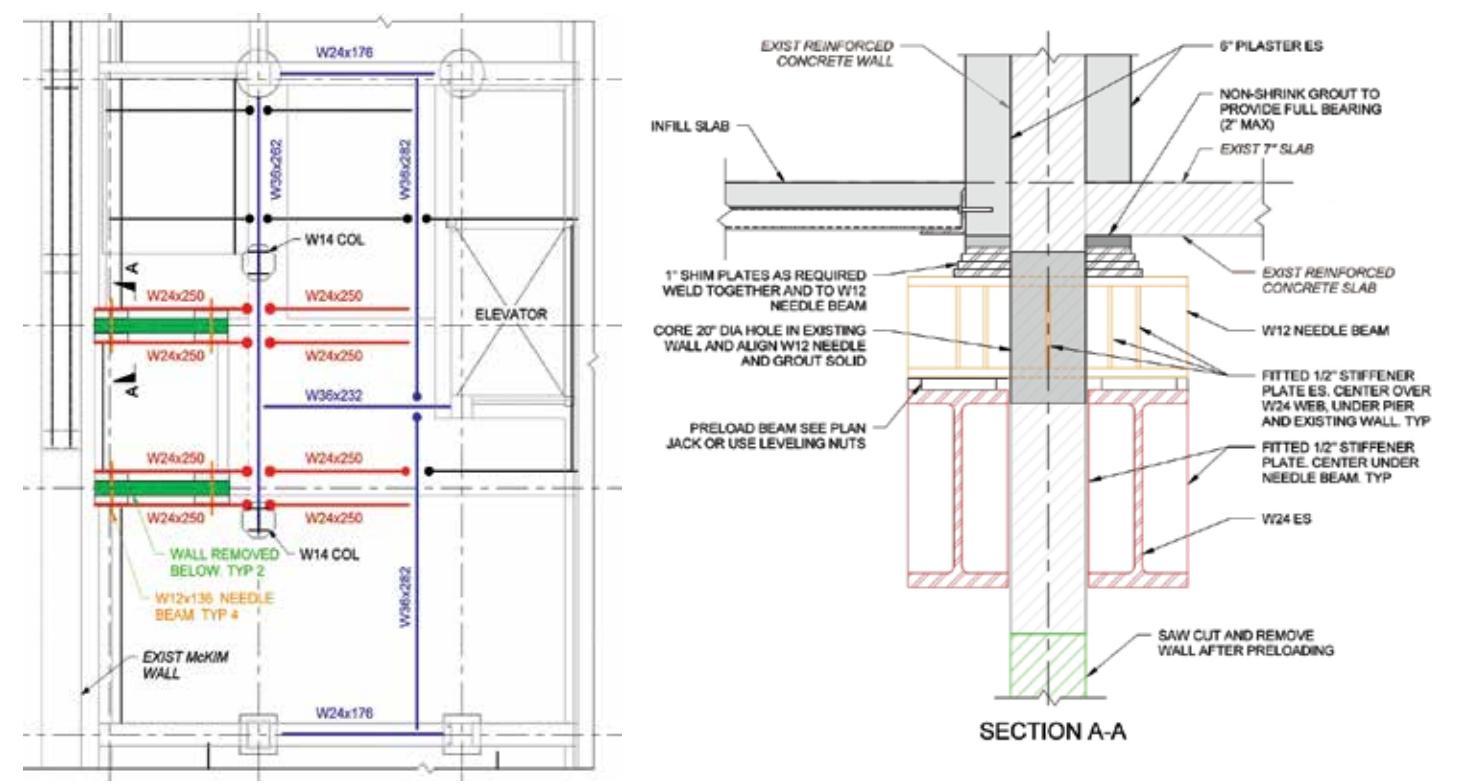
Johnson Building wall removal. Partial plan of second floor framing at Johnson wall removal and McKim Link. Green – removed walls below. Red – cantilever and backspan W24. Blue – support framing. Orange – needle beams. McKim wall let; (left) Wall to W24 detail (right).

Between the new Boylston Hall and the new opening to the McKim building was an existing stair servicing all floors. Two 10-inchthick by 8-foot-long reinforced concrete walls on either side of the stair supported both the stair and surrounding floor structure. The walls not only supported vertical loads but also acted as cantilevers extending from the mat slab foundation. The transformation required the relocation of the stair and the removal of the walls to provide an open and clear connection between spaces. Temporary lateral wall bracing was provided between walls to allow for removal of the mezzanine slab prior to removal of the wall. Also, a 4-foot 2-inch opening was made in each of the walls above the second floor to accommodate the relocated stair.

A steel framing scheme was developed to allow for erection, jacking, and demolition without the need for temporary shoring. Cantilever steel framing was provided to support the wall above the second floor. Two W24x250 beams, one on either side of each wall, cantilever 10 feet with a 10-foot backspan and are both supported by a shared system of W36 girders and W14 columns. One column was required to be discontinuous and supported by a transfer girder at the first floor to accommodate the architectural program. The original 7-foot-thick reinforced concrete mat slab provided flexibility in locating new columns as required to meet the architectural layout without the need for new foundations. The wall sections to remain on either side of the new opening above the second floor were reinforced with concrete sections on either side of the wall, creating two reinforced concrete columns per wall. W12 needle beams centered below the newly created columns (i.e., two W12s per wall) were designed to transfer the load between the walls and steel framing. The framing was designed to limit live load deflections to L/800.

Walls were estimated to each support a load of over 450 kips, with unreduced live load representing approximately 15 to 20 percent of the total. The steel framing was preloaded for the estimated dead load with hydraulic flat jacks to limit deflection, reduce the required steel tonnage, and protect the existing Johnson Building. Jacks were located between each end of the needle beams and W24 cantilevers, a total of four jacks per wall. The initial Contractor-proposed scheme was to preload a pair of W24 beams at one wall, remove the jacks and then preload the second pair of W24 beams at the other wall. The design team demonstrated that over 25% of the force would be lost in the first W24 pair when the second pair was loaded. Therefore, it was agreed that both pairs of W24 beams would be loaded simultaneously to eliminate any preload losses.

Deflections were monitored during preloading to ensure that calculated wall weight was accurate and the building was not raised. Preloading resulted in approximately $1\frac{1}{4}$ inches of deflection in the steel framing with less than $\frac{1}{8}$ -inch of deflection in the framing after jack removal.

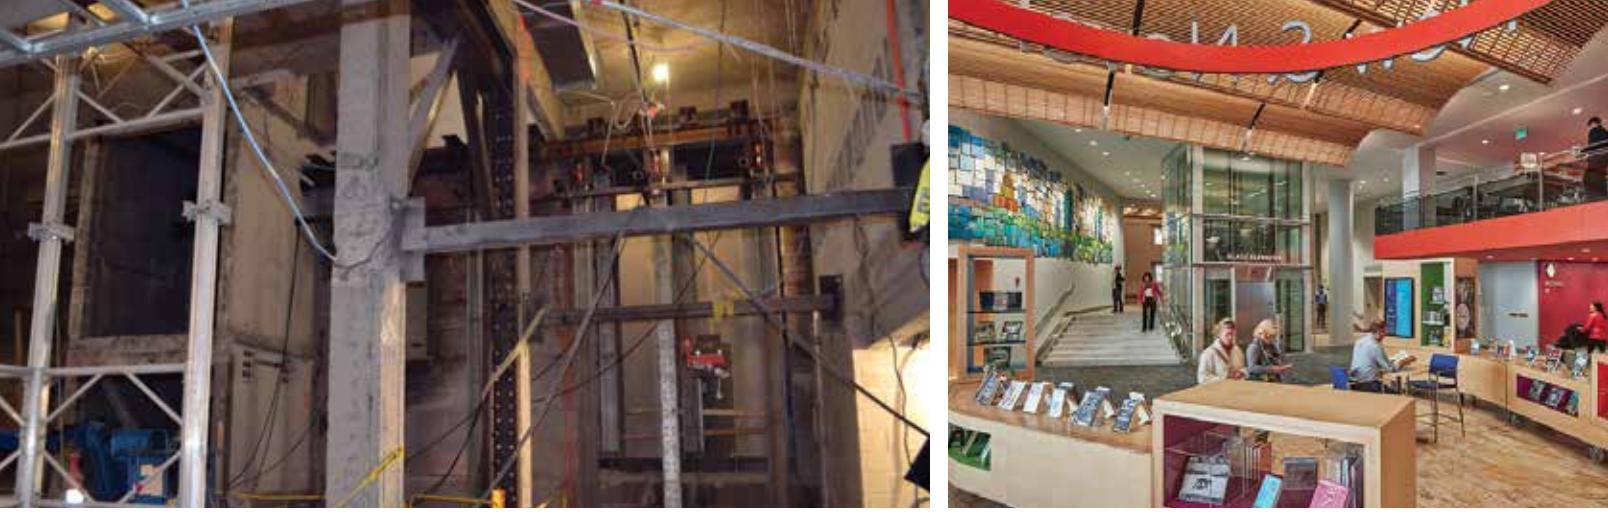
Temporary shoring for McKim wall removal, Johnson concrete walls remain for new link (left); Finished McKim Link (right). Courtesy of Bruce T. Martin.

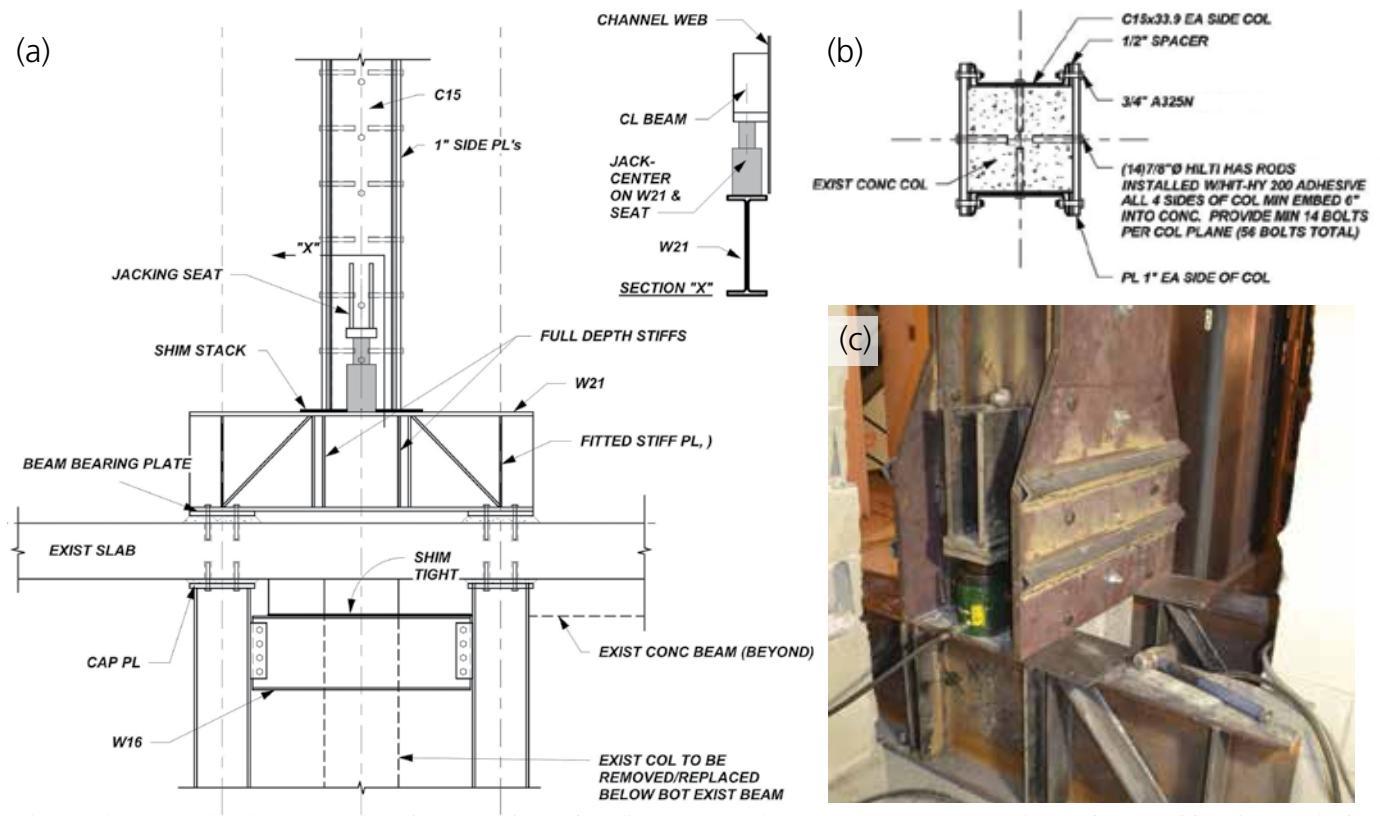
Column replacement at glass elevator. a) Section of temporary shoring; b) Collar to concrete column connection; c) Temporary shoring above second floor during preloading.

The shoring scheme utilized to replace the existing column was to construct a steel collar around the existing column above the second floor. The collar was constructed of steel channels and plates, with adhesive anchors utilized to transfer the column loads to the collar. Just above the second floor, two steel girders were utilized as jacking points. Jacking of the column above was considered critical to assure that the load would be removed from the existing column and transmitted to the shoring system. The steel girders were supported on temporary W12 steel columns. The columns were grouted to the floors that were to remain, but cored through the existing mezzanine so that the mezzanine could be removed once the column was unloaded. Column locations were coordinated in extremely tight spaces, avoiding active electrical conduits and other utilities. In one location, a column flange had to be notched and the remaining column reinforced for the column to fit in the proper location. At another level, the temporary column forces had to be redirected with a transfer girder cantilevering at each end to avoid interferences. The bases of the columns were founded on the existing 7-foot-thick foundation mat.

The column load supporting the existing two-way concrete flat plate was estimated at 550 kips with full live load, which was included when sizing shoring elements. Only dead load was considered when determining jacking forces for shoring preloading. Because some of the floors supported by the column that was being shored were occupied during regular library operations, the jacking and cutting of the existing column were performed at night, during off hours. To ensure that loads were properly removed from the existing column and transferred to the shoring system, monitoring points were established on the jacking collar. The points were observed for movement during jacking using a construction auto level located away from the jacking site.

Two hydraulic rams, with a common manifold, were used to jack the collar from the steel girders. The common manifold was needed to ensure that the jacks on either side of the column were lifting at the same pressure and, therefore, a balanced force. The jacking was stepped at 25-kip intervals, with a 10-minute hold at 50-kip intervals to allow for monitoring of the structure and to observe any slippage that might occur in the column collar. The maximum predicted jacking force was 320 kips. At 275 kips, the collar had moved up $\frac{1}{16}$ inch, indicating the column was raised. At that jacking increment, it was decided to lock off the hydraulic rams.

To install the new column, the demolition of the existing column required a clean cut where the column met the structure above and below. The initial cutting was performed at the level directly below the jacking site at the top of the column. A 42-inch-diameter hydraulic rotary cutting saw was utilized to make the cut immediately after jacking. After demolition, the new steel column was set, grouted in place, and anchored top and bottom with adhesive anchors completing the column replacement.
