This four-part series discusses the adaptive reuse of the Witherspoon Building in Philadelphia, PA. Part 1 includes the building history and description of the structure, including previous structural additions and alterations. In addition, numbered photos are provided with the print version of the articles, and additional lettered photos are provided with the online version of the articles.

Adaptive Reuse OF THE Historic WITHERSPOON BUILDING

Part 1: Building History and Structure By D. Matthew Stuart, P.E., S.E., P.Eng, F.ASCE, F.SEI, A.NAFE, SECB

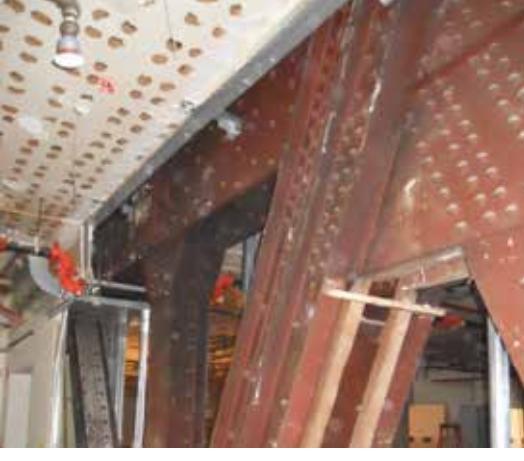
Figure 2. Voussoir keystone hollow clay tiles on each side of a typical

Carnegie Steel beam.

flat arch construction with voussoir, or "keystone," hollow clay tiles placed parallel to and on each side of the supporting 12-inch-deep Carnegie Steel B section "I" beams (*Figure 2*). The voids of the keystone tiles are also oriented parallel to the beam span and therefore perpendicular to the main arch tiles. This is referred to as a combined end and side configuration. The beams are typically supported by built-up

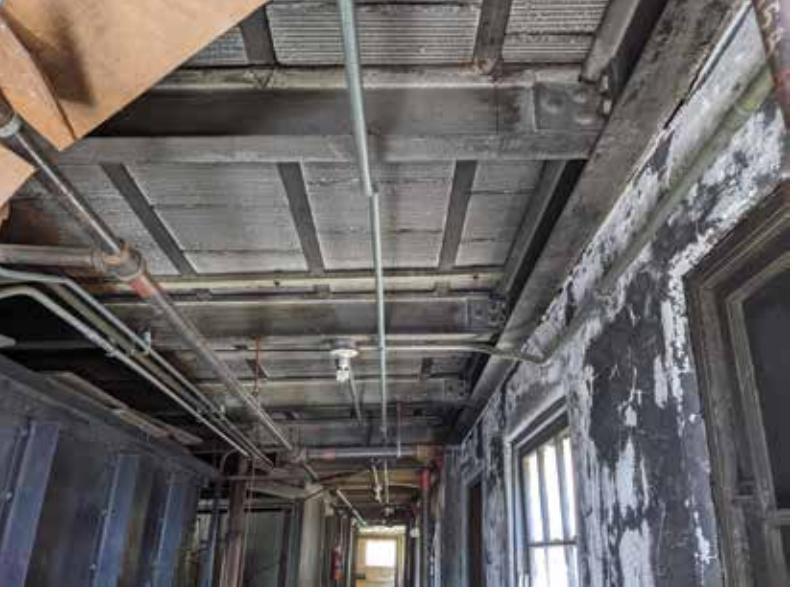
Figure 5. Book tiles supported by bulb tees spanning between Carnegie Steel beams at the penthouse roof.

Portions of the basement floor framing over the sub-basement were constructed with brick arches spanning between steel beams. In contrast, the roof over the mechanical penthouse was constructed with 4-inch hollow clay "book" tiles that simple span between inverted tee or "bulb" steel purlins supported by steel B section beams (Figure 5, page 34). Round, hollow cast iron columns support the beams. There is also an ornamental, cast-iron framed, single-story gabled roof structure that occupies what was originally an open courtyard area at the 1st or ground floor on the west side of the building.

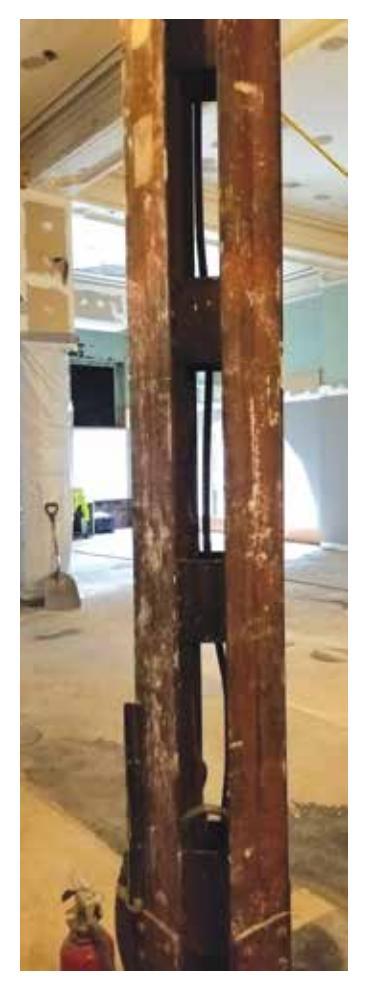
Figure 4. Typical Gray column.

riveted steel plate and angle girders (Figure A, online) or steel B section girders. Built-up, story-high, riveted parallel top and bottom chord steel transfer trusses (Figure 3) support the south portion of the 4th and 5th floors and the columns that support the floor and roof framing above. Also, similarly constructed roof trusses clear span across the north end of the building above the 11th floor. In addition, except at the mechanical roof penthouse and standalone 1st floor shed, the main building columns consist of built-up riveted angle sections known as Gray columns (Figure 4, page 34).

Gray Columns

It is interesting to note that fabricated columns in the Witherspoon Building appear to have been used because the engineer and contractor had not transitioned from employing rolled steel "I" sections as horizontal beam elements to vertical column elements, as is done today. The Gray columns used in the Witherspoon

Building were a patented section that could be fabricated with structural shapes, in this case, angles that any steel mill could roll.

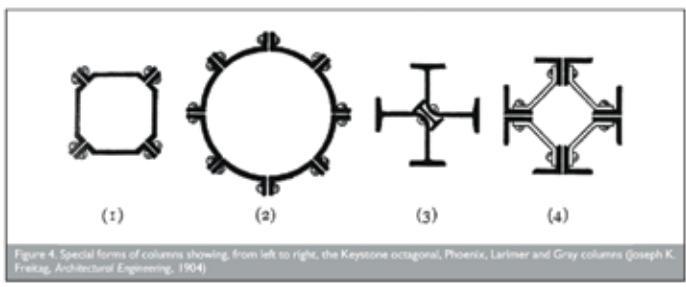
Figure B. Gray column. Courtesy of S.E. Wermiel, Ph.D.

Similar patented sections, like Phoenix columns, could not be fabricated with rolled sections. Therefore, because Carnegie Steel supplied the beams for the building, it was assumed that the Gray column components were likewise rolled by Carnegie (cross-section (4) in *Figure B, online*). In addition, it was confirmed via field measurements that the vertical angles used in the Gray columns conformed with the available standard angle sizes provided in the 1896 Carnegie Steel Pocket Companion. It is also interesting to note that both the Fisher Building in Chicago and Guaranty Building in Buffalo, constructed at the same time as the Witherspoon Building, used Gray columns.

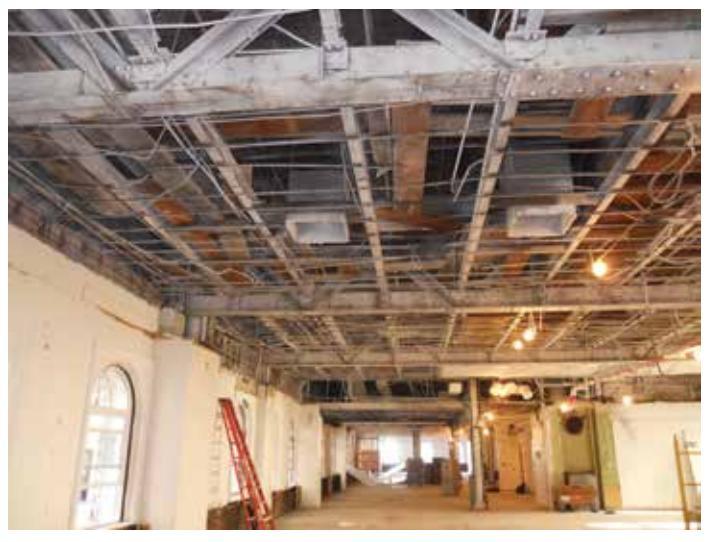
Figure C. Main roof trusses.

At the north end of the building, to provide a column-free space at the 11^{th} floor, 4-foot-deep Warren steel trusses, fabricated with angles, plates, and rivets, were constructed to clear span from the east to west sides of the building (*Figure C, online*). The trusses support the main roof framing, the original mechanical penthouse floor and roof framing, and the 11^{th} -floor walk-on attic/ceiling in this same area of the building.

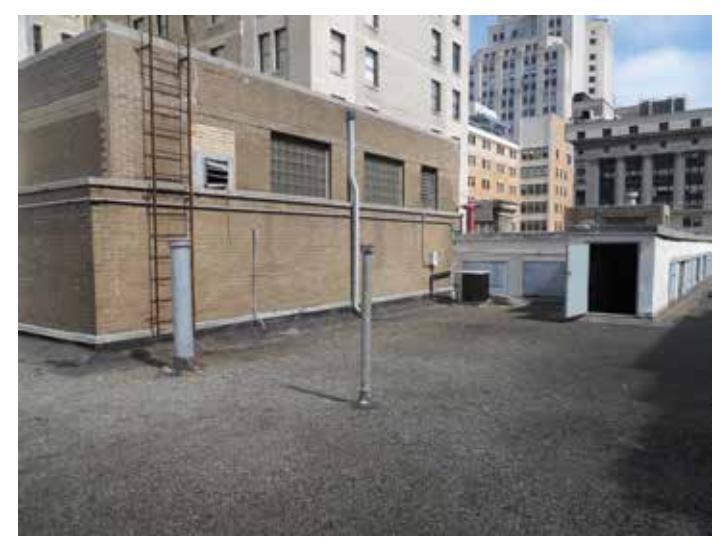
Figure D. Passenger elevator machine room penthouse (left) and original mechanical penthouse (right).

According to the NRHP Inventory Nomination Form, the original passenger elevators were upgraded in the early 1960s. However, a comparison of the Sanborn Map for the original facility to the current building indicates that the only structural manifestation of this renovation appears to be the construction of a rooftop machine room penthouse located above the original elevator shafts (*Figure D, online*).

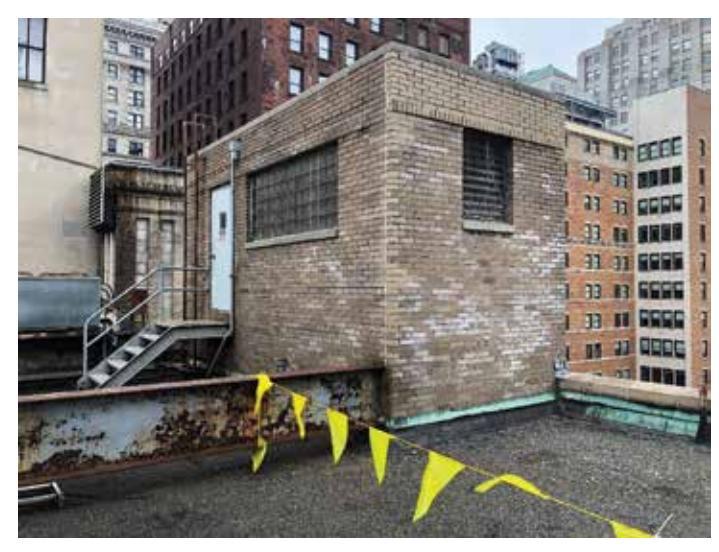
Figure E. Freight elevator machine room penthouse.

Similar to the passenger elevators, it appears that the freight elevator was upgraded during the life of the building. The structural renovations included a new machine room penthouse supported by rooftop dunnage beams that span between the main building columns, except at the south end of the eastern beam, which is supported by the northernmost roof truss (*Figure E*, online). In addition, drawings provided by the Otis Elevator Company, dated 1950, indicate that the original two shafts at this elevator, shown on the Sanborn Map, were converted to a single shaft elevator as a part of the renovations.
