# Adaptive Reuse of the Historic WITHERSPOON BUILDING

Part 2: Adaptive Reuse and Structural Investigations

By D. Matthew Stuart, P.E., S.E., P.Eng, F.ASCE, F.SEI, A.NAFE, SECB

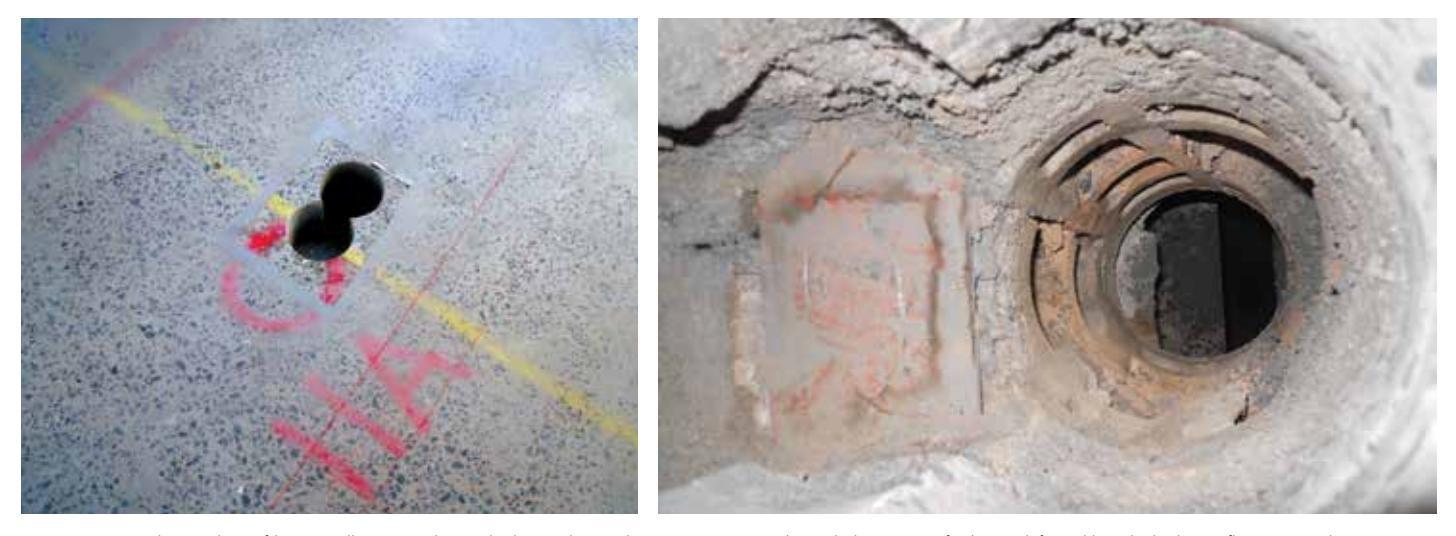
Figure 8. Typical centerline of beam yellow paint line (which was located via a GPR survey on the soffit side of the framing) and core holes.

Figure 8. Typical centerline of beam yellow paint line (which was located Figure 9. Typical core holes on top of a beam (left) and beside the beam flange tip (right).

Once the beams were located and the centerline of the members was accurately marked on the top of the finished floor, the slab was then cored directly on top of the wide flange section to reveal the beam width. A second core was then taken through the entire depth of the topping and

tile immediately adjacent to the flange tip of the beam to confirm the beam depth (*Figures 8* and *9*). Both of the core locations allowed the dimensions of the steel section to be accurately recorded and the thickness of the concrete topping, hollow clay tile, and plaster ceiling to be

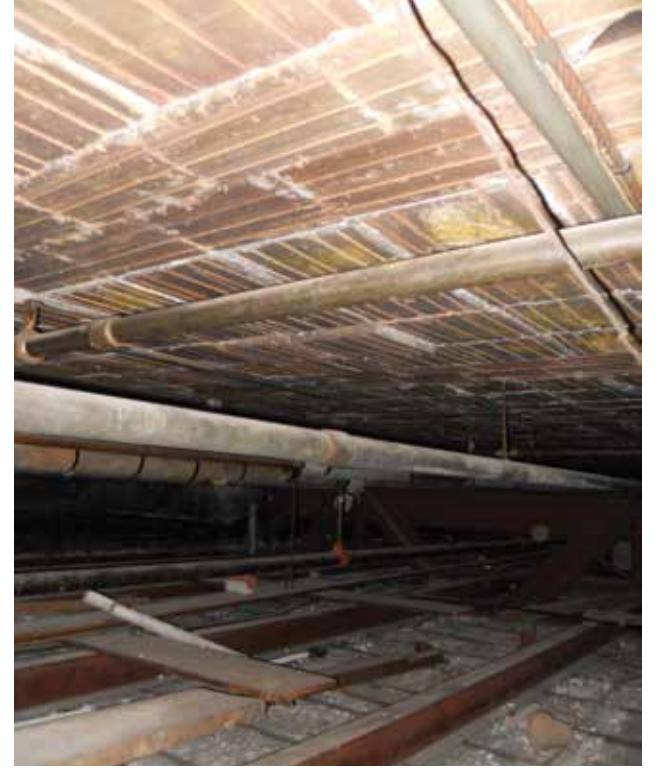
Figure 10. Voussoir arched tiles on each side of and parallel and directly beneath the concealed steel beams.

roof beams and the direction of span of both the beams and tile arch were visible from the 11<sup>th</sup>-floor attic framing because plaster had not been applied to the tile soffit. As a result, the scored bottoms of the 12-inch-wide by 9-inch-long (in the direction of the arch span) hollow clay tiles were visible, with the beam locations identified by the scored bottoms of the end voussoir and beam soffit tiles arranged parallel to and centered about the entire beam span (*Figure 10*).

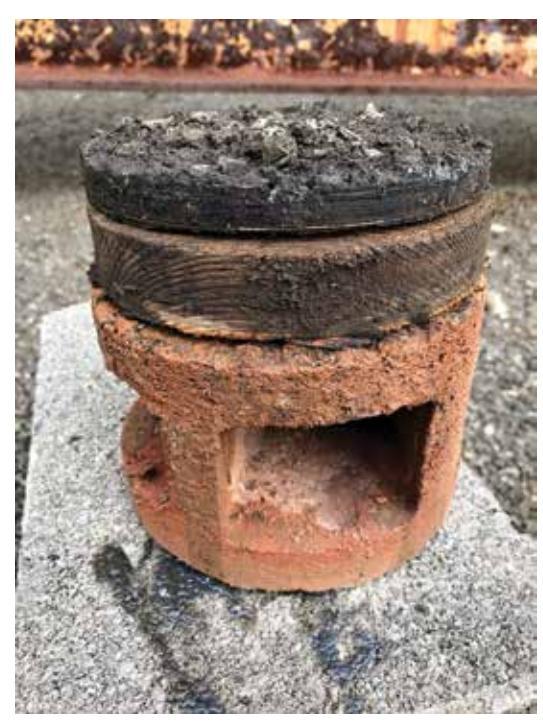
Figure 11. Mechanical penthouse high roof 4-inch hollow clay book tile core.

Similarly, because the soffit of the high penthouse roof had not been plastered, the location and direction of span of book tiles, bulb tees, purlins, and beams were also readily apparent. In addition, full-depth cores were taken at both the high penthouse and main roofs to confirm the thickness of the 4-inch book tiles (*Figure 11*) and 12-inch-depth hollow clay tiles, respectfully, and the associated existing roofing.

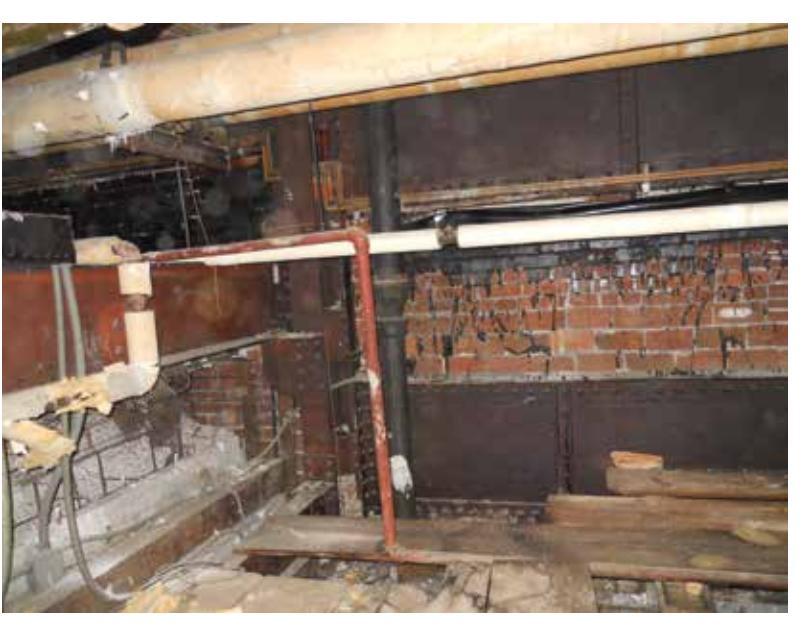
Figure 12. South side roof and 11th floor attic framing.

As indicated in Part 1 of this article, the southern portion of the main roof was not framed with trusses and instead was

constructed with Carnegie Steel B Beams and built-up, riveted steel plate and angle girders as shown in *Figure 12*. This area of the building was subsequently investigated as a part of the Mechanical Penthouse and Cooling Tower Dunnage investigation that will be provided in Part 3 of the article.

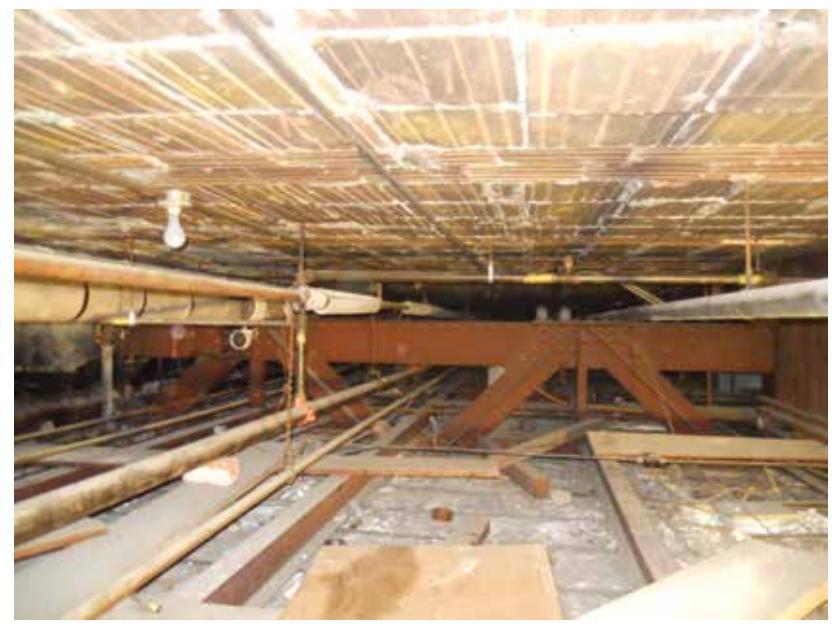
Figure I. Typical main roof truss with top chord not directly supporting the main roof framing above.

The results of the analysis of a typical Warren roof truss (*Figure I and J*, *online*) indicated that the member did not have reserve capacity to support the proposed new rooftop assembly space deck; however, it did have adequate capacity to support the reserve capacities noted above for the penthouse high and main roof framing.

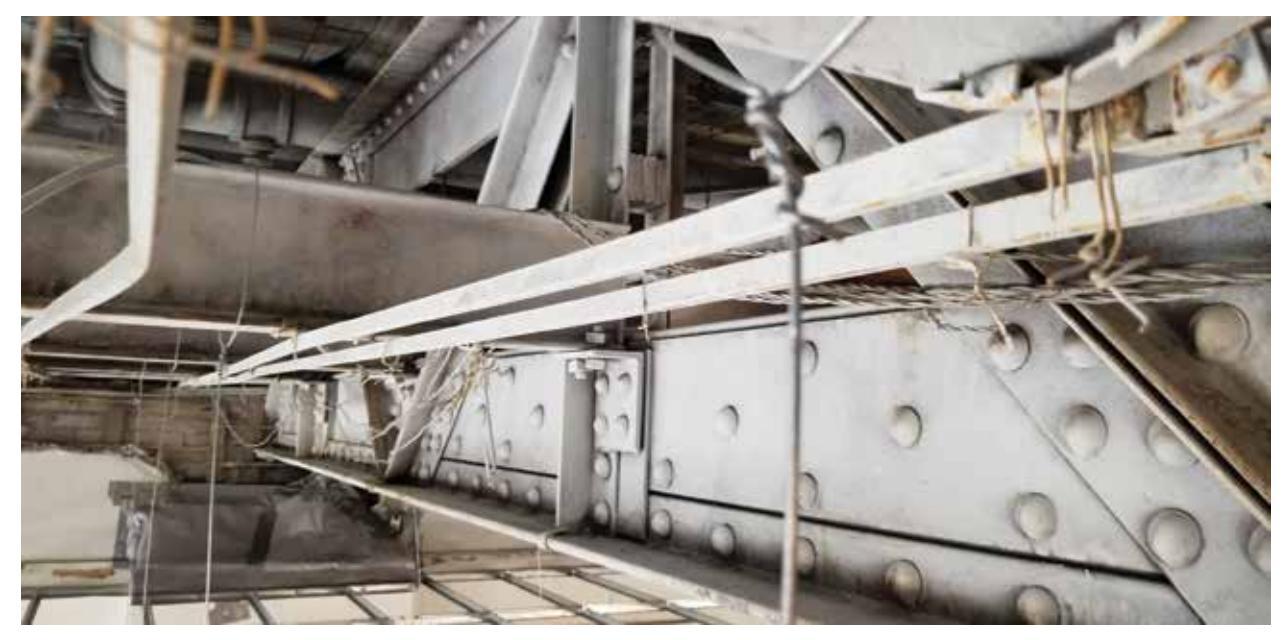
Figure J. Exposed roof truss during renovations.
