SPOTLIGHT

The First Unitarian Society Meeting House

Creative Solutions for a National Historic Landmark

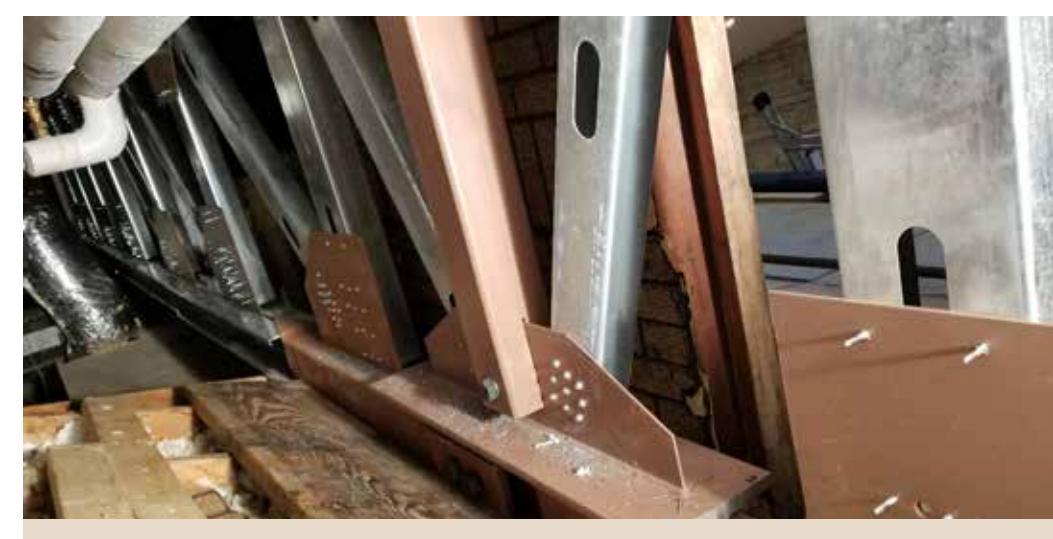
to be completed in a dry attic with wood framing and old insulation, so fire concerns limited welding. With these limits, PE proposed assembling a cold-formed steel (CFS) and structural steel hybrid truss that would be assembled in the attic. Members could be passed through the ceiling opening and were light enough to carry with no special equipment.

This new truss ("truss J1") was placed 4 feet from truss J and spanned roughly 5 feet. Typical chords were (2)600S350-68 (placed back-to-back) with webs ranging from 400S250-68 to 600S300-97. Typical panel point connections consisted of #12 screws with 10GA gusset plates (¼-inch-thick Gr. 50 steel at chord splices). The client requested that one panel in the truss be left open to walk through, so some truss chords were HSS6x4x¼ due to moments from a missing web diagonal.

It is common to support existing framing with shore posts, install new members, and then release shoring to shift the load onto new framing. In this case, roof sheathing was essentially being used as a compression flange for the trusses. PE had concerns about reversing member/connection loading that had been in a state of fragile equilibrium by 'jacking up' the structure. Therefore, PE designed a pretensioning mechanism to transfer the load into truss J1. A 1-inch-diameter threaded rod was installed on the bottom chord at midspan, and a nut on the rod was tightened with an impact wrench that shortened the bottom chord. This lifted the truss and engaged the roof purlins without the need for jacking. Pretensioning also had the critical benefit of tightening truss connections. By analyzing several upper and lower bounds of stiffness, a pretension force of 18,400 pounds was selected based on the amount of load needed to shift away from truss J while keeping in mind that too much upward movement could damage roofing. FE modeling suggested that this amount of force would result in a maximum net upward movement of ³/₁₆ inch at midspan. Though pretension force could be estimated by a "turn-of-thenut" method, movement/pretension needed to be closely monitored during the operation to avoid damaging the structure. Therefore, PE installed two strain gauges on the threaded rod that were monitored during the pretension process. Torquing was terminated at the desired force, and the pretension mechanism was welded in its final position. Upward movement during pretensioning matched calculated values without damaging the existing structure.
