Tested Guardrail Post Connections for Residential Decks

By Joseph Loferski, Dustin Albright, and Frank Woeste, Ph.D., P.E.

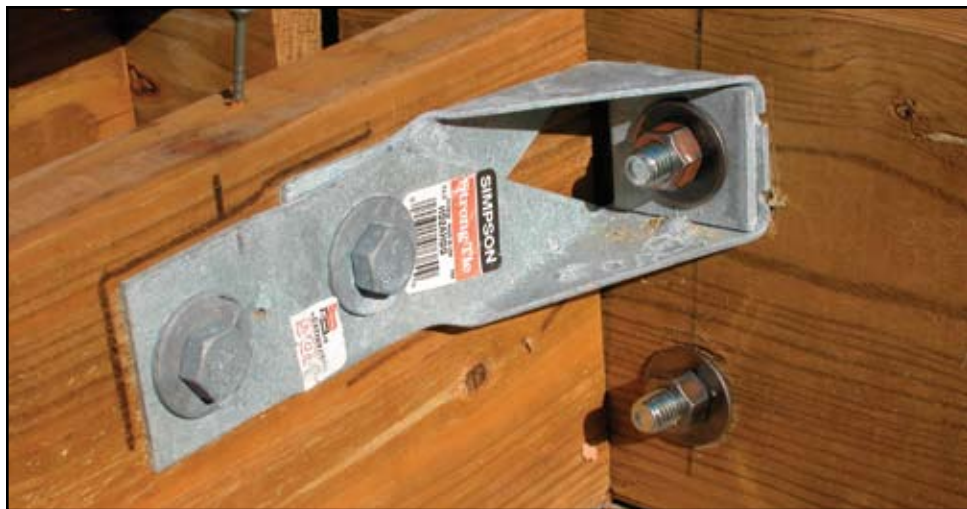
Figure 3: Simpson Strong-Tie™ HD2A connector used to test an assembly with the post inside band joist (shown) and outside band joist.

design had to utilize bolts that are arranged in a way that they can transfer load from the post to the joist in shear (lateral loading) because bolted connections are very strong when resisting lateral, or shearing type loads. Therefore, a connection design was sought that loaded bolts in lateral or shear mode. A commercial steel connector (Figure 3, see page 56) was identified that is typically used to resist wind and earthquake loads in shear walls, but could also be used to attach a guardrail post to a deck joist. In this deck application, these connectors utilize three 1/2-inch diameter bolts: two bolts are installed in the joist and are loaded in shear, and the third bolt passes through the post, the band, and the connector itself. The third bolt is loaded in tension. These designs are depicted in Figures 4 (see page 57) and 5. In each case, another 1/2-inch bolt is installed in the lower part of the post and the band joist.

Only one Simpson Strong-Tie™ HD2A connector was used per post, and the centerline of the connector was positioned 2 inches below the top edge of the 2x8 joist. Maintaining this dimension in the field is extremely important because it severely impacts the forces involved in the connection. In no case should the centerline of the HD2A be more than 2 inches from the top of the joist. A hot dipped galvanized (HDG) HD2A connector was “special ordered” for these tests,

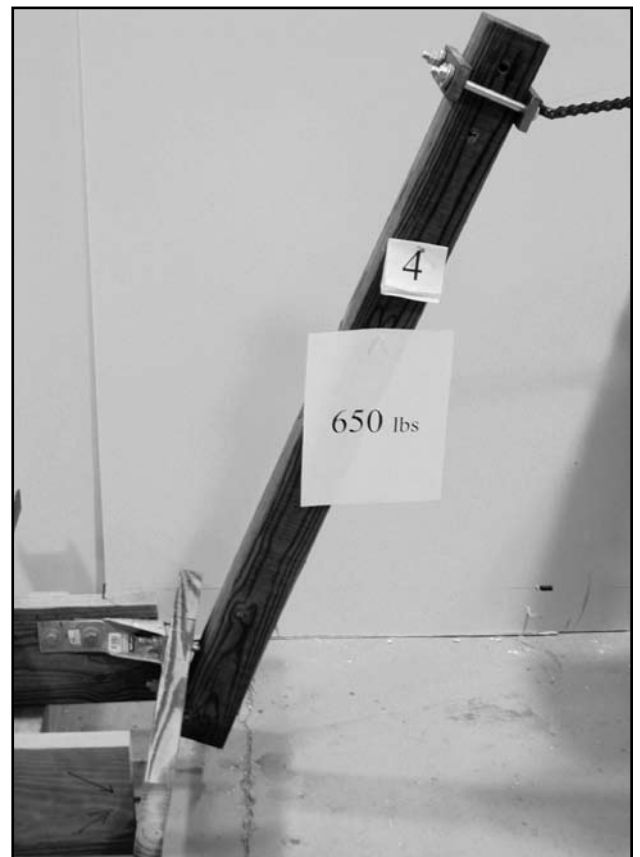
Figure 6: Outside band joist specimen loaded with 650 pounds. The specimens exhibited extreme “ductility” and this test characteristic is considered a desirable safety feature.

Figure 6 depicts a typical maximum deflection during one test for the case of “post outside the band joist.” From *Table 1*, the average deflection at the 200-pound design load at 37.5 inches above the simulated deck joists was 2.0 inches and 1.9 inches for the “inside” and “outside” details, respectively. Different failure mechanisms were observed for the two cases as the load increased up to
