# DALLAS FIRE STATION #27

Rebuilding with Site Constraints

By Akshai Ramakrishnan, P.E.

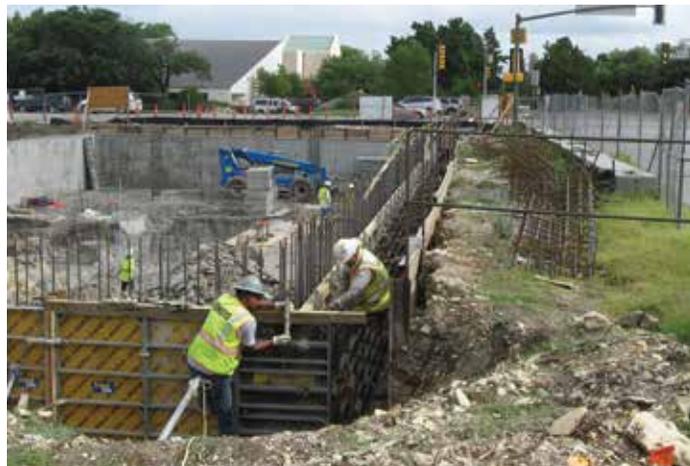
The width of the apparatus bay extended a few feet over the westernmost basement wall, which was constrained due to the two-way access to the parking level. That basement wall required the design of the hydrostatic forces behind the wall (considering a drained condition

as perforated drain pipe ran along the bottom of the wall) with an additional surcharge load of 250 psf for the apparatus bay.

The solution implemented by Ancortex Inc. and AP Engineering Consultant, Inc., was a cantilevered soldier pile retention system with timber lagging, constructed of W6x25 piles embedded six feet into the limestone stratum and encased in a ten-inch diameter grout filled bore spaced at 4 feet on-center. The footing for the east basement wall extended 12 inches beyond the exterior face of the wall but, due to the eccentric loading of the upper-level structure in some locations, the footing extended a minimum of 24 inches from the exterior face of the wall for about 50 feet. As a result, a two-sided forming system by Doka USA was utilized for the basement wall construction, with traditional diagonal strut bracing onto the basement slab to brace for loads imparted by concrete installation and backfill placement between the lagging and the basement wall. This also proved to be a difficult task, as utility easements ran along the east edge of the site and a workable cavity space was required to apply waterproofing. A low strength flowable fill (gravel mixture) was used for backfill because of the lack of space for compaction.
