Protecting a Landmark

The War Memorial Veterans Building

By Stephen K. Harris, P.E., S.E. and Benjamin A. Mohr, P.E., S.E.

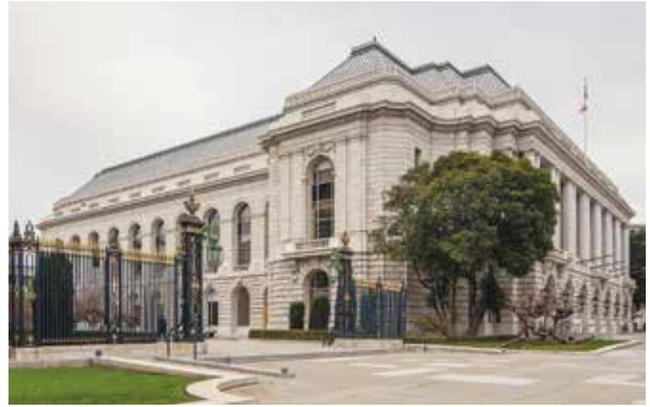
Heavy steel coupling beams were designed to connect the walls across the building's main corridors, while maintaining the shape of the vaulted ceilings, to control the rocking

behavior of the shear walls. A system of extensive steel bracing in the building's attic space was also designed, essentially providing a supplemental horizontal diaphragm where none existed before. All this allowed SGH to limit the expected drifts in the Maximum Considered Earthquake to less than 0.5%. The final design meets the Enhanced Rehabilitation requirements of ASCE 41 – equivalent to a new Risk Category III structure designed per ASCE 7. The design also included a new 70-foot span truss to allow removal of two columns at the Herbst stage, a new gridiron above the stage, new steel catwalks throughout the attic, and seismic bracing of historic hollow-clay-tile partitions and heavy plaster ceilings.
