Accelerated Bridge Construction Keeps Tappan Zee Bridge Open

By Helena Tam, P.E., Mohammad Shams, Ph.D., and Kenneth Standig, P.E.

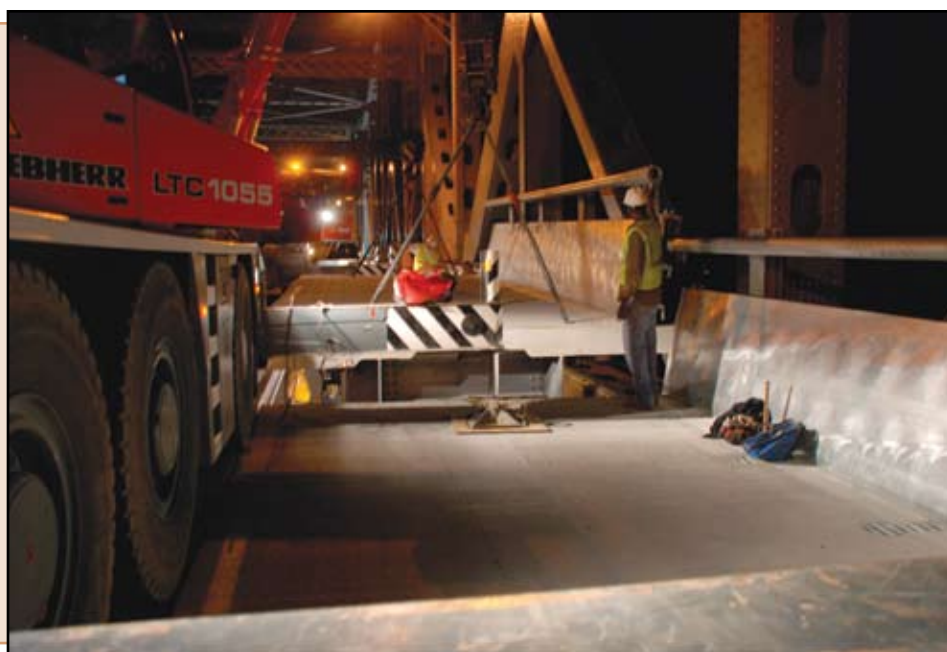
Installation of exterior precast deck panel, including permanent steel barrier, at main span, ready for vehicles to ride on in the morning.

As a result of the stringent traffic criteria, the deck replacement scheme was developed with strict limitations on lane closures to minimize traffic delays. (The contractor was required to open all lanes at the end of each night shift, in time for the morning rush hour, and was subject to penalties of a minimum of \$500 per minute for missing the deadline.) Three local contractors were contacted during preparation of the design to obtain feedback on the construction staging sequence and associated productivity rates. Based on these meetings, each prefabricated module was designed to be supported by two steel stringers with a concrete edge beam. They were sized to cover one lane of traffic, making it easy to lift and handle for installation during a single overnight shift. Also, since the deck of the main span and the West Deck Truss are at high elevations above the river, and because of the overhead members of the through truss, delivery from a barge was not practical. Therefore, the overall size of the deck module was determined based on roadway delivery constraints. Panels were transferred from flatbed trucks and set in place using on-roadway or barge-mounted cranes.

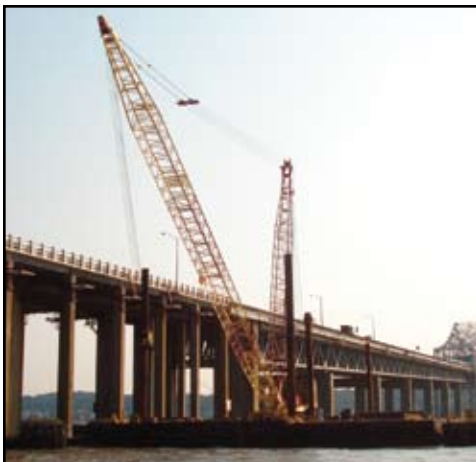
Barge-mounted crane is used to replace deck. Courtesy of New York State Thruway Authority.

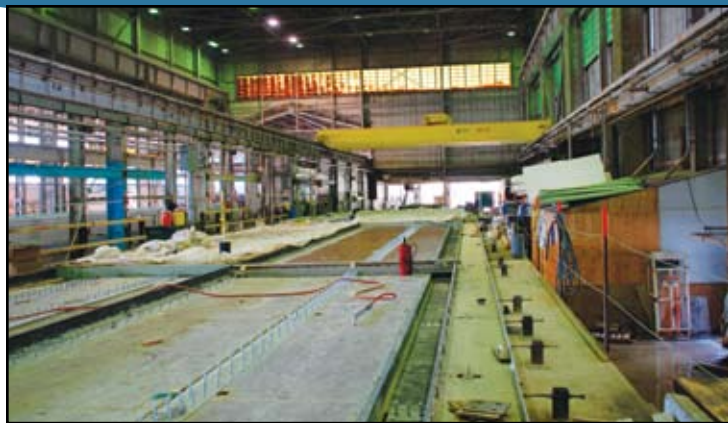
Deck panels are fabricated in this large precast plant in New Jersey.
