ENGINEERS WITHOUT BORDERS

Go to Guatemala

By Dan Mazzei, P.E.

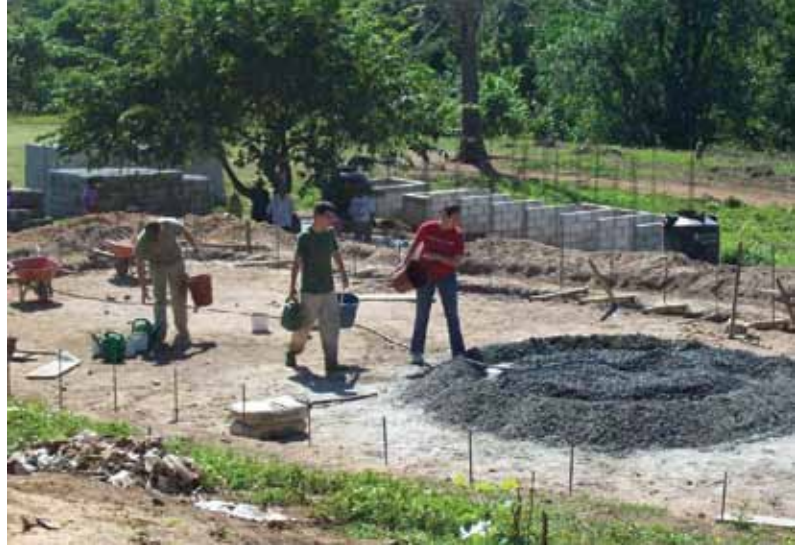
Figure 1: Local Method for Mixing Concrete and Water Distribution.

electricity. We solved the running water problem by repairing and rerouting a water line fed by a spring box about a half mile from the project site. The line was gravity fed, with minimal head and very slow flow, but still much faster than relaying buckets full of water to the site from the nearby river. Once repaired, the line was fed to an onsite and 'empty' septic tank for storage. We were now ready to mix and place concrete (Figures 1 and 2).

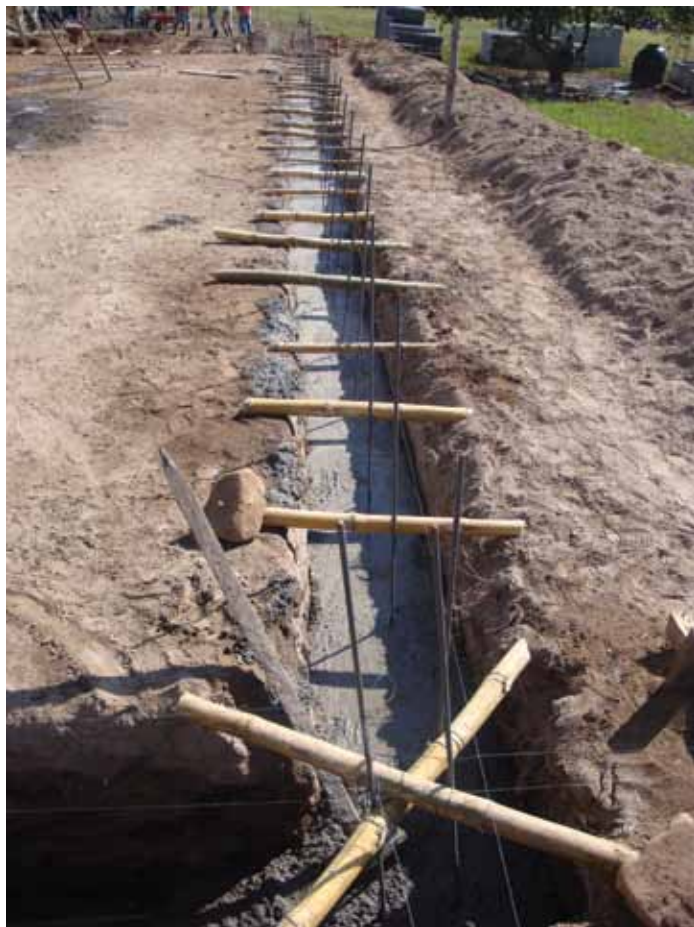
Figure 2: Reinforced Concrete Footings With CMU Dowels.

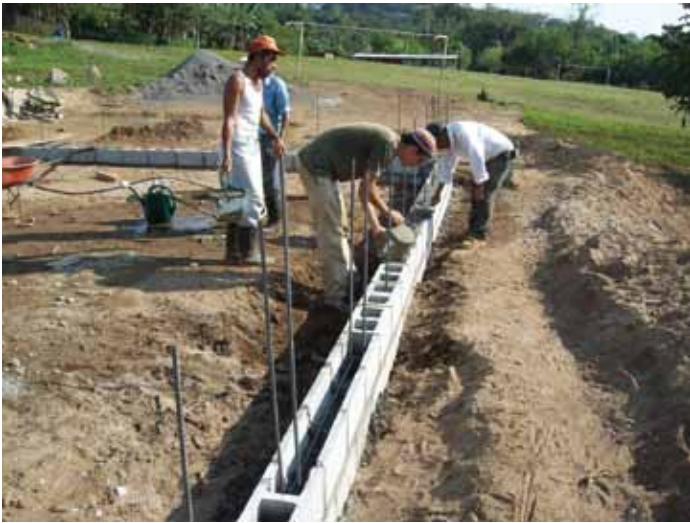
Figure 3: Placing High Slump Concrete for Grout in CMU Cells Near Door Opening.

experience, so this was a challenge to say the least. Our local master mason, Hugo, kept us inline and the CMU walls went up surprisingly fast and gratifyingly straight. The greatest challenge, beyond simply laying the blocks, mixing the mortar, mixing and installing high slump concrete grout, keeping reinforcing steel aligned, and keeping CMU lines straight and plumb (Figures 3 and 4), was making bond beam blocks out of lintel blocks. This was done with rebar chisels, hammers, and lots of elbow grease.

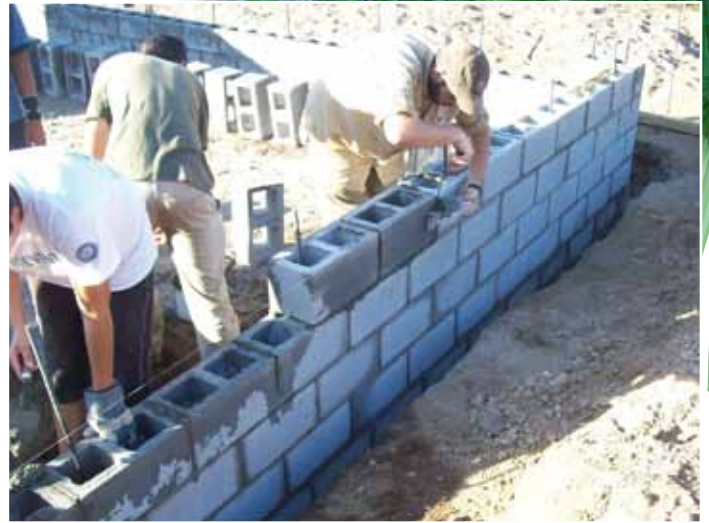
Figure 4: Working Off a Corner, Placing Block and Pointing Joints.

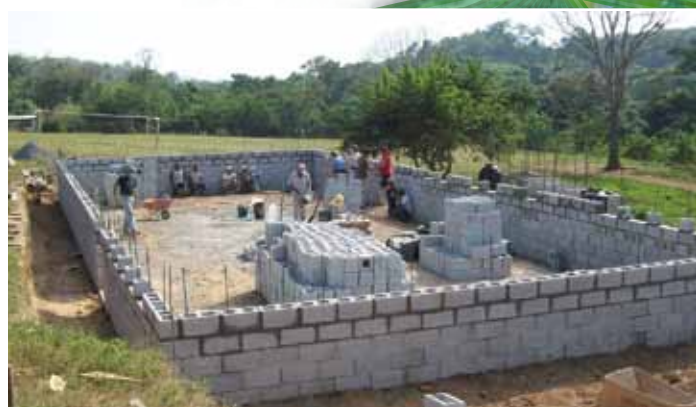
The School Building with Walls Erected Up to Midspan.
