Engineer with Your Eyes Open

By Scott R. Harpole, PE

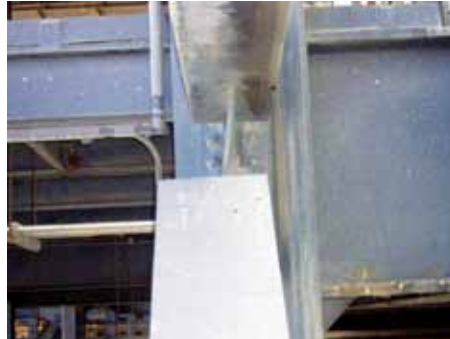
Figure 1.

A recent site visit to investigate the failure of slide plates on a flue gas ductwork system reinforced this concept as well as any class, design concept, or code document ever has. As a structural engineer, my eyes are continually drawn to the steel and concrete infrastructure that dominates the power industry in which I work. On the trudging climb to the top of a precipitator structure to walk down the subject ductwork, an oddity in the braced frame structure jumped out. To the chagrin of many architect counterparts, this structure was intended to be concentric, aligned, straight, square, the whole bit – but it was no longer. One of the large first-tier vertical braces had shifted noticeably out of plumb (Figure 1). After further investigation, I discovered that the gusset and web splice connection plates had buckled, further causing the web of the wide flange brace to begin tearing down the axis of the member (Figure 2).

structure that was in mid-design back at the office, soon to be built adjacent to the precipitator. It would be counting on this existing structure for both lateral and vertical support in varying capacities. As is typical in retrofits, the client had provided a set of existing structural drawings, the contract was written such that the new design could reasonably rely upon the owner-provided documents, and consequently the small proverbial snowball of design began rolling, formed around the nucleic assumption that the structure would look and act as the drawings indicated. Though it was later determined that the existing structure had likely relieved its excess load through the displacement of the brace, thus finding a new path to its foundation, and was stable in its current condition, it most certainly would not have been sufficient for the new loads that were going to be introduced.

Luckily, that snowball had not yet reached terminal velocity – about which a structural engineer knows nothing, but it sounds great in print – on its way down the hill of the project schedule toward construction, and thus the design could be redirected to stand on its own without the help of the failed bracing system. Though a more expensive approach, it was certainly the prudent one given the developments, and it would provide the client with the expected reliability and safety.
