STRUCTURAL REHABILITATION

Divine Design: Renovating and Preserving Historic Houses of Worship

Part 4: Architectural
Components and Finishes

By Nathaniel B. Smith, P.E. and Milan Vatovec, P.E., Ph.D.

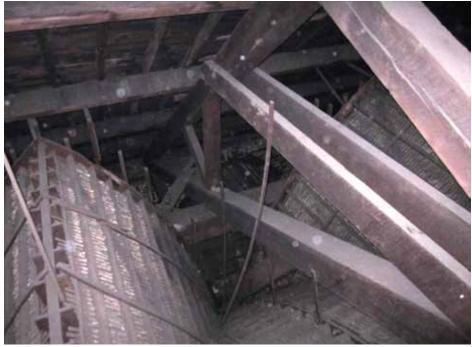
Plaster ceiling framing can be quite complex.

Structural engineers are often called upon to evaluate the plaster-ceiling support system to determine if it has adequate capacity to support additional ceiling loads (cover-board) or other architectural features (lighting, insulation, etc.), or in some cases partial removal to accommodate access. In other cases, these framing systems require evaluation to determine if their condition renders them inadequate to continue carrying the ceiling loads. Understanding the ceiling-framing layout is a key step in this process. The support framing for flat-ceiling systems is typically straightforward, with a series of parallel joists supporting the lathe and plaster; these systems are easy to assess and analyze for additional loads. However, many houses of worship are not flat and feature very intricate ceiling geometries, often with gothic arches. Despite the large level of redundancy, the framing for such ceilings is often independent from the main roof structure and can be much more difficult to analyze due to complex geometry, a multitude of components (with various stages of effectiveness or deterioration that may be difficult to quantify), unclear load paths, and lack of accessibility.
