Accelerated Bridge Construction to Rehabilitate Aging Highway Structures

Replacing Riding Surface to Maintain Structural Integrity and Durability of an Orthotropic Deck

By Ric Maggenti, P.E. and
Kenneth Brown, P.E.

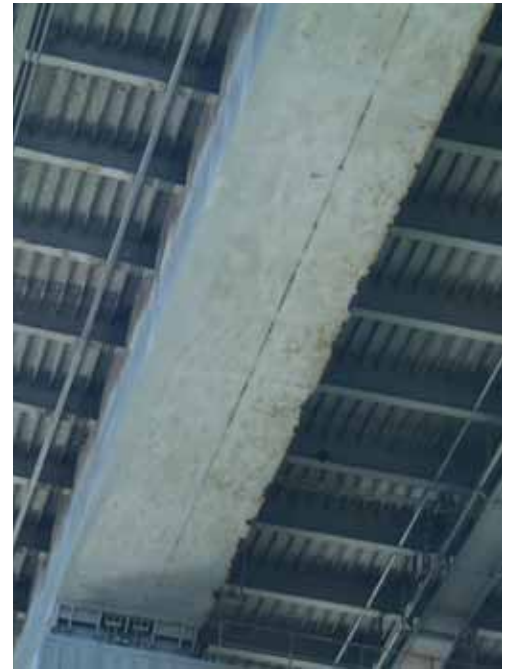
Figure 1. View from under showing ribs, girders and floor beams welded to deck plate.

form a composite structure. With the steel deck acting as the top flange for the ribs, beams and girders, this meets the definition of an orthotropic bridge, which is derived from the terms *orthogonal* meaning having properties at 90 degree angles and *anisotropic* meaning directionally dependent properties. The steel deck is on the fourteen 292-foot long spans, the main channel span of 750 feet, and the two anchor spans of 375 feet each (Figure 1).

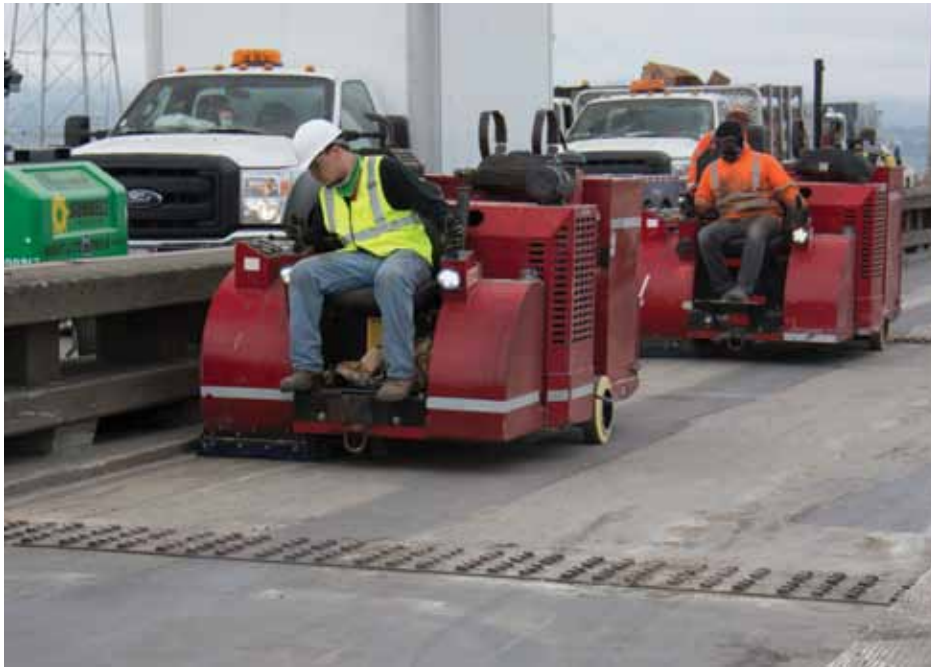
Figure 2. Deck being shotblasted after removal of old EAC. Note: Transverse bolted splice plate in foreground.

With the noise of pavement-breakers, excavators, loaders, and a variety of other heavy and hand equipment, the removal of 11 million pounds of 48 year-old EAC began (Figure 2, page 19). After midnight, loaded volumetric batched mixing trucks rolled onto the deck discharging polyester concrete into the pavers (Figure 3). Just prior, the deck was abrasively cleaned by self-propelled shot blasters followed by hand-held "sand" blasting. The prepared surface was checked for compliance with SSPC-SP 6/NACE. A liberal coat of methacrylate containing 85% by weight of zinc powder was then applied to the surface. Removal, deck preparation, and paving continued on through the weekend – the last of the paving completed shortly after midnight on May 11. A little more than half the bridge was resurfaced and, after clean-up and temporary striping, the bridge was opened prior to the scheduled 5 AM deadline. The process was repeated starting Friday, May 22 and by 3 AM on May 25 the bridge, now with a new riding surface, was opened to traffic.

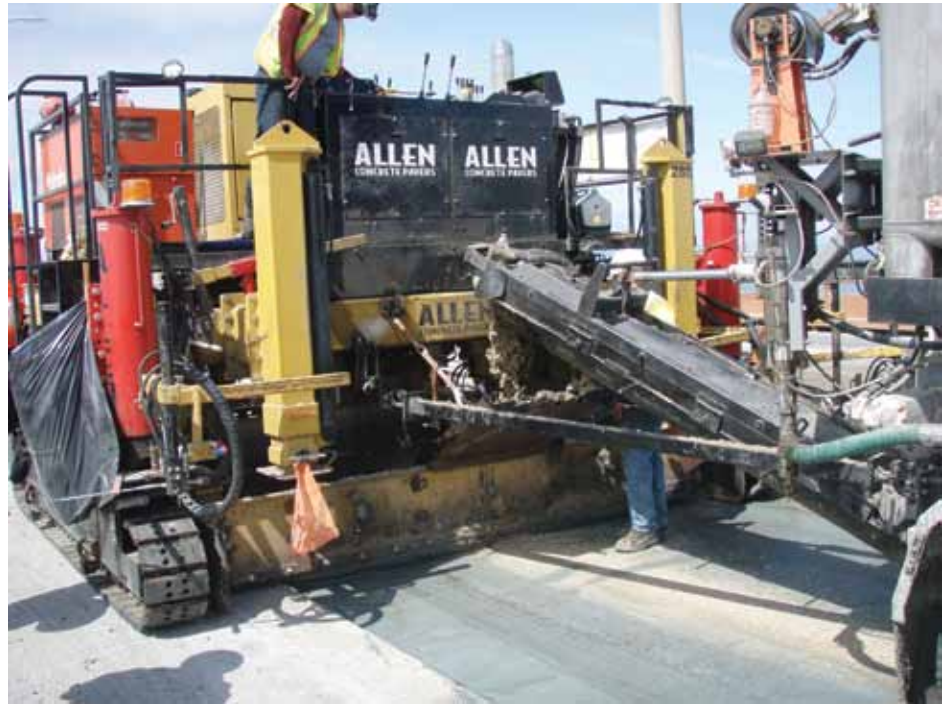
Figure 3. Continuous mixer/batching truck discharging into paver. Prepared surface has a coating of the methacrylate prime coat containing 85% by weight zinc powder as a corrosion inhibitor.

Conversely, a polyester concrete can be batched and mixed by continuous mixer and immediately discharged into a moving paver's hopper, resulting in no more than the small amount of material in the hopper needing attention at any given time. The paving rate can be easily adjusted since the batching

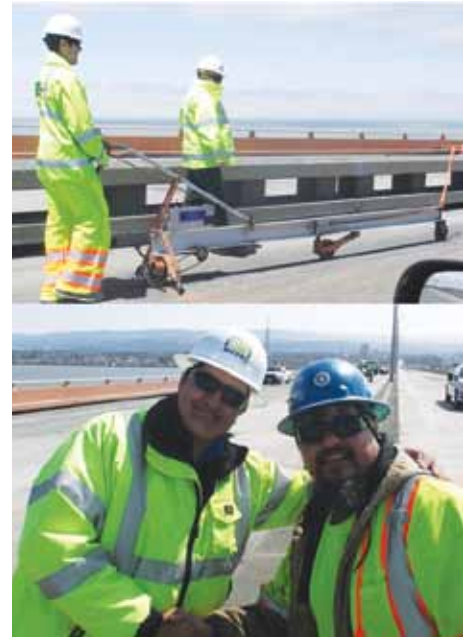
Figure 4. Top: Profilograph measurements ensuring contract compliance of quality ride. Bottom: Joint venture contractor foremen crossing paths in middle of bridge. One contractor worked eastbound lanes while the other worked westbound lanes.
