## When Good Engineering Ideas Go Wrong

By Jeremy Herauf

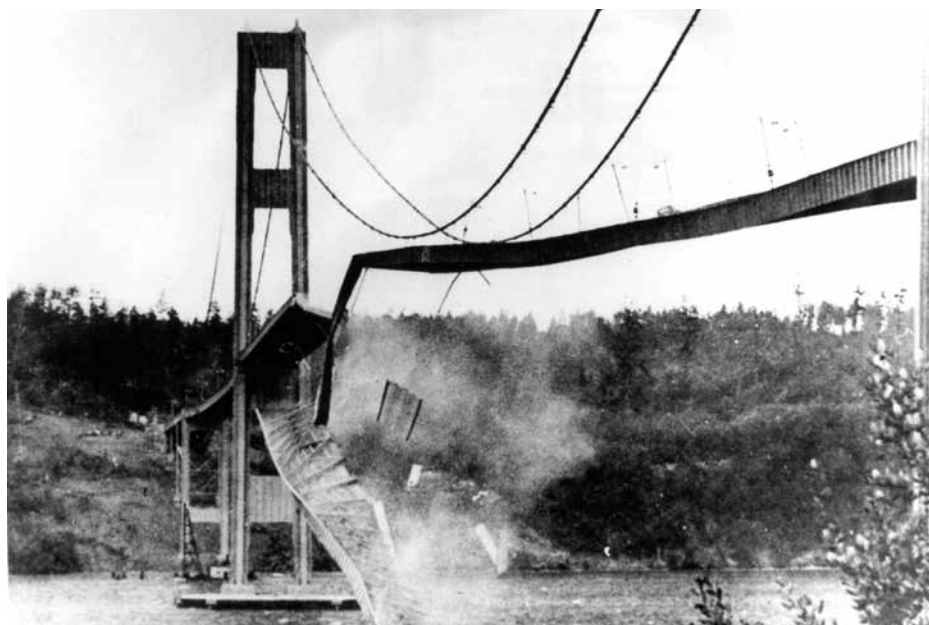
Tacoma Narrows Bridge collapse, 1940.

Despite all the great engineering minds that reviewed the bridge plan, they failed to see that all the factors that made the bridge *strong* and *stable* also made it *too rigid* to withstand the extreme winds that would batter it day after day.

While under construction, workers noticed that the bridge shook in unprecedented ways whenever the wind blew. It was so extreme, they nicknamed the bridge “Galloping Gertie.” Surprisingly, Moisseiff and the on-site engineers dismissed the shaking, assuming the issue would resolve itself once construction was complete. Work continued, and the bridge opened on July 1, 1940.

Just over five months later, on November 7, the bridge collapsed under 42 mile-per-hour winds, due to aeroelastic flutter.

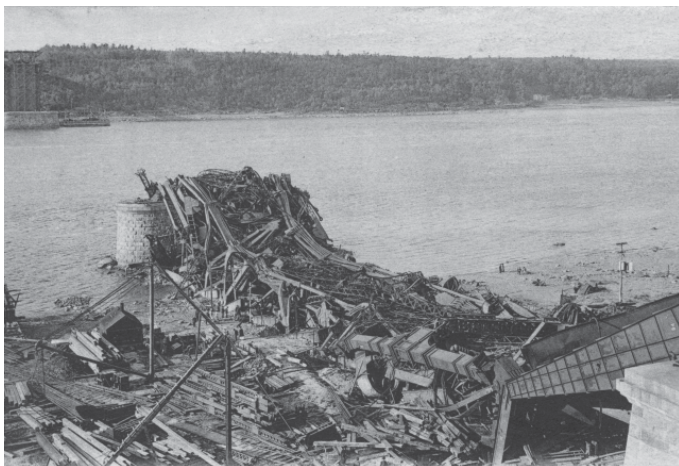
*Pont de Québec Bridge collapse, 1907.*

As early as 1904, when the bridge was almost half completed, engineers confirmed that the bridge itself weighed far more than its carrying capacity. They apparently ignored this, as construction kept going through 1907. In the summer of that year, the team began noticing stretching and contorting of important structural elements. Some engineers claimed that they were installed in this condition and the issues were once again ignored.

Soon after, the southern and central sections of the bridge suffered a catastrophic collapse, tumbling into the river in less than 15 seconds. Of the 86 workers on the bridge at the time, 75 were killed and the rest seriously injured. It is the world's worst bridge construction disaster and was officially blamed on engineers not closely

monitoring and managing the development of this novel design.
