Braced Frames: The Quest for Ductility

By Rafael Sabelli, S.E., and Patxi Uriz, Ph.D., P.E.

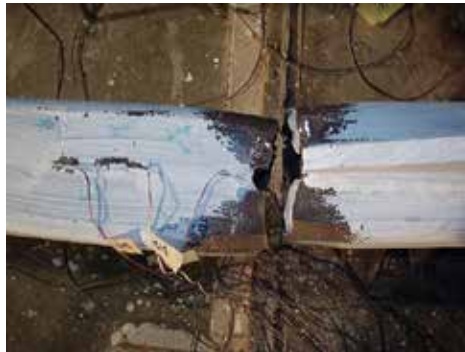
Figure 1 a. Net section fracture occurring at ductilities less than expected.

Typical HSS bracing connections utilize a “knifed” gusset plate, resulting in a reduced section immediately adjacent to the gusset plate. While this “net-section” area was known to be the weak link in brace behavior, the reduction in ductility was never quantified. The research demonstrated that typical designs were not ductile, *Figure 1a, page 13*, whereas reinforced connections performed well. New design provisions mandated reduced sections to be designed to be stronger than the brace, allowing distributed brace yielding. Typical details now include reinforcement plates (*Figure 1b, page 13*).

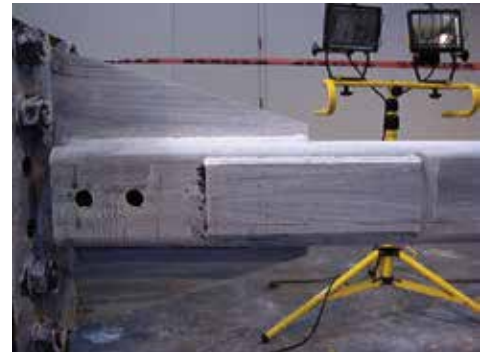
Figure 1 b. Cover plate details now commonly used to increase brace ductility.

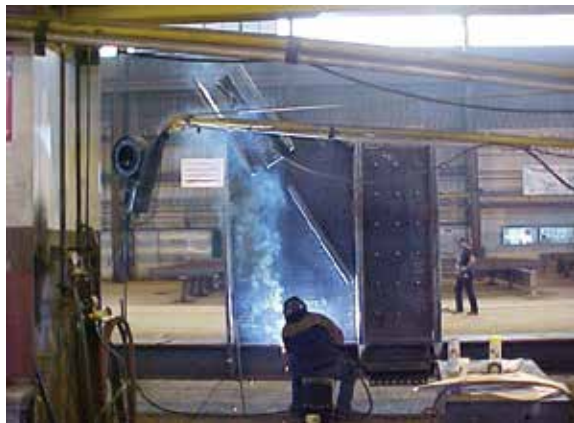
Figure 2a. Large gusset plate being fabricated.

Designers have sometimes favored large gussets, *Figures 2a and 2b*, for questionable reasons: reduction of weld size, simplification (or misunderstanding) of “Whitmore yielding,” etc. Such large gussets may result in weld failure and gusset plate separation from the beam-column joint. New design requirements mandate this to be remedied by requiring consideration of the design of such connections for flexural forces and rotation capacity.

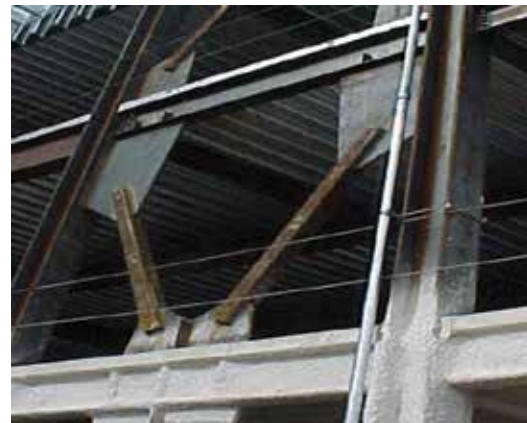
Figure 2b. Very large gusset plate installation.

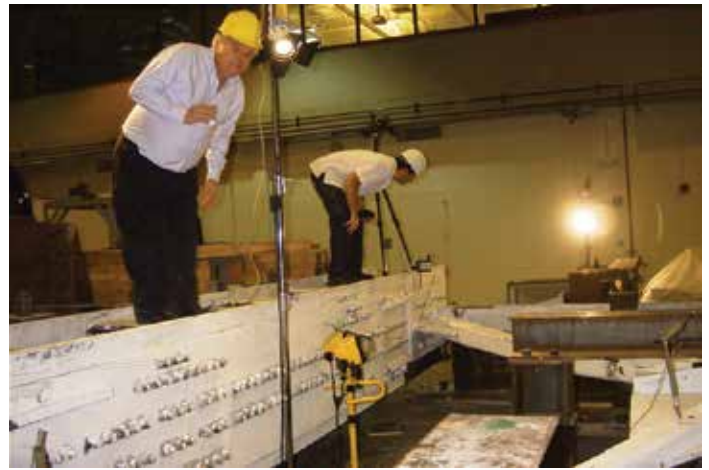
Figure 3. The authors acknowledge their debt to the late Professor Stephen Mahin, (pictured left) whose insights into the seismic response of steel braced frames (among countless other topics) has guided their work for many years.

In a similar vein, Simpson and Mahin (2018), *Figure 3*, have developed a design method to employ a “strongback” truss to prevent the formation of story mechanisms in braced-frame structures. Integration of such an approach into the code regimen of design is problematic, but the benefits in performance are considerable.
