A Coastal Community's Response to a Natural Disaster

Incorporating Resiliency to Coastal Designs in The Florida Panhandle

By Lance Watson, P.E., and Tyler Marsh, P.E.

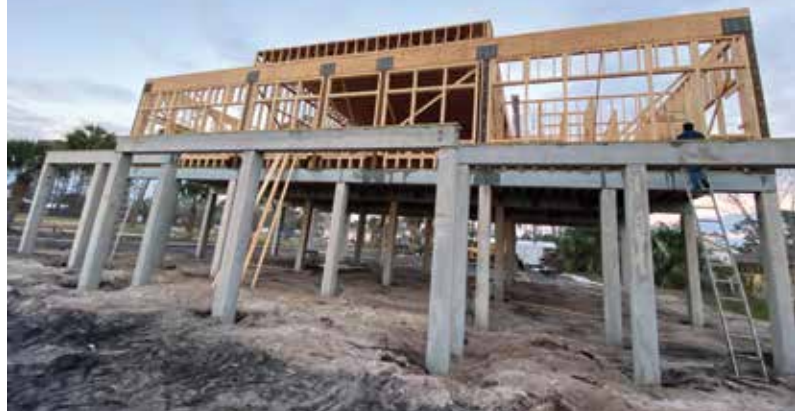
Performance-based design utilizing a moment frame to maximize openings on a new coastal home in Port St. Joe (Gulf County).

In many cases, performance-based design is implemented in coastal communities and other areas prone to natural disasters like hurricanes. This methodology considers a design approach that will protect the functionality and maintain the intended service and use of structures to continue to meet the needs of the owners and users. In the wake of a natural disaster, the term *resiliency* becomes a key factor in rebuilding a community. Most property owners that endured the devastation associated with Hurricane Michael want to ensure that, as they rebuild their homes, businesses, and more, all sensible measures are taken to ensure that their investment can withstand a similar storm event. Performance-based design presents the ability to meet the aesthetic and functional demands of homeowners and developers for the intended use of the structure while remaining within the established budget. The designer has the comfort level of providing a conservative design to suit the wants and needs of the Owner, while also preparing for the unknown, whether it be defective building materials, human construction errors, or natural disasters. This is especially important in Hurricane prone regions that are subject to high wind-speeds and velocity storm surge because the damage is unpredictable and highly variable. This approach can be suitably utilized with other climatic hazards as well.
