NAVFAC DELIVERS

A RESILIENT REMOTE HANGAR

By Yuriy Mikhaylov, S.E., and Frank K. Humay, Ph.D., S.E.

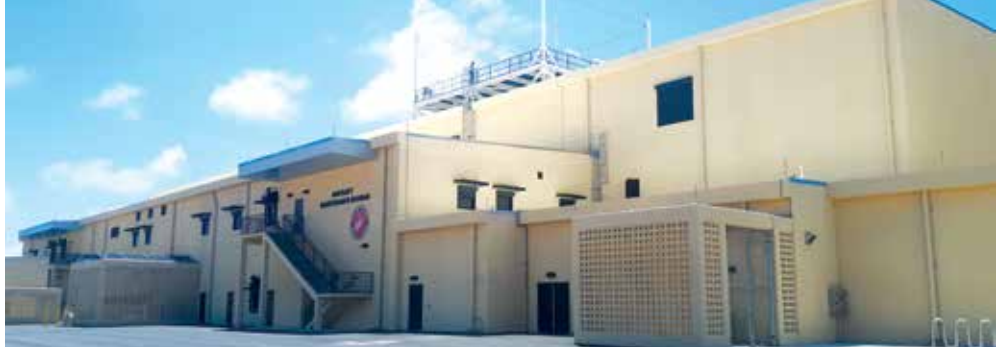
Figure 2. North elevation of the completed hangar.

The overall facility is 414 feet long by 176 feet wide by 65 feet tall and consists of three areas: the hangar bay, the shop and maintenance area, and administrative spaces. The single-story hangar bay has interior clear dimensions of 325 feet by 125 feet by 39 feet (to the bottom of the bridge crane) with 46-foot-wide door pockets on each side of the door opening (Figure 1). The facility's shop maintenance and administrative portions are located at the rear of the hangar in a two-story structure (Figure 2). The two-story structure's exterior dimensions are 272 feet long by 50 feet wide by 33 feet tall.

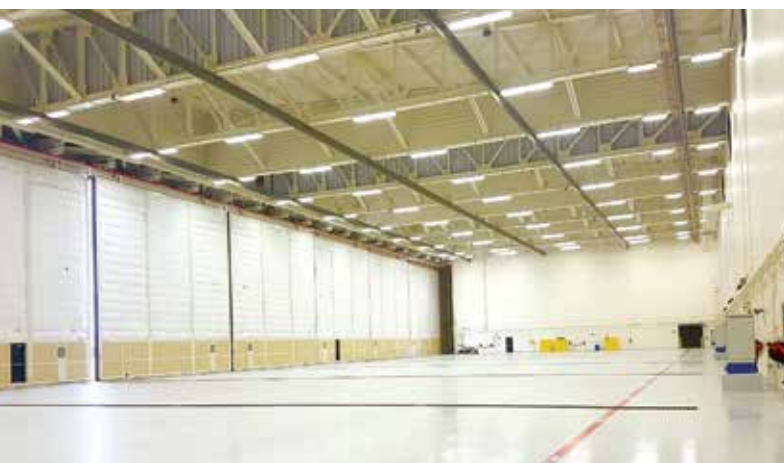
Figure 1. Interior of the completed hangar bay.

The hangar bay's interior has an overhead bridge crane with very stringent deflection criteria for the supporting structure (less than a couple of inches on spans greater than 100 feet), and the maximum variance between the crane rail supports cannot exceed 1/2 inch. Careful coordination with the crane supplier and steel fabricator was essential to meet these requirements.

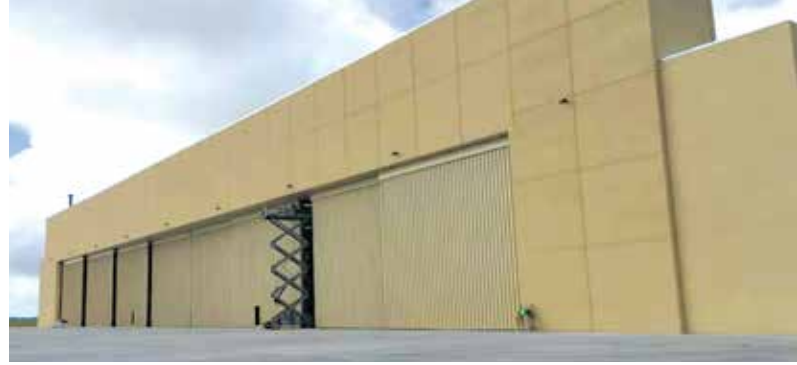
Figure 3. South elevation of the completed hangar.

pockets outboard of the hangar bay, four panels on each side. The door pocket enclosures support and protect the door panels and provide shear walls to stabilize the building's front in the longitudinal direction (Figure 3).

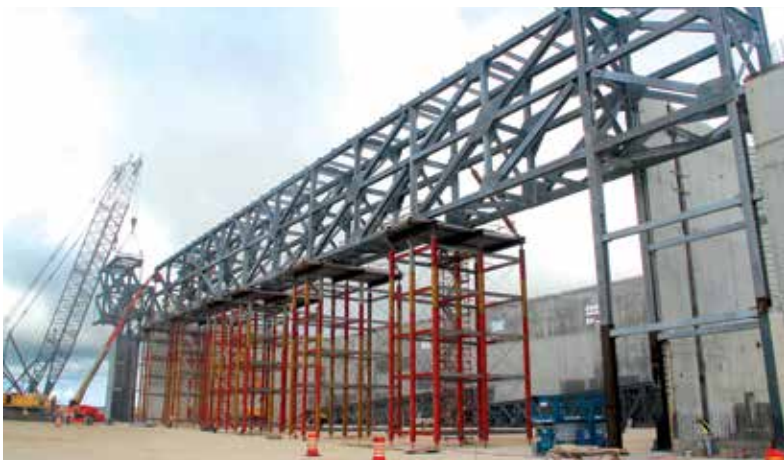
Figure 4. Box truss during construction.

The 325-foot-long box truss was designed and fabricated with a significant initial camber at mid-span that was expected to flatten as the box truss was progressively loaded. The camber was induced during fabrication by precisely adjusting the geometry of the individual members and connections. This large camber presented the final challenge – how to best sequence erection to ensure that, once the structure is complete, the estimated final camber is attained and the precast cladding panels are level and properly aligned. Developing a workable strategy involved close coordination between the design team, general contractor, cladding manufacturer, and precast erector.

First, the box truss was erected and supported using six shoring towers. Next, the main roof trusses, purlins, and metal deck were set, and the concrete topping poured. The weight of the roof structure removed 6.25 inches of camber. The box truss was then preloaded with concrete blocks that approximated the precast panels' weight to force the box truss to deflect into its final position (*Figure 5, see cover*). After each precast panel was aligned and erected, the concrete blocks representing the weight of that panel were removed. The box truss deflections were carefully monitored in the field over several months, and adjustments were made during construction where required.
