IT TAKES A VILLAGE TO Save a Bridge

BY MARK KANONIK, P.E., FASCE

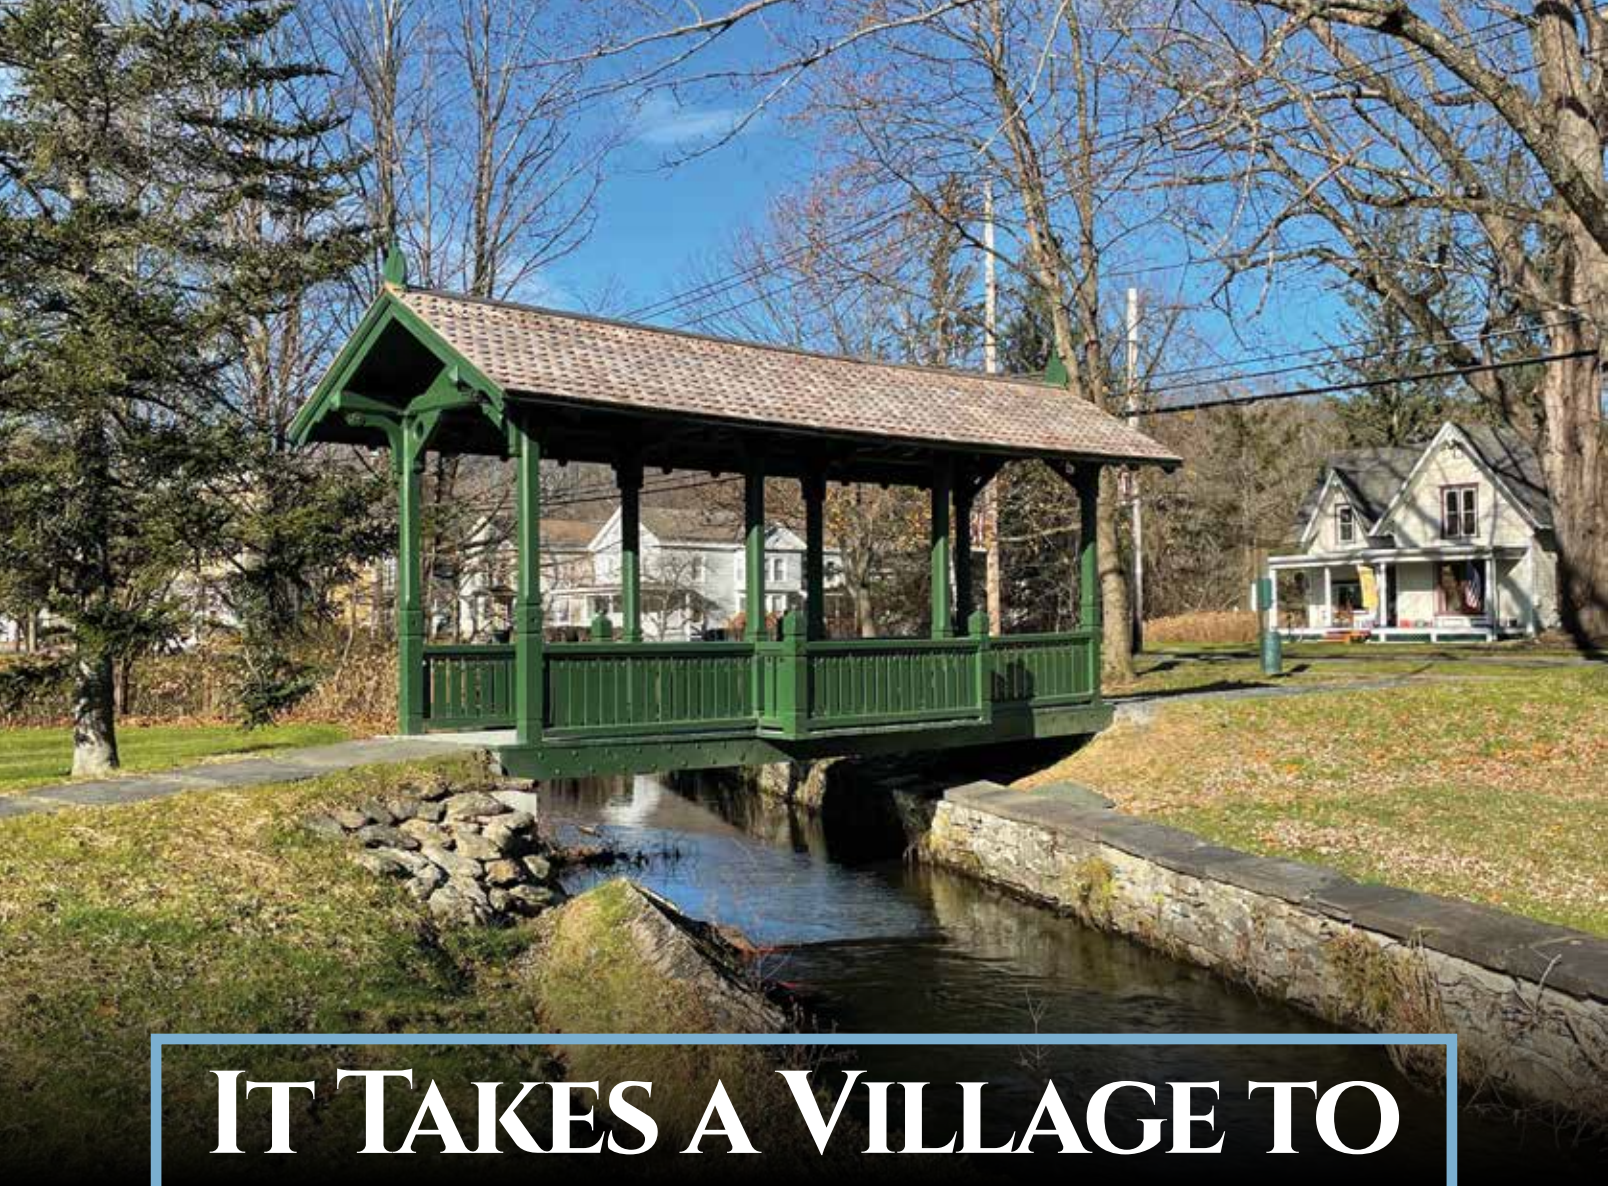
Pictured above: Completed bridge; note the failed stone lining wall on the left and the leaning stone wall on the right.

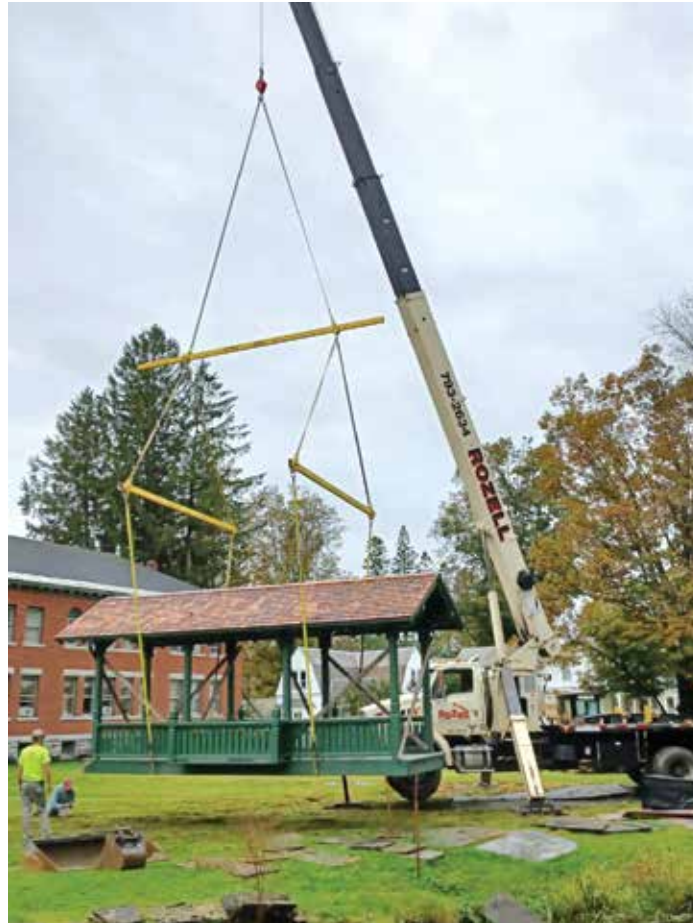
Bridge being set on new abutments with the help of donated crane services.

After four years in storage, the bridge was finally set on its new abutments in September, but something did not seem quite right – the bridge sagged by a few inches and it vibrated whenever anyone walked across it. The distance between the stone walls lining the stream was much shorter than the bridge’s overall length, meaning that the bridge was cantilevered over the stone walls by a couple of feet on each side. Probably for the first time in its 130-year history, the bridge was spanning its full length, and the stringers, while adequate to carry the dead and live loads, deflected noticeably. The Contractor temporarily jacked the bridge to as close to level as possible and installed engineered lumber beams alongside the existing stringers. The bridge remained relatively level when the jacks were removed, and the vibrational characteristics were significantly improved.

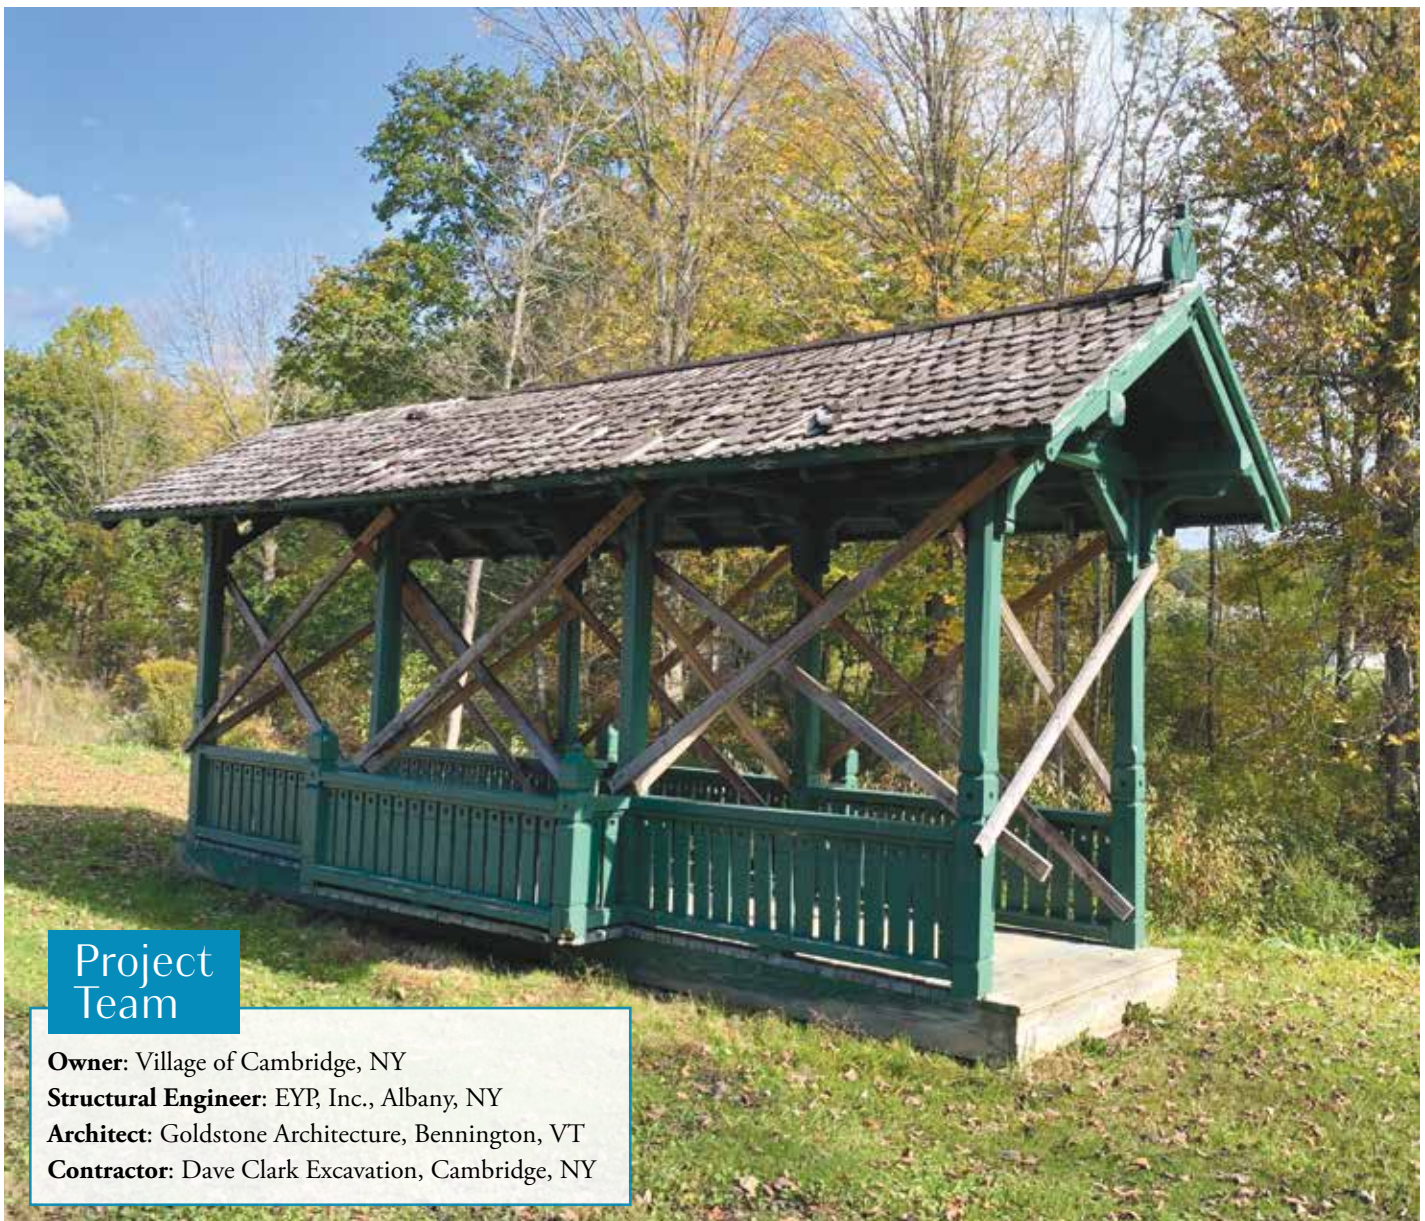
Bridge in storage off-site at the Village DPW yard; note that many diagonal braces were added to stabilize the bridge during lifting and transportation.
